# Conservation through calibration and communication

B. P. Tullis & S. L. Barfuss  
*Utah State University, USA*

The Summit Creek distribution system, located in Northern Utah, provides irrigation water to area farmers, the distribution of which is controlled, in part, by four open channel flow measurement structures. Two factors lead to the selection of Summit Creek as the case-study site for this project; its close proximity to Utah State University (~ 12km) and a River Commissioner with an expressed interest in project participation.

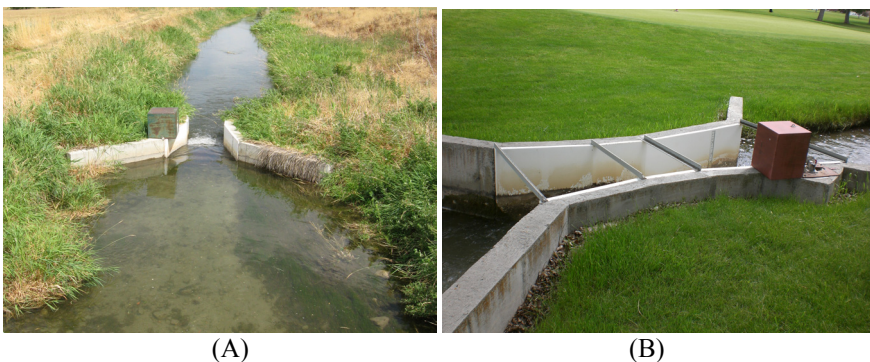
Structure #1 was out-of-level and had a staff gage  $\Delta Z$  offset of  $\sim 95$  mm. The uncorrected flow depth staff gage data, however, predicted a head-discharge

curve consistent with the theoretical head-discharge curve (using the standard 3-ft *Parshall* flume head-discharge relationship). The discharge predictive error associated with the corrected flow depth data (adjusted to the crest reference elevation) was significantly higher than the uncorrected data. Apparently, the staff gage elevation had been altered to account for flume geometry problems such as being out of level. Consequently, no corrective action was required.

Structure #2 was also out of level and  $\Delta Z \sim 6$  mm. Adjusting the staff gage reading by  $\Delta Z$  decreased the average discharge predictive error from  $\sim 6\%$  to  $3.5\%$ . Some of the dimensions of Structure #3 were inconsistent with standard design and  $\Delta Z \sim 29$  mm. Adjusting the staff gage decreased the average discharge predictive error from  $40\%$  to  $3.5\%$ . The maximum errors associated with the pre- and post-correction data were  $66\%$  and  $8\%$ , respectively.

Figure 3: 3-ft (0.9-m) *Parshall* flumes, Structure #1 (A), Structure #2 (B).

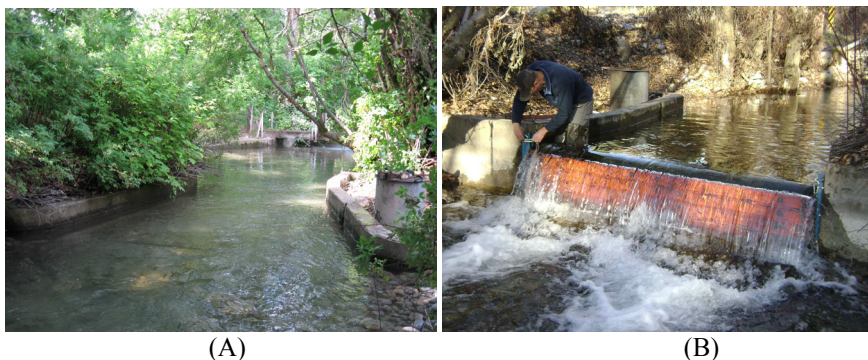
Structure #4, referred to a “three creeks,” presented the most interesting challenge. A two-creek confluence was located just upstream of the flume. Immediately downstream of the flume was the confluence with the third creek and a diversion structure. The flume tailwater, influenced by the diversion structure, created a  $\sim 100\%$  flume submergence condition, as shown in Figure 4(A). Producing a “rated section” calibration was not possible as the head-discharge relationship through the flume was non-unique due to independent variations in head and discharge caused by the downstream confluence and diversion structure. With buy-in from the River Commissioner, a decision was made to fabricate and install a sharp-crested linear weir on the downstream side of the *Parshall* flume. It was determined that under base-flow conditions, there was sufficient freeboard upstream of the weir to accommodate an elevated linear weir crest, capable of forming a critical section above the high tailwater. During spring runoff, the weir will be removed due to flood risk associated with high flow rates and because the momentum associated with the elevated flow rates will likely sweep out the downstream end of the *Parshall* flume, allowing it to function unsubmerged. A photo of the removable sharp-crested weir is shown in Figure 4(B). The linear weir will be calibrated during the 2009 irrigation season.

Figure 4: 8-ft (2.4-m) *Parshall* flume (Structure #4), operating fully submerged (A) and with the sharp-crested linear weir installed (B). (Note: tailwater lowered for weir installation.)
