Assessment of water logging and salinity problems in South Africa: an overview of Vaal harts irrigation scheme

O. I. Ojo¹, G. M. Ochieng¹ & F. O. A. Otieno²

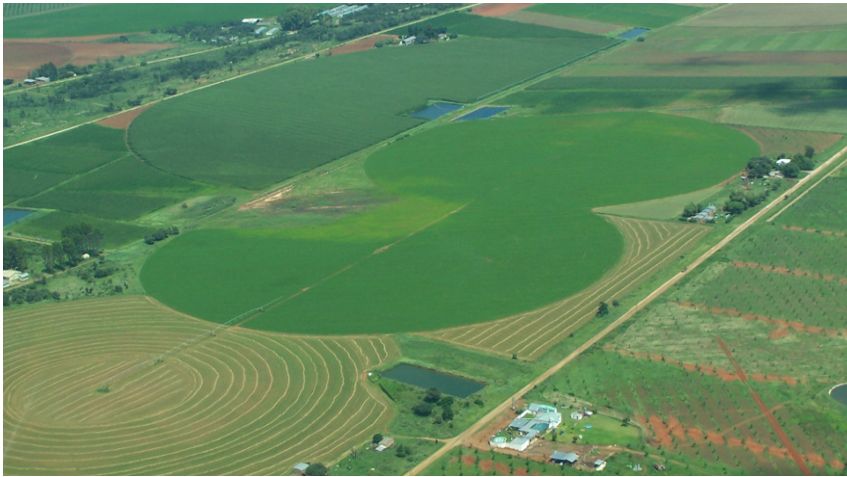
Figure 1: Aerial overview of VIS [9].

The Vaal harts Irrigation Scheme (VIS) covers about 36 950 ha and is one of the largest areas in the world. Water is provided to some 680 farmers [7]. The scheme is supplied with water abstracted from Vaal River at the Vaal harts weir about 8 km upstream of Warrenton.

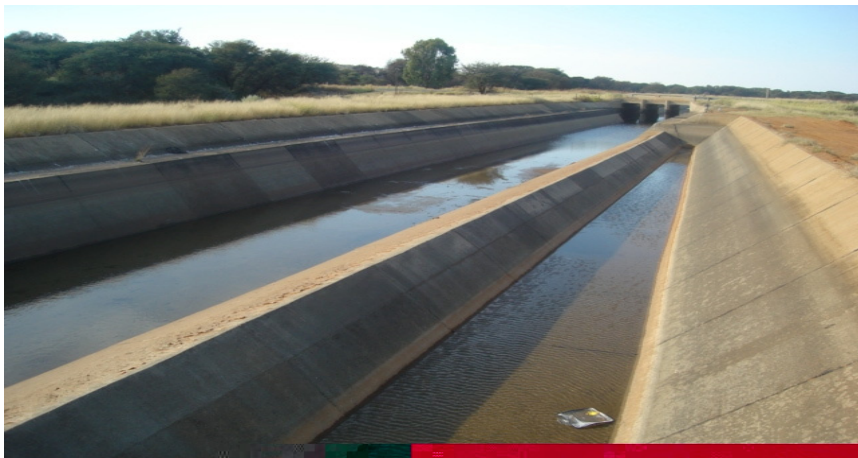
Figure 2a: VIS main canal with low level of water.

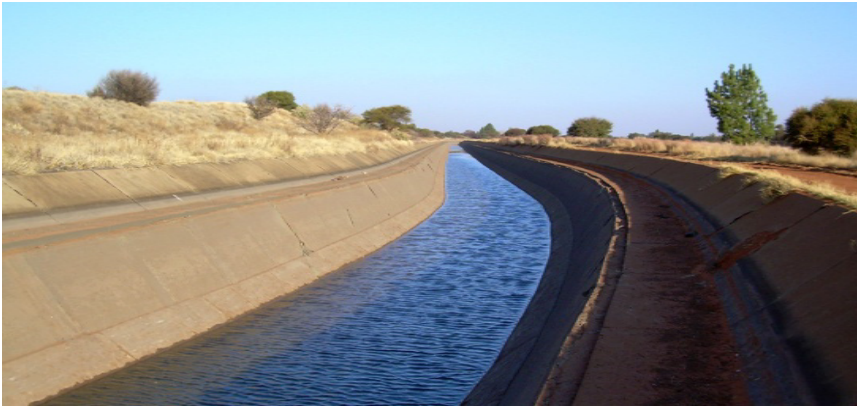
Figure 2b: VIS main canal [9].

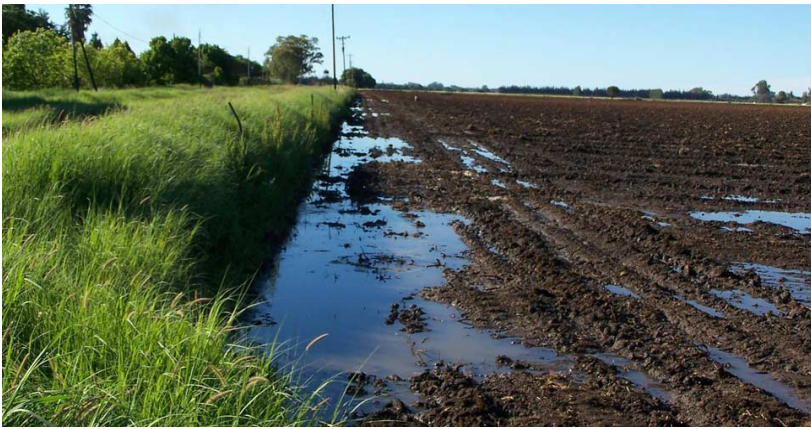
Figure 3: Waterlogged irrigation field in VIS [9].

According to Streutker *et al.* [10] flood irrigation commenced at the Vaal harts Irrigation Scheme of 30 000 ha established in 1940 and soon after, the groundwater table rose to between 0.9 and 1.5 m over the whole area. In 1956 several salinisation cases were reported and in the 1960s, a number of soil profiles from all over the Scheme, contained more salts in the subsurface than measured during the initial soil survey, indicating a disturbing tendency, although not alarming at that stage. Within 35 years the fine, sandy soils of this scheme were severely salinised. They reported on the reclamation of some 30 000 ha saline or saline-sodic soils (depth 0.3 m) at the VIS. Salt-affected soils resulted in a South African Rand R1.4–R2.1 loss in gross income for the irrigation scheme farmers. The installation of 218 drainage systems totaling 500 km of subsurface lateral drains at a cost of R2 million were undertaken between 1975 and 1977. Although the subsurface drains were successful in keeping the groundwater table below 0.7 m and leaching salts from recently salinised patches, there were still some 1 500 ha of saline soils by the end of 1977 and 1 000 ha in 1980. Bearing in mind that an estimated 100 000 ha of the 885 000 ha of the land of State Irrigation Schemes were salt-affected by 1976, the cost of

reclamation is justified only if maintenance of the water table does not require a considerable amount of over-irrigation and does not cause pollution down-stream which requires a high level of irrigation and drainage management. In the period 1974–1976, the semi-arid Vaal harts area (218 farms) received above average rainfall resulting in a critical level of soil salinisation. Surface storm water did not drain fast enough and the water table quite often rose to 0.3–0.6 m from the soil surface. Farmers started depending on the high water table and ignored leakage as well as drainage planning and continued over-irrigation with devastating effects. A further R2 million then had to be invested to install sub-surface drains on farms and to link these drains to the partially developed system of open storm water drains, in an attempt to lower the water table and to leach salts [10, 11].

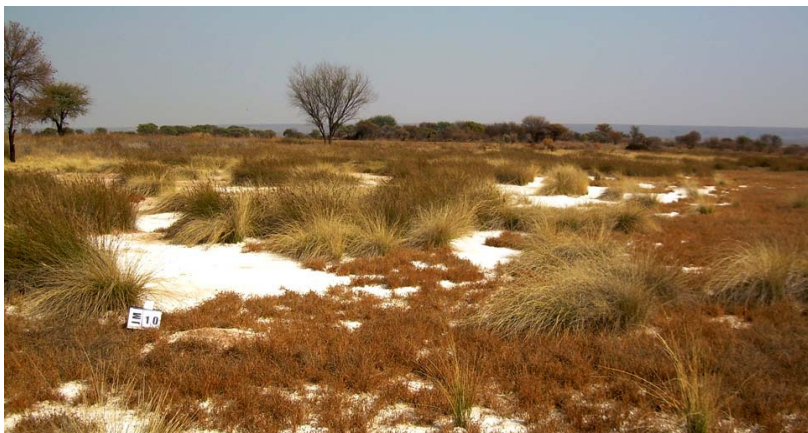
Figure 4: Salined area in VIS [9].
