# Infrared thermograph image analysis for the identification of masonry coatings in historic buildings, in relation to several samples prepared as patterns

L. Palaia, J. Monfort, P. Navarro, R. Sánchez, L. Gil, A. Álvarez, V. López & S. Tormo  
*Polytechnic University of Valencia, Spain*

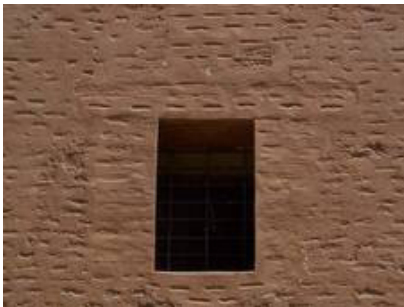
Figure 1: Existing window.

The first approaches with the IR thermocamera gave interesting results for the detection of building material discontinuity under the façade coatings. This device was able to capture images of the building walls, producing thermal images showing lintel elements as in figs. 1 and 2, also previous repairs and signs of demolished walls on the existing ones, as in figs. 3 and 4. A previous window that had been walled up was also identified, as in figs. 4–6.

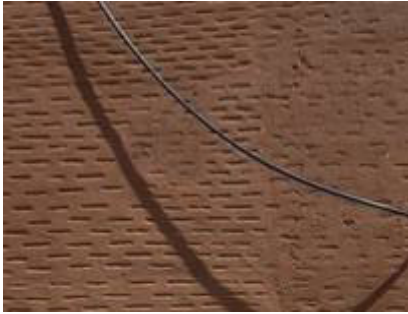
Figure 3: Image of the wall.

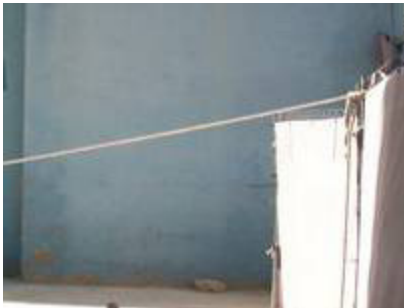
Figure 5: Image of a wall.

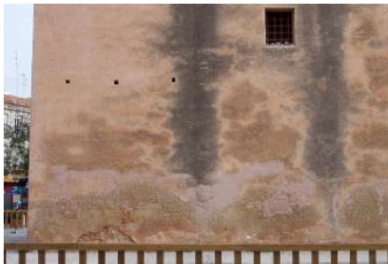
Figure 7: Detail of the tower.

A medieval tower was surveyed by means of IRT images, with promising results, so the research group resolved to improve the applied method. In this tower, located at Torrent village, close to Valencia City [7], different IRT images were captured in the same day, at different hours, in order to detect the best time to capture IRT images. The factors considered for the IRT images analysis were insulation level, orientation and wind velocity.

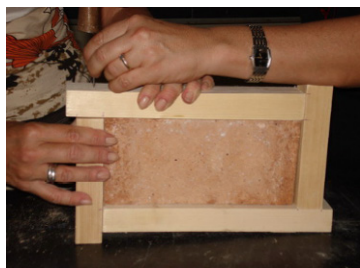
Figure 10: Wooden frame preparation.

Mortar samples were prepared with the following characteristics: manual bricks, measuring:  $22.5 \times 10.8 \times 3.4$   $\text{cm}^3$ ; wooden frames to provide uniform thickness of mortar coatings,  $4.6, 5.5 \times 6.5 \times 3$   $\text{cm}^3$  (section); iron plates,  $30 \times 120 \times 2$   $\text{mm}^3$ ; current sand for mortar coatings, cement CEM II-B L 32.5 N; gypsum YG and soaked lime.

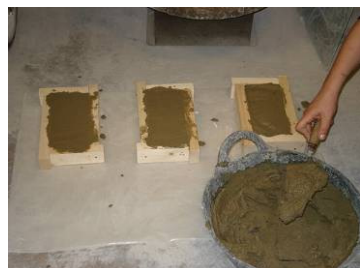
Figure 12: Cement mortar samples.

Samples 1, 4, 7 and 10 were prepared with cement mortar, those numbered 2, 5, 8 and 11 were prepared with lime mortar, and finally, samples 3, 6, 9 and 12 were prepared with gypsum mortar, always varying the thickness: 1, 2 and 3 cm. Samples 10, 11 and 12 did not contain iron plates and have a 3 cm thick coating. IRT images were captured at different times: 15:30, 16:30 and 17:30. The obtained results were very revealing.

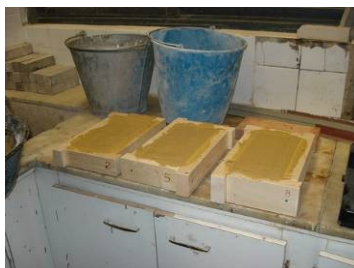
Figure 13: Lime mortar samples.

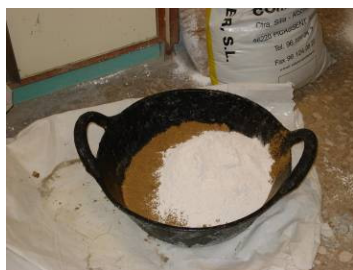
Figure 14: Gypsum mortar preparation.

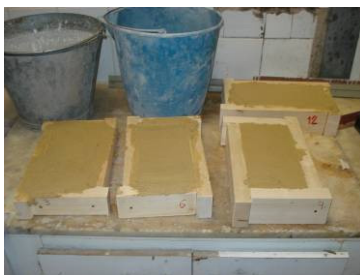
Figure 15: Gypsum mortar samples.

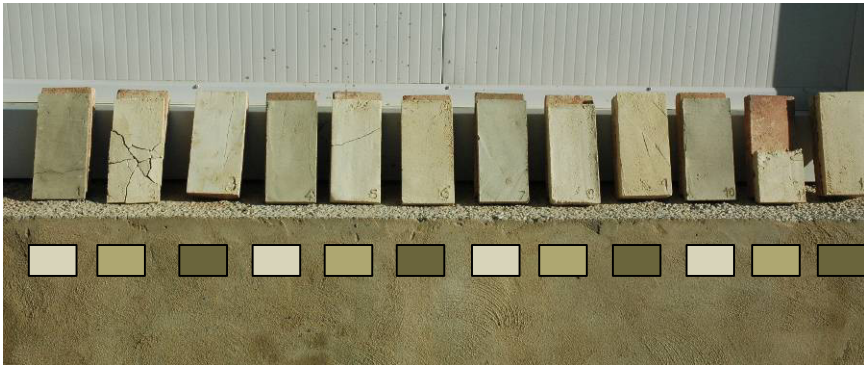
Figure 16: General view of the mortar samples.

The mortars prepared as samples were: cement mortar, 1:3; lime mortar, 1:3; gypsum mortar, 1:2, with increasing thickness as shown in table 1. Iron plates were introduced beneath the mortar coatings in nine of the mortar samples (1 to 9), with the aim of detecting their presence thermographically. The preparation of the samples can be seen in figs. 10–15. The samples exposure to sun radiation is shown in fig. 16 and the corresponding IRT images at 16:30 hours are shown in figs. 17 and 18.
