# The cause and mechanism of Gouras stream mudflow in Epirus (W. Greece)

## Abstract

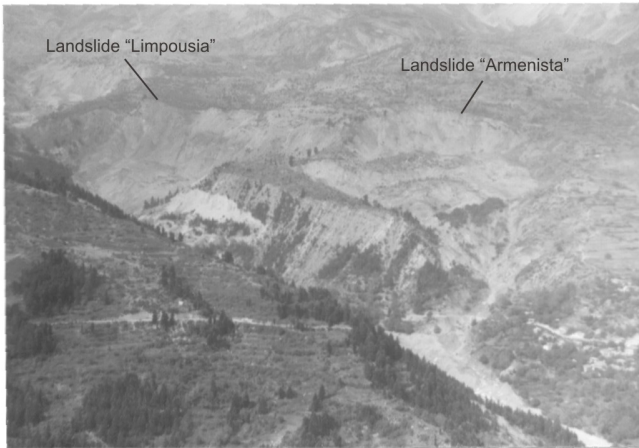
Figure 6: The landslides «Limpousia» and «Armenista».

**The great landslide or “Limpousia” (1):** it is developed on the right side of Gouras in a distance of about 1200 m upwards the village (fig. 6).

It is a general and abrupt collapse of an elongated significant slope, whose voluminous geomasses created mudflow and caused serious problems in the area of this current.

**The landslide “Armerista” (2):** It is developed in higher altitudes than the village (Figure 7). Although the first land sliding took place here in 1926, the great landslide happened later in 1963.

As a result of the way that the above landslides are developed and arranged in the area (Figure 6), there is an impression that they comprise partial landsliding occurrences of a united landsliding whole, which is extended to the center of the watershed area of Gouras current and dangerously surrounds the Theodoriana village (Fig. 7).

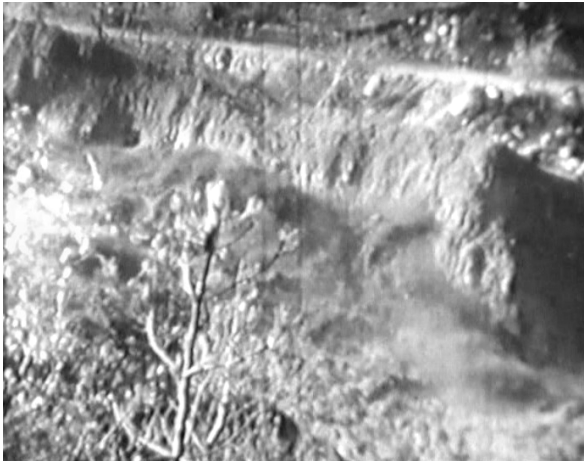
Figure 8: The mudflow movement on the bed of Gouras torrential current.

The great landslide happened on 16 December 1981. The descriptions of the eyewitnesses make obvious that the ground of the landslide indicate creeping that resulted in a “waving” shape of the surface a few days before the event. Thus, small cavities were created and were filled with rainwater. The main landslide took place during the noon on 16.12.81. The movement of the geomass was abrupt. Great bulks of materials collapsed downwards to the gradient and vertically to the water flow, fell on the torrent’s bed, blocked it and created an earth dam.

A lake was formed from the blockage of the torrent’s bed. At 12.25' on 16.12.81 the earth dam, which in the meantime had been pulped due to its saturation with water and its high hydrostatic pressure, was put in motion. This resulted to the first mudflow on the torrent’s bed that was followed by a great rumble and strong vibration of the ground. The height of its “head” was about 30 m and its speed was estimated to 100 km/h according to eyewitnesses (Fig 8).

More than 20 similar waves took place and moved till about 3.00' in the morning the materials of which were discharged in River Acheloos. However, their traces still remain in the gradients, while bulky stones can still be found on the riverbed giving evidence of the above-mentioned event.
