Restoration projects and mitigation of post-flood hazards – a case study on the Maruyama River in Japan

M. Takezawa¹, Y. Maeno¹, Y. Yamashiki¹, H. Gotoh¹,
M. Kawashima² & T. Tanaka²

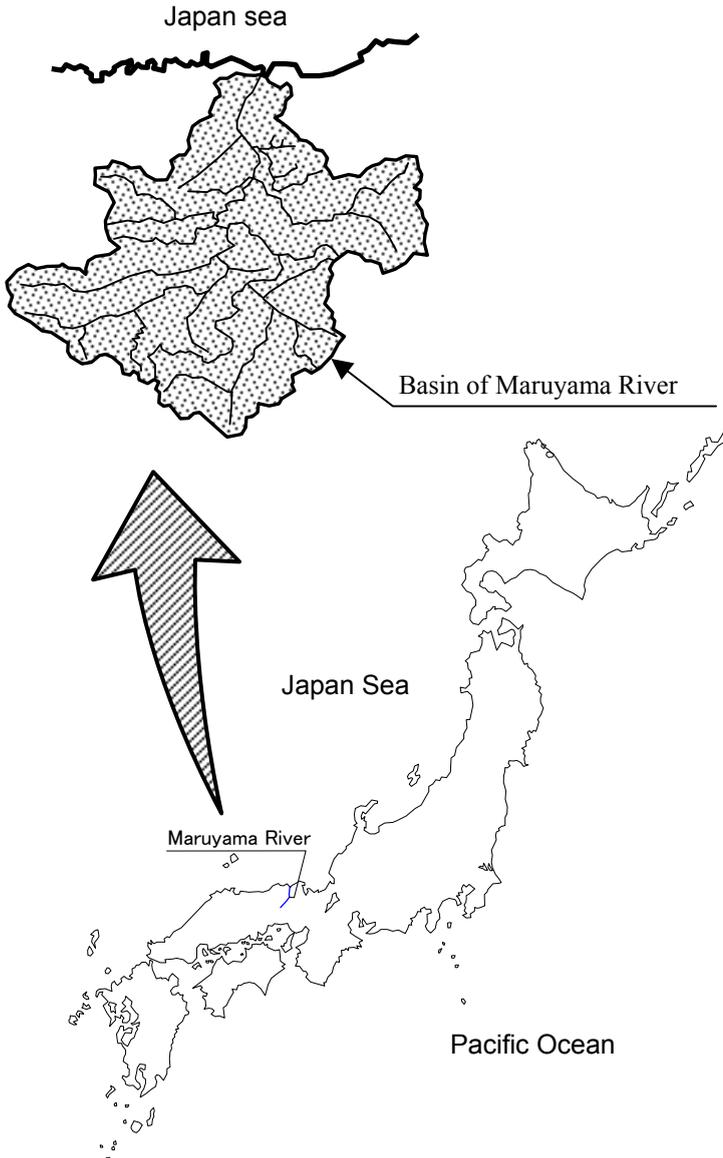
Figure 1: Location of the Maruyama River.

The Maruyama River, which flows from the Cyugoku Mountains, is located 640 m above sea level and consists of 97 branches. The main river is 68 km long and has a drainage area of 1300 km². Figure 1 shows the location of the Maruyama River and a detailed map of the river basin. The ancient Maruyama River had an inlet lake facing the Sea of Japan, with sedimentation from the upper Maruyama River blocking the river mouth. As a result, the Maruyama River basin was damaged by annual flooding. To improve river flow, large rocks were installed at the mouth of the Maruyama River to allow for smooth discharge of water from the inlet lake to the Sea of Japan. The floodplains of the Maruyama River basin changed from marshes to cropland as a result of the structural improvements. The basin of Maruyama River is 86% mountainous and 14% flat land, which is used to cultivate grain. The lower reaches of the Maruyama River have a very gentle slope, 1/9,000, forming an estuary. The upper reaches of the Maruyama River meanders and have a riverbed slope of 1/850 ~ 1/640.

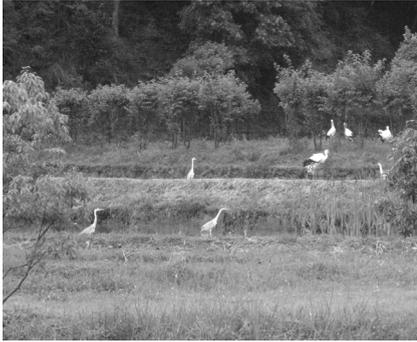
Figure 5: Stork habitat.

Natural Monument in 1956 and stork breeding farms were opened in 1965. Although three pairs were captured during the period from 1965 to 1968, the last wild stork in Japan died in 1971. Six juvenile storks were donated from Russia in 1985, and the stork pairs were successfully bred in 1989. As a result successful annual breeding, the number of storks exceeded 100 by 1999. The Stork Release Promotion Liaison Council was established in 2002, coordinating the efforts of residents, government, and various industries such as agriculture and fishing to create a habitat for the stork and other marshland species. The liaison council developed the Stork Release Promotion Plan in 2003, and on September 24, 2006, five incubated storks were returned to the wild in Toyooka City [8]. Figure 5 shows a created stork habitat and Figure 6 shows a stork nest.

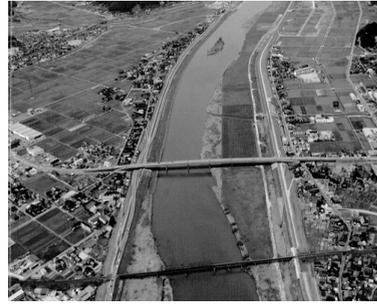
Figure 8: River terrace after cut.

Several Maruyama River flood management projects have integrated environmental benefits. To create an alternative pathway for flood waters, the river terrace was excavated in the midstream reaches of the Maruyama River, as shown in Figure 7. As a result, the wetlands along the river shore were regenerated by constructing a shoal along the river terrace (shown in Figure 8) and providing a appropriate habitat for wetland species [10].

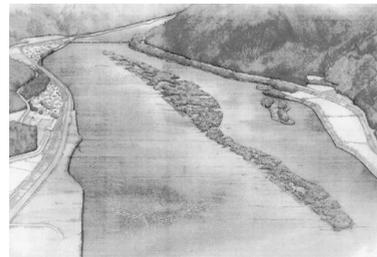
Figure 10: Future profile of Hinoso Island.

Figure 9 shows Hinoso Island, which is located 1,400 m above the mouth of the Maruyama River and obstructs the smooth river flow. Plans are in place for excavating half of Hinoso Island (Figure 10). Planning for the excavation of Hinoso Island must consider potential habitat disturbance and proceed in a manner that will conserve the island's plants and animals [11].

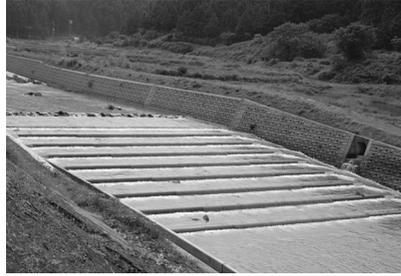
Figure 12: Weir with fish ladder.

Another threatened species in Hyogo Prefecture is the Japanese giant salamander. Certain disaster recovery projects such as the restoration of the river, road facilities and agricultural facilities, may potentially impact the habitat of the giant salamander. As a protected species, impacts to the giant salamander must be considered during the planning and implementation of these construction projects [4]. Several river reinforcement structures have been constructed that accommodate the needs of wildlife. Figure 11 is the Japanese giant salamander that is about 55 pounds and five feet long. Japanese giant salamanders inhabit the cold, fast-flowing mountain stream and rivers of the west in the Japanese Island, eat almost anything they can, from insects to fish to mice to small invertebrates like crabs [12]. Figure 12 shows a weir with fish ladder, Figure 13 shows natural river materials, such as gravel and reeds, and Figure 14 shows a stone masonry revetment built with a fish reef.

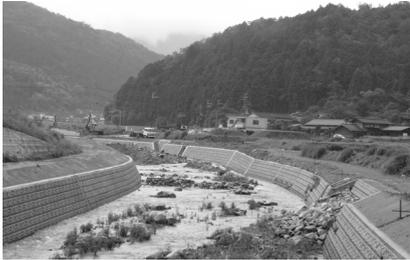
Figure 13: Natural river materials.

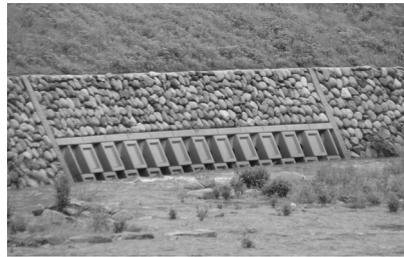
Figure 14: Stone masonry revetment fit with a fish reef.
