Remember the “*MAINE*”

O. P. Jons

Abstract

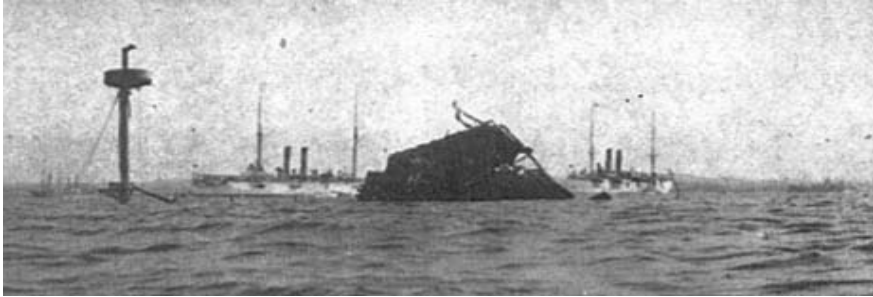
Figure 2: USS *MAINE* Wreckage (1898-1911).

The U.S. Navy quickly put together a court of inquiry to investigate the disaster. Four naval officers headed by Captain William Sampson undertook the investigation. The Sampson Board was faced with a wreck of a ship mainly under water, Figure 2. The Board was conducting its inquiry on a small ship tied up next to the wreck. Sailors from other ships were drafted as divers. With little knowledge of ship architecture, these men tried to make sense of the underwater wreckage.

Three weeks into the investigation, divers reported a large flap of metal, pushed into the inside of the ship. The fact that it was painted green indicated that it had been part of the outer bottom hull structure, in other words: an outer hull section had been pushed upward/inside.

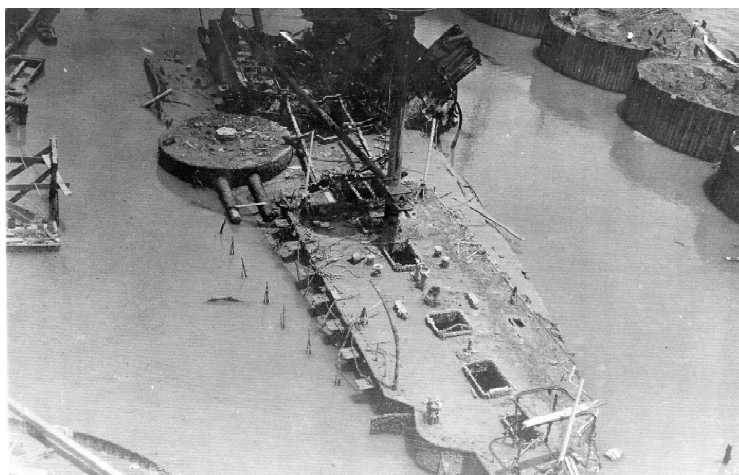
Figure 3: Recovery of the *MAINE* in 1911.

The U.S. Army Corp of Engineers accepted the challenge. A cofferdam was built, surrounding the wreckage, to be able to pump the water out. Eventually, the engineers were successful and sections of the *MAINE* began to emerge, as shown in Figure 3.

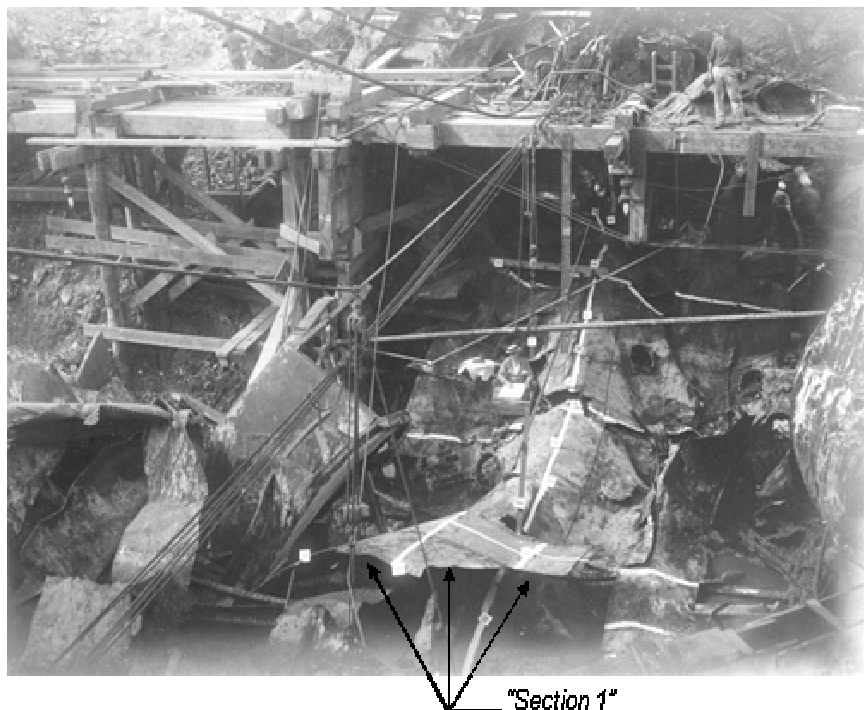
Figure 4: “Section 1” – The Smoking Gun.

On November 7, 1911 Ferguson reported to Washington a very important discovery: The large flap of steel that had once been part of the **outer hull** had been located, - **inside** the hull, as clearly illustrated in Figures 4 and 5. It became

known as “Section 1”. This was viewed as clear evidence that a mine explosion had caused the sinking of the *MAINE*:

It is clear that the combined force of the magazine explosions blew major parts of the ship structure in their path *outward*. One section, the infamous “Section 1”, however, was found bent *inward/upward*. This clue was cited in 1898 in the Sampson Report, and also in 1911 by the Vreeland Board of Inquiry, as clear evidence that only a force acting from the outside, ergo: a mine, could have pushed it inward.

In Rickover's book the Hansen/Price analysis argues that, following the (internal) explosion, the dynamic effect of the water (rushing into the gaping hole) caused this section to be bent inward/upward. Others, non-engineers in particular, had doubts.

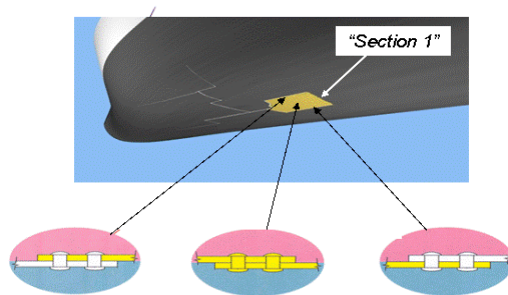
Figure 6: Illustration of “Section 1” in its original location.

Looking at the ship's hull from below, “Section 1” is shown in Figure 6 in its original location as part of the outer hull before the sinking, together with an illustration of some details of its “anatomy”, of how it was connected to adjacent structural elements.

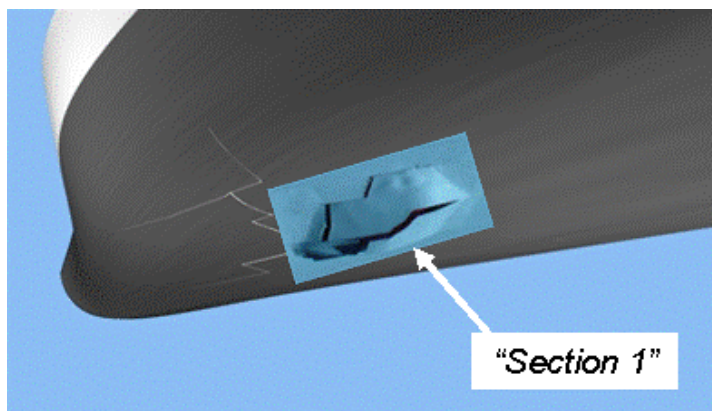
Figure 7 “Section 1” as part of a “blister”.

Instead, it will be shown that it actually was separated from its support structure: A “blister”, as illustrated in Figure 7, had been created when the initial (internal) explosion, pushing downward, separated the plating from its support structure.

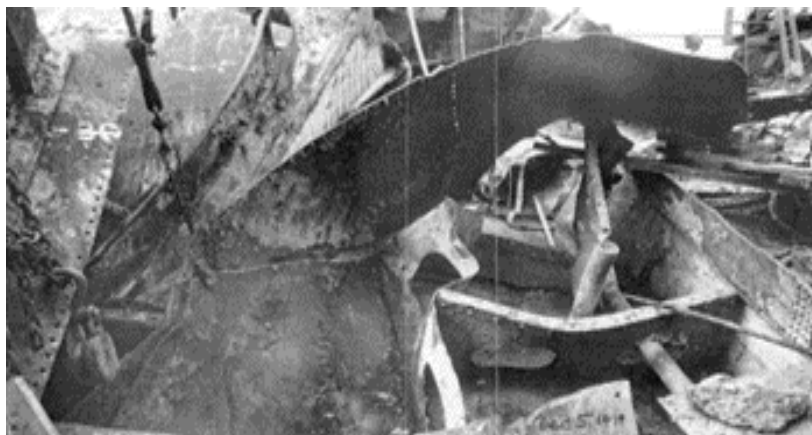
Figure 8: View of “Section 1” from below.

Evidence that this actually occurred is presented in a rare photo showing the (now) underside of “Section 1”, i.e., taken from below. This view is shown in Figure 8, above. It reveals that the internal pressure had cleanly detached the plating from the supporting double bottom structure (**Clue 1**).

“Section 1” was just a flap of steel.
