The flushing of the sediments near the power intakes in the Dez Reservoir

S. Emamgholizadeh^{1,2}, H. Samaadi Borojeni^{2,3} & M. Bina¹

Abstract

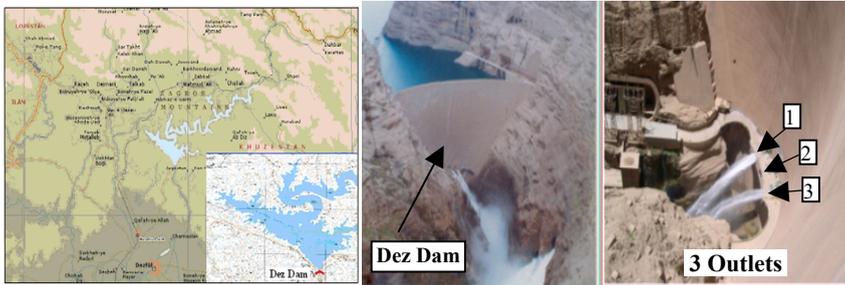
Figure 1: Dez Reservoir. Figure 2: The arrangement of the Outlets.

The Dez Dam was constructed in 1963 upon the Dez River and it is located approximately 25 km north of the city of Dezful and 22 km from the city of Andimeshk in the Khuzestan Province (fig. 1). It is one of the most important dams in Iran because it has a very important role in power generation (520MW) and frequency control of the national power network, the provision of water (125 thousand hectares of irrigated lands) and flood control. It is provided with three low-level outlets, within the dam body, having a centerline at el 222.7, which is 129.3 m below the reservoir full supply level of el 352m. The original purpose of the low-level outlets was to provide irrigation releases downstream during periods of low flow through the turbines. In addition, these outlets were to provide a means of emergency release from the reservoir if required. It is not certain whether the valves were originally designed to discharge sediment but they have been used for this purpose, at various times, since 1994. Twin powers intakes are provided with invert set at el 270 m. Fig. 2 show the arrangement of the Outlets.
