Adobe: an environmentally friendly construction material

R. Illampas, I. Ioannou & D. C. Charmpis
*Department of Civil and Environmental Engineering,
University of Cyprus, Nicosia, Cyprus*

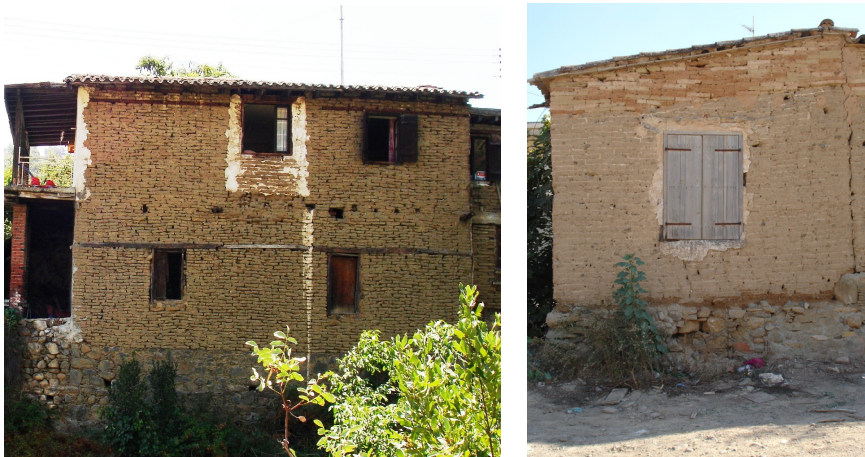
Figure 1: Local traditional buildings with load bearing walls composed of adobe masonry.

The material was used, almost exclusively, for the construction of load bearing walls (fig. 1). In some mountainous regions it was used to form the upper part of load bearing masonry walls. Occasionally it was employed for the construction of partition walls. Before the erection of the walls started, continuous foundations were first laid. In order to form the foundations and the base of the walls, a trench was dug and was filled with a mixture of lime,

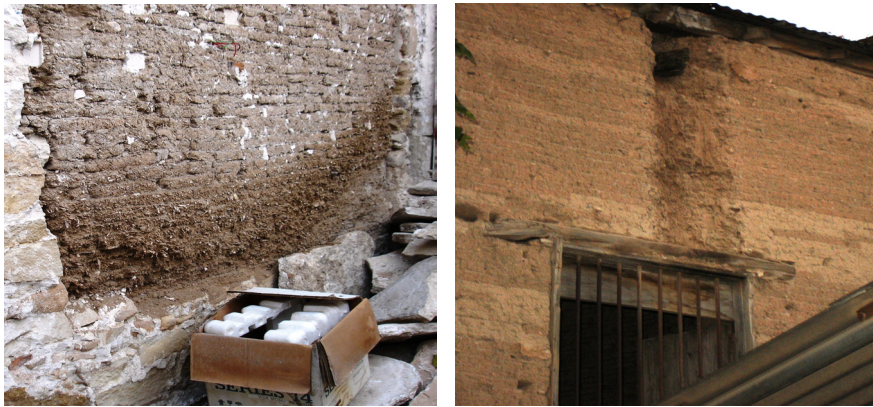
Figure 2: Deterioration at the base of an adobe wall (left) and characteristic fissure on the upper part of an adobe wall caused by the action of rainwater (right).

This type of damage (fig. 2) is caused by the penetration of ground water into the wall due to the fact that most traditional adobe structures do not have waterproof foundations. The result is the formation of continuous deep horizontal fissures on the boundary between the stone base and the adobe wall. The loss of supporting area on the base of the wall introduces load-bearing eccentricities into the structure, which may lead to the failure of the structural element. It also causes the loss of connection between the wall and its coating, thus resulting to the bulging, cracking and detachment of plaster.

When the upper part of adobe structures is not adequately protected or the protection mechanism fails, water coming from the overflow of gutters, or through the roof due to the lack of maintenance, penetrates into pre-existing micro cracks causing the disintegration of the material. The action of rainwater on the upper part of walls leads to the formation of fissures and cracks (fig. 2). It also causes deterioration of surface coatings and deformation of roof beams.

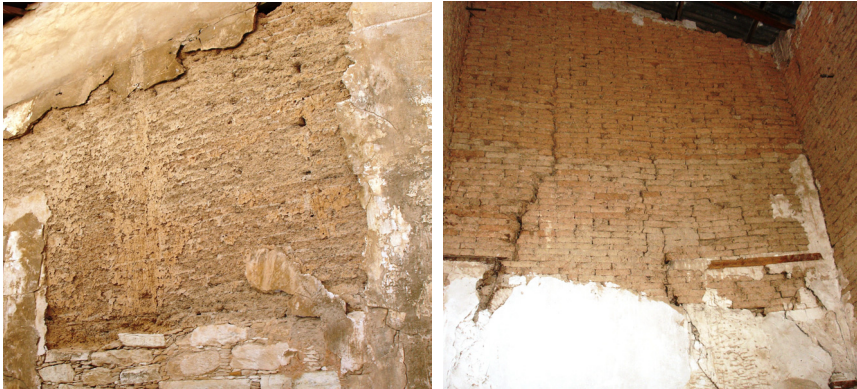
Figure 3: Disintegration of adobe and loss of the protective coating as a result of trapped moisture and water washing down the surface of the wall (left). Various vertical and diagonal cracks in the body of an adobe wall (right).

Disintegration (fig. 3) occurs when the soil forming the adobe loses cohesion and the binding material (straw or seaweed) rots. The process starts when water penetrates the body of the wall or when it runs directly on the surface of adobe masonry that is not protected by any kind of coating. Depending on the

temperature and humidity conditions of the atmosphere, trapped moisture can evaporate, suffer freeze-thaw cycles, condensate or deposit soluble salts within the masonry. These mechanisms result in the formation of internal cracking and cause the particles of the material to lose their cohesion and detach from the rest of the body [5]. Quite often, dampness causes the timber wedges, which provide cohesion between the surface of the wall and the coatings, to swell. Consequently, large parts of plaster are detached from the wall leaving the surface of adobe exposed to weather conditions. When water washes down the surface of uncoated adobe masonry, further erosion occurs.

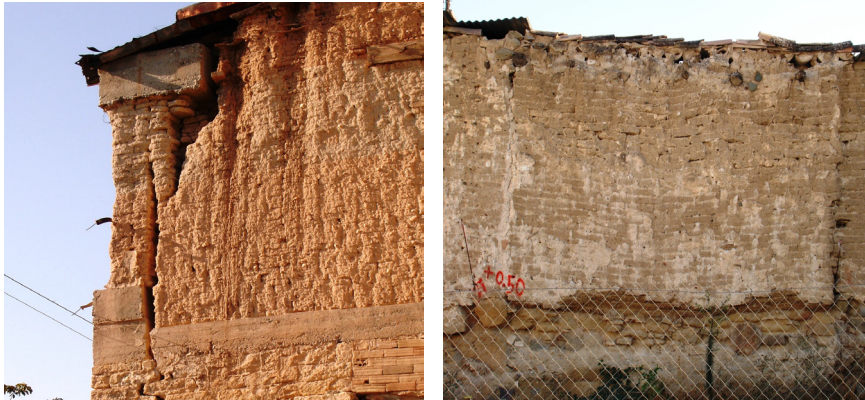
Figure 4: Building exhibiting various forms of structural damage such as the deterioration of its upper part, the disintegration of adobe and the formation of detachment cracks (left). Slumping of adobe wall that has been caused by the deterioration of its base (right).

application of materials with different mechanical properties within the body of adobe walls can also result in bulging or slumping. Additionally, slumps and bulges may occur as a result of the deterioration of the base of the wall (fig. 4). Moreover, settlement can lead to local buckling or the development of bulges. Occasionally, bulging is caused by the growing roots of vegetation and trees that penetrate within the main body of adobe walls.

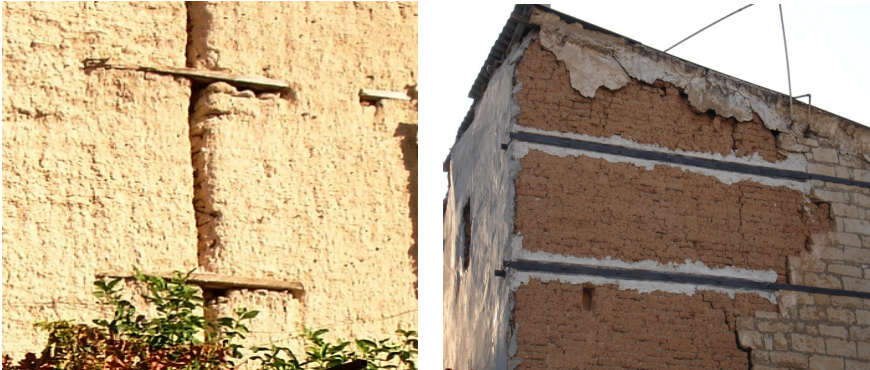
Figure 5: Installation of timber beams for the treatment of a vertical discontinuity (left). Steel straps that have been installed in an adobe structure to repair cracking (right).

When deteriorated or damaged material is located in a part of a structure, the area is locally demolished and reconstructed. Quite often, readily available fired bricks are used instead of new adobe bricks because they are considered to be more durable. A similar technique is often used for repairing cracks. A small part of the wall, on both sides of the crack, is demolished and rebuilt using masonry units. In some cases, the cracks are treated using grouting injections. This technique can only achieve the transfer of compressive stresses if the crack is fully sealed. In addition to filling the crack, stitching may also be used to transfer stresses from one part to the other. Wooden beams and steel straps are the most common materials used in this case (fig. 5).

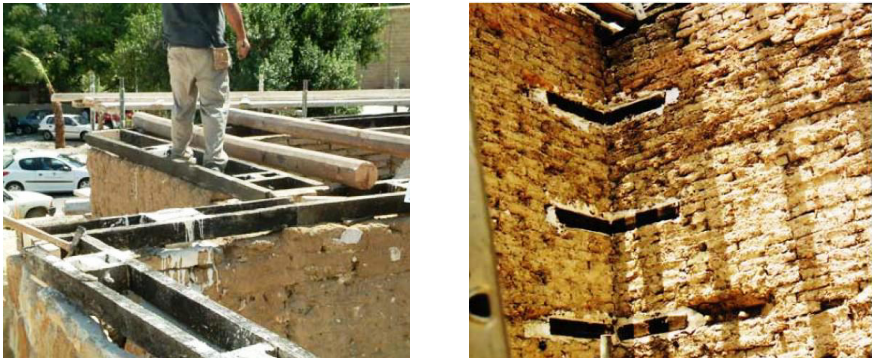
Figure 6: Installation of a wooden ring beam on the upper part of an adobe structure (left) and of timber beams at the corner of adobe walls (right).

Usually, the first step for strengthening adobe structures is the restoration of the various building elements to their original size and state. A very common technique is to improve the interlocking of the walls at the corners either by installing timber beams (fig. 6) or by the local demolition and rearrangement of adobes to ensure keying. In many cases the interlocking of the structure's walls with the floor and roof is improved by installing wooden beams and poles or a combination of timber elements and steel straps. This enables the floors and the roof to act as a diaphragm that provides lateral support and resists out-of-plane movements. Strengthening is also achieved by the installation of additional resisting elements. These are usually wooden ring beams that are placed on the upper part of the wall. It must be noted that apart from the techniques mentioned above, the construction of reinforced concrete frames has been encountered in some buildings. This is a non-reversible, intrusive type of intervention that changes the structural system of the building and alters the traditional character of adobe structures.
