# The House of Bahrain Press Heritage

The purpose of this paper is to focus on a renovation and rehabilitation experience of one of the traditional houses that was built in 1834. This house has social and cultural values for being the place where the founder of the first press in Bahrain and one of Bahrain's famous authors was born and raised. In addition, the house enjoyed many cultural events at that time. Furthermore, this house has distinguished architectural elements and traditional building materials.

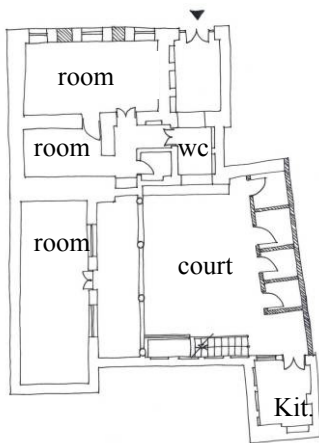
Figure 1: Ground floor plan (before renovation).

The total area of the house is 330 m<sup>2</sup>, it consists of two floors. The main rooms in the ground floor were the guests' room (majles) which had a direct relation with the court, family living room and other services such as kitchen, bathrooms and storage rooms (figure 1). Bedrooms were on the first floor, open to roofed terrace (liwan) which looks to the court on the ground floor (figure 2).

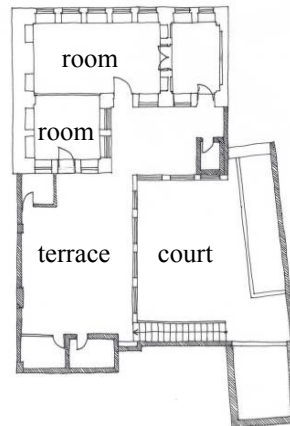
Figure 2: First floor plan (before renovation).

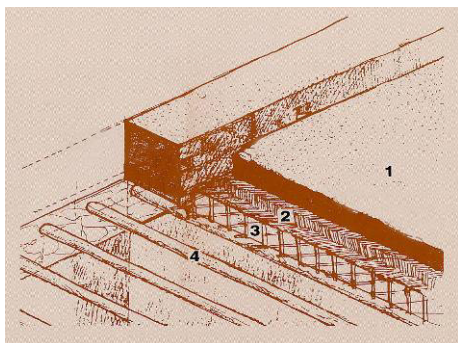
Timber wooden beams (Danchel) of 10 cm diameter were spanned from wall to wall; forming the main structure of the roof. A layer of thin bamboo sticks was applied over the beams diagonally covered by netted bamboo sheets (mangrof), and then topped with a layer of mud (figure 3).

1. mud
2. bamboo netted sheet (mangrof)
3. bamboo sticks
4. timber round beams (danchel)

Figure 3: Roof structure.

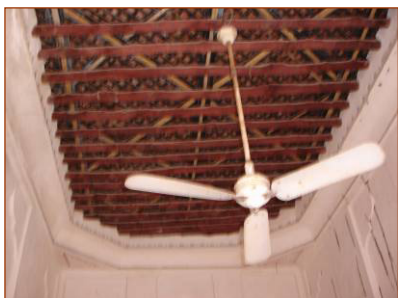
The roofs' structures were left exposed to the rooms (figure 4). However, in the living room it was covered by colored wooden sheets (figure 5).

Figure 4: Exposed roof structure.

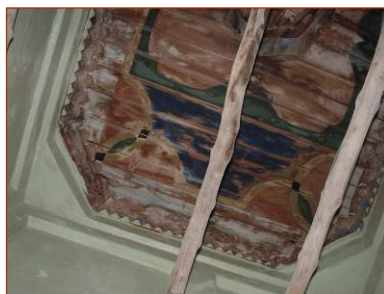
Figure 5: Colored wooden roof.

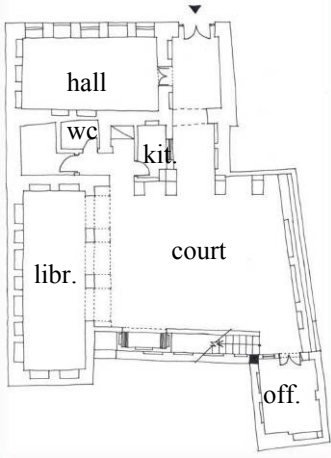
Figure 6: Ground floor plan (after renovation).

foundations were in good condition, some walls needed only external renovation, and others needed deep treatment so gypsum mix was pumped into the walls to fill gaps between stones. Roofs of the ground floor were kept but renovation was applied to it. The roof of the first floor was reconstructed. Renovation plans and architectural drawings were prepared, respecting the main volumes and relations between rooms, despite the idea of changing the use for the house (figures 5–11).

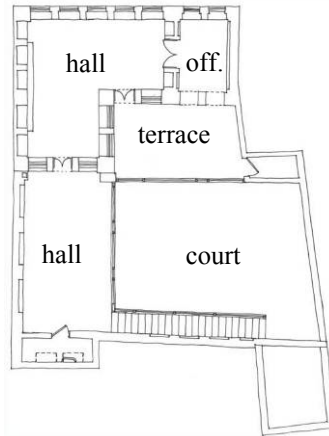
Figure 7: First floor plan (after renovation).

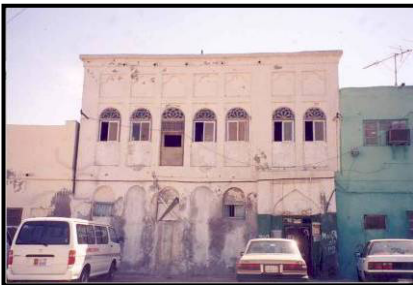
- Air conditioning pipes were applied externally.
- Galvanized gutters were added instead of traditional wooden ones (merzam).
- Electrical units and wires were applied on the external walls and on the front elevation.

Figure 8: Front elevation (before renovation).

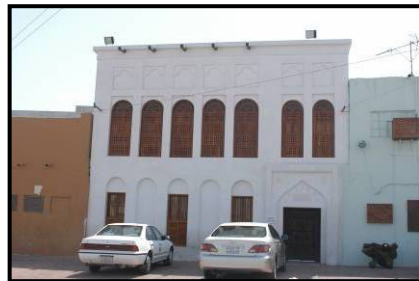
Figure 9: Front elevation (after renovation).

The main aim of the strategy was to eliminate all additional structural and architectural elements and peel the walls from added cement layers, and work on reinforcing the building structurally.

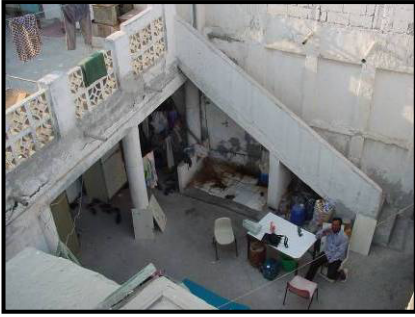
- Wooden doors, windows, gypsum decorations and stained glass were not maintained nor renovated.
- Sewage pipes were added externally which disturbed the inner elevations of the court and there was a manhole in the middle of the court.

- Water tank, shower sink and water heater tank were in the court in the ground floor and the balcony on the first floor.

Figure 10: Court before renovation. Figure 11: Court after renovation.

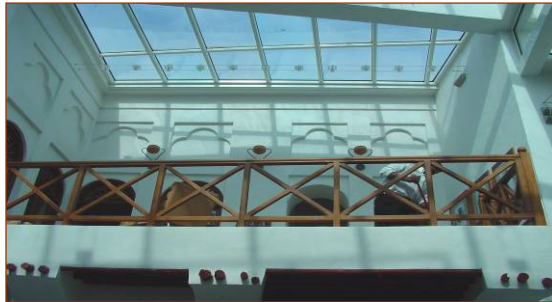
In order to make use of the court all the year through, the architect thought of covering it. The material used was completely different than what was used to build the house originally. These materials were glass and steel, which created a kind of contrast between the ancient and the modern (figure 12).

Figure 12: Court, glass and steel roof.
