Seismic stabilization of heritage structures in California

S.E. Thomasen & U.M. Gilmartin
Wiss, Janney, Elstner Associates, Inc.
Emeryville, California USA

Abstract

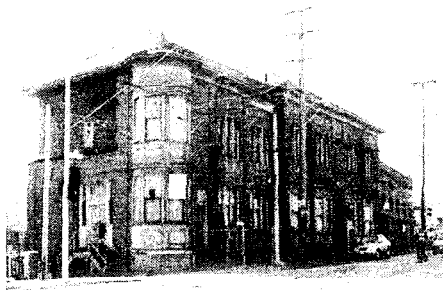
Fig. 3: Geneva Office Building

The two-story and basement office building was built in 1901. The structure has exterior walls of unreinforced brick masonry and wood framed floors, roof and interior partitions. The masonry walls suffered damage in the 1906 and again in the 1989 quake. The building is a listed landmark and the stabilization design followed the requirements of the SHBC. The weak elements of the structure are the low shear strength and lack of stability of

the masonry walls and the missing connections from the wood floor and roof framing to the masonry walls. The strategy for the seismic stabilization was to increase the lateral shear strength of selected sections of the masonry, improve the stability of the exterior walls and to improve the anchorage between horizontal framing and the vertical walls. The design for the stabilization included:

- Renail roof and floor sheathing to improve diaphragm action.
- Strengthen the timber roof trusses with steel sections. Reinforce connections between trusses and their supporting masonry walls.
- Anchor floor framing to the masonry walls in order to stabilize walls and to improve diaphragm action.
- Improve the shear capacity of the masonry walls by repointing the bricks. Stabilize selected wall sections by removing the inner layer of bricks and replacing it with reinforced concrete. Stabilize other selected sections by applying epoxied fiber reinforcement to the interior face of the wall.

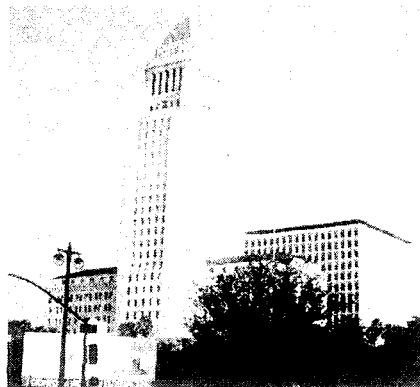
Fig. 5: Los Angeles City Hall

The 32-story, 138 meter tall Los Angeles City Hall was built in 1926 before the enactment of seismic design requirements. The steel framed heritage structure has unreinforced masonry infill walls with an exterior cladding of terra cotta blocks. The terra cotta was damaged in the 1992 earthquake and it was decided to seismically stabilize the building to meet the high life safety demands for a public building. To insure integrity of the building façade in a future quake, the story drift limit for the stabilization design was established by in-situ testing of the crack formation of the terra cotta façade [7].

For the stabilization, which is to a level that exceeds any code requirement, three schemes were considered: a reinforced concrete shear wall system; a reinforced concrete shear wall with steel bracing system; and a base-isolation system with supplemental dampers. The analysis results indicated that the use of base isolation bearings in conjunction with viscous dampers at the base and the top of the building was the most effective technique for reducing inter-story drift, story shear and acceleration. The seismic stabilization program for the City Hall has required the installation of 416 high-damping rubber bearings, 90 flat slide bearings and 64 viscous dampers. The base isolation design will allow the City Hall to remain stationary while the ground during the quake moves up to 500 mm in any horizontal direction.
