Monitoring of long-term damage in Gothic Cathedrals

Abstract

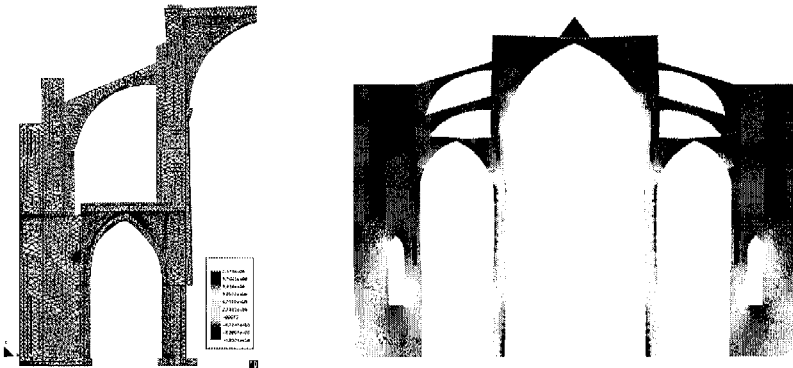
Fig. 3. Numerically predicted deformed shapes of the transverse sections of Tarazona (left) and Mallorca (right) cathedrals subject to gravity load (amplified by 100).

It must be noted that, in spite of the quantitative disagreement between the observed and numerically predicted deformations, the corresponding overall shapes are very similar qualitatively (Fig 3); it can be said that part of the historic or long-term actions experienced by the construction produced a certain amplification of the initial deformation caused by gravity load.

Numerical analyses carried out for gravity load in the cases of naves of Tarazona and Mallorca Cathedral (Fig. 3) did not permit immediate explanation of these cracks, even if the possibility of cracking at reasonably low stress levels was considered. It must be noted that these calculations were carried out on the actual deformed shape of the transverse sections.

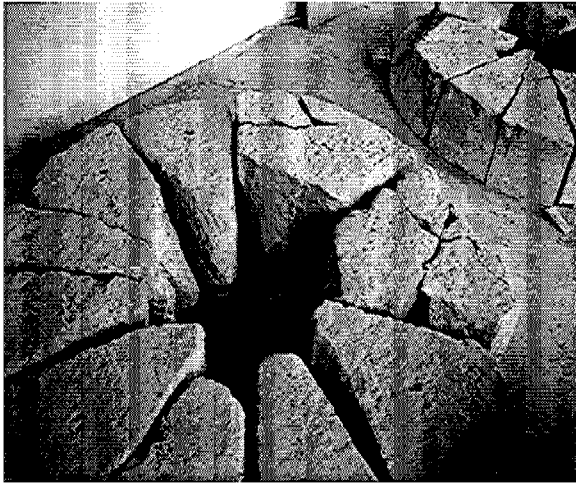
Fig. 4. Stacked stone blocks from a dismantled pier of Tarazona Cathedral.

The authors have observed vertical cracking in some of the piers in almost all studied Cathedrals. Vertical cracks and related lesions in piers are particularly significant in Tarazona Cathedral (before the restoration, Fig. 4), Mallorca Cathedral (Fig. 5) and the Basilica of Santa Maria del Mar in Barcelona. In all the above-mentioned buildings, severe cracking appeared in spite of the moderate average compressive stress caused by gravity load.

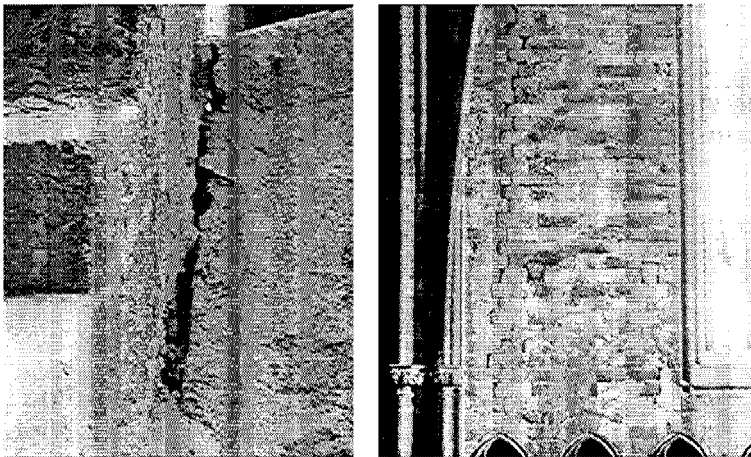
Fig. 8. Cracks developed in the junction between arch and vault (Mallorca Cathedral, left.) and in a construction joint (Girona Cathedral, right)

Similar effects may be caused by thermal environmental actions. Large cracks affecting walls or roof elements are observed, which because of their location and geometry strongly suggest an acquired role of expansion joints. Examples are found in Girona and Barcelona Cathedrals, with cracks appearing along construction joints (Fig. 8, right), and Mallorca Cathedral, whether wide discontinuities are observed between some of the transverse arches and the vaults of the nave (Fig. 8, left). Unlike soil settlements, which tend to mitigate with time as the soil consolidates, temperature cycles are always acting and may cause indefinitely cumulating damage through their multiple repetition.
