A small valley in Greece and its bridges throughout the centuries

Abstract

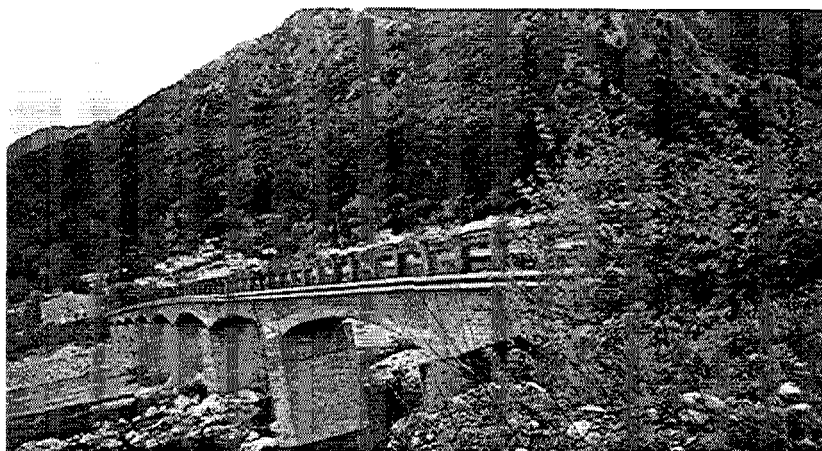
Photo 3: The new bridge of St. Bessario

The construction of the new bridge of St Bessario began in 1960 (photo 3) and was completed a year later. Its main purpose was to provide motor access to the small villages of Trikala’s county (St Bessario, Pialia, Filyra, Pyli etc.).

The static system of the bridge is based on a Gerber-type beam, forming four opposite-projecting parts each of 26.49m long, and five opposite-bearing parts (three of those are 11.33m long and the remaining two are 11.75m). The cross section of the structure has a Π shape while the height is variable-the intrados of the slab forms a parabolic curvature, which expands from the abutments towards the spans (photo 3). The total width of the structure is 4.4m and the upper deck-road is 3.10m wide. The bridge rests on abutments, which are 8.50m high.

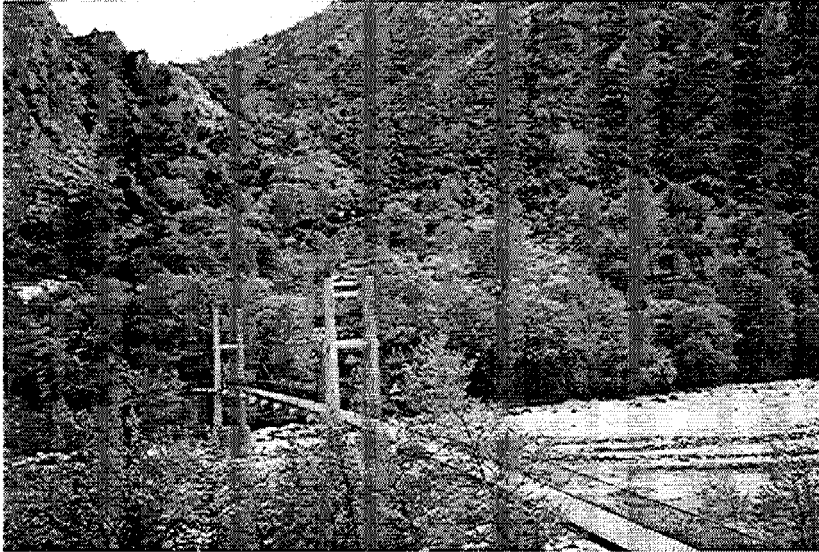
Photo 4: Suspended pedestrian bridge

Pyli's suspended pedestrian bridge (photo 4) stands in a distance of 1000m away from the arched masonry bridge at the west entrance of the city (Fig. 1). It was constructed in 1981 and, as it has been already mentioned, it is the first bridge in Greece with a framework hanging from straight cables. Currently, it is used in order to cover the access of local people, thus moving from the city center to the Porta Panagia suburb, where there is also the homonymous famous Byzantine church.

The length of the bridge is 122m and the pathway is 2m wide. The two middle piers allow a total span of 54m beneath them, while supporting two great gateways of 14m high (photo 4).

The static system of the bridge is based on a continual beam which bears three spans of 24m, 54m and 24m respectively, while hanging every 6m from linear cables, which are connected with the two gateway's top. The latter were made of two triangular frames linked to each other with cross sectional beams.
