# Historical towers and fortified houses in central Greece

A. Vagelakos & M. Karaveziroglou

*Department of Civil Engineering, Aristotle University, Greece*

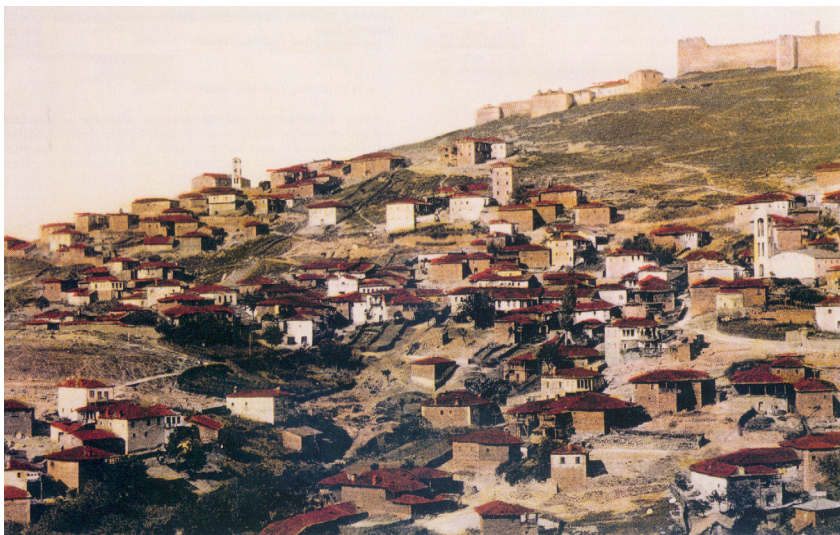
Figure 1: Amphitheatre-like layout of the fortified houses in the historic village of Fanari near Karditsa.

A common feature of these settlements is the terraced layout of the houses overlooking either a sheer hill or an expanse of more level ground, fig.1. The defensive appearance of these tower houses and mansions, the result of measures taken to fortify them against bandit raids and revolutionary events, is singularly impressive. Today, many of these historical buildings are being rescued. For the most part, they are scattered around the mountainsides and many of them are used mainly as holiday homes since, over the past fifty years, a large number of the inhabitants of the mountain villages have moved to the city (Travlos [2]).

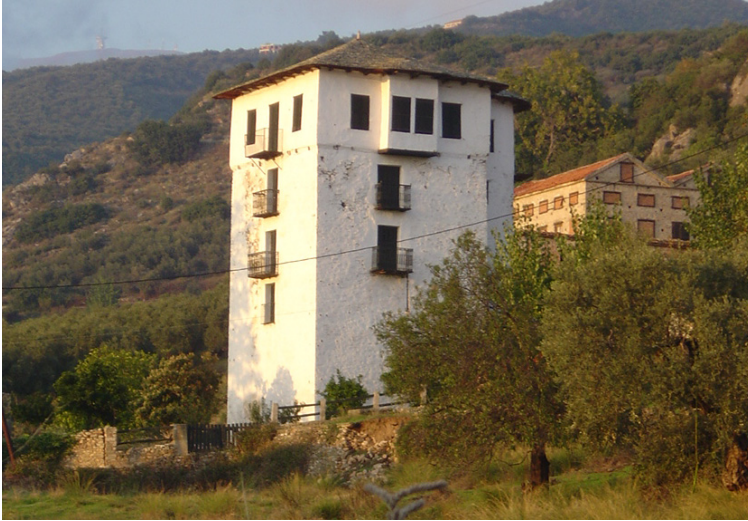
Figure 2: The high Kokoslis Tower at Ano Lechonia in the Mt. Pelion region.

The number of floors and the height of the buildings vary. More commonly, they have two or three floors though some towers have as many as five floors, fig. 2. Intercommunication between one floor and another was by an internal wooden staircase.

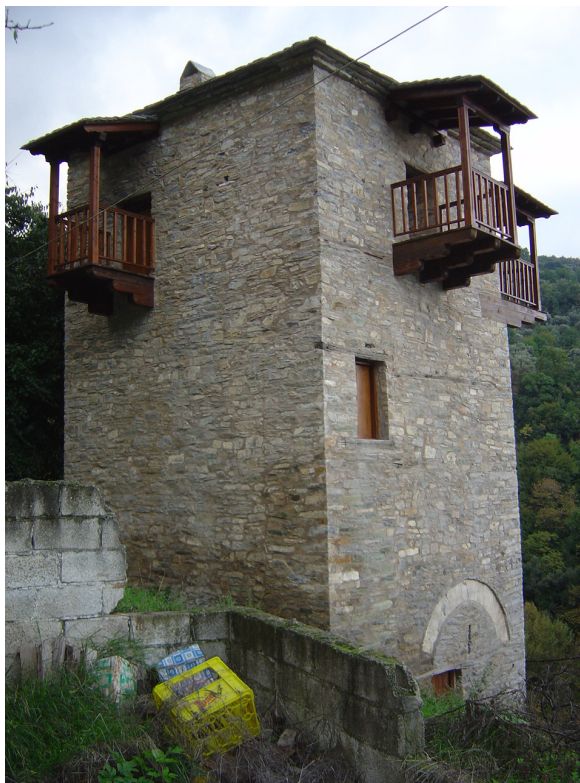
Figure 3: The Tower of Skoteiniotis at Makrinitza on Mt. Pelion.

The floors are of wood, as is the roof, which is covered with slates or ceramic tiles. The balconies are usually supported by the interior wooden beams which jut out under the balcony and are reinforced by double and triple cantilevers, fig. 3. In the past, the beams were supported by wooden oblique braces.

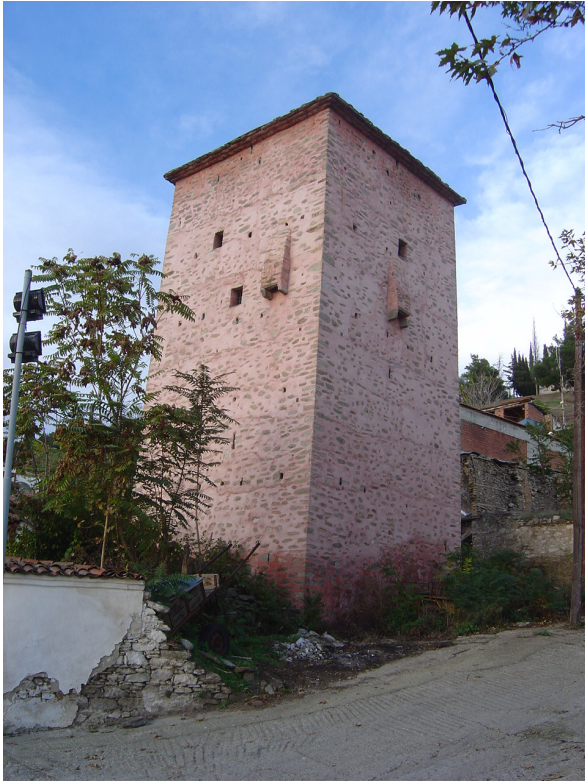
Figure 4: The Tower of Mamjios in Tsaritsani, with its battlements and loop-holes, on the outskirts of Larissa.

Over the years, many wooden beams have been replaced either by similar wooden or metal ones. The ceilings of the interior on each floor are usually covered with lath and plaster. On account of the fortified nature of the dwelling, the number of openings on the lower floors is limited, and more numerous and larger on the top floor. A typical feature of this type of building are the battlements with slit-like loop-holes on the towers, built for defence against enemies and bandits, fig. 4.
