## Characterisation of mechanical properties of historic mortars – testing of irregular samples

J. Válek<sup>1</sup> & R. Veiga<sup>2</sup>

## 2 Characterization of mortars from Pišce castle

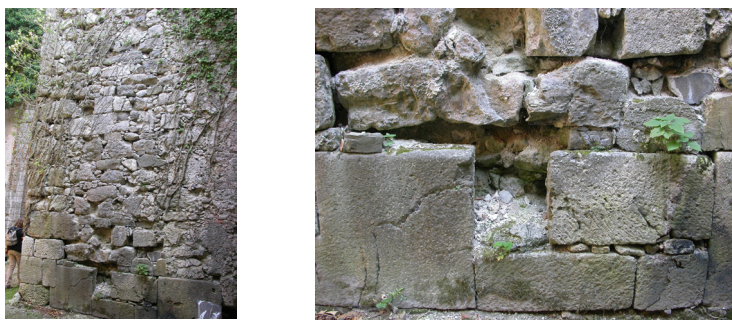
Figure 1: Location of the mortar sampling – Pišce Castle.

Historic mortar used in this experiment was from Pišce castle in Slovenia. The mortar came from the north side of the tower which was the oldest part of the castle from the first half of 13<sup>th</sup> century. The exact dating of the mortar was unknown. The mortar samples were taken from the open face of the exterior masonry where a facing stone was missing (see Figure 1). The mortar was possible to cut out by hammer and chisel in relatively good bulks averaging around several centimetres in diameter (see Figure 2).

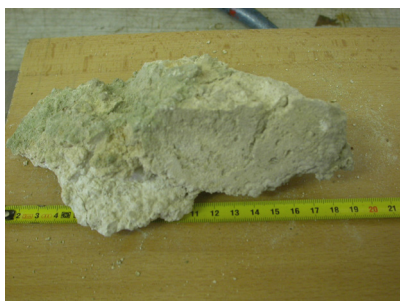
Figure 2: Typical sample of historic mortar.

The aim was to carry out compressive and flexural strength tests on irregular samples of historic mortar. It was decided to cut the samples into small non-standard cubes and prisms. First of all, the samples were assessed on macroscopic scale in laboratory (Figure 2). The samples contained a relatively large particles of aggregate and were, apart from several cracks (probably shrinkage cracks), intact and sound. To keep the orientation of the sample, as it was in the masonry, and to obtain a reasonably sized cubes or prisms without visible cracks was not possible. It was decided to minimise the cutting and produce specimens with only two regular parallel sides. The remaining sides were left irregular or cut to create approximate cube 40x40x40mm or prism with app. height of 10-15mm, see Figure 3. The specimens for testing were cut wet by diamond circular saw.

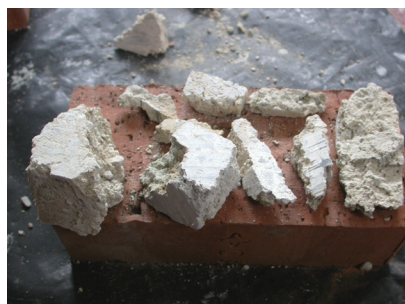
Figure 3: Mortar cut to specimens.

The cube like specimens were tested in compression with the parallel surfaces placed between the loading plates. The strength was calculated as the maximum load divided by the average area in the middle of the specimen. To carry out three point bending test the methodology of extension by wooden prostheses was utilised [9]. The small mortar prisms were glued to wooden pieces which had the same dimensions in the cross sections as the mortar specimens (see Figure 4). The span between the supports was 120mm. The mortar part was centred in the middle of the extended specimen. The cut parallel sides were the bottom and top

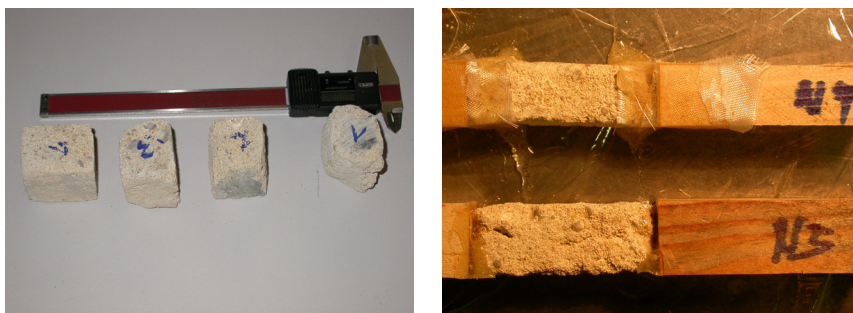
Figure 4: Mortar samples from one year old rubble wall cut to small ‘cubes’ and ‘prisms’

In order to obtain some comparable results similar irregular samples of mortars were acquired from one year old stone rubble masonry wall. Together with the wall there were also made standardised 40x40x160mm mortar specimens. The mortar was made of non-hydraulic lime putty prepared from lime hydrate (CL90) and river sand with maximum particles 4mm. The mixing binder-aggregate ratio was 1 portion of lime putty to 3 portions of sand by volume with some water added to adjust the workability. This resulted into b/a ratio of carbonated mortar of app. 1:4.5 by volume. To re-produce the testing, several mortar samples from the wall were taken. The same sample preparation procedure was applied on this modern mortar samples. Four specimens for both the compressive and flexural tests were prepared and tested (see Figure 4).

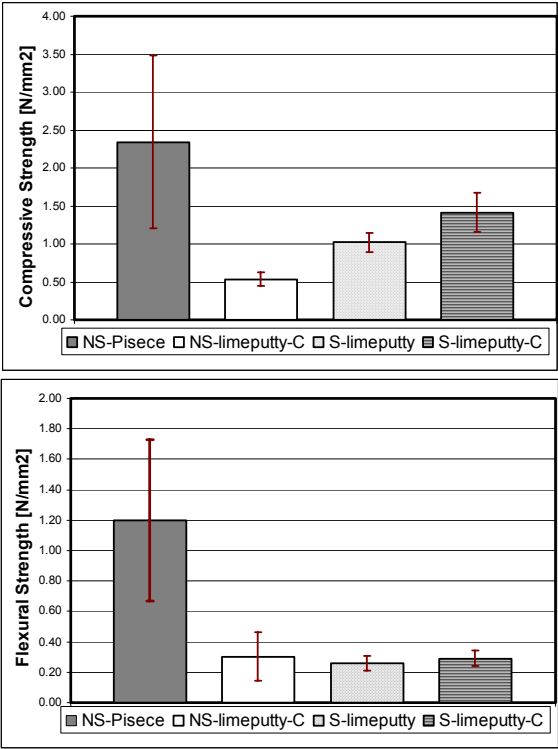
Figure 5: Results of tests on non-standard specimens (NS) compared to the standardised specimens (S). C-carbonated mortar specimens.

The specimens, prepared together with the rubble wall mentioned in 3.1, were split into two groups for curing and ageing. Group one was cured and aged for one year together with the wall in outdoor conditions and was fully carbonated when tested. The other group was left in indoor conditions with averaging  $T = +20^{\circ}\text{C}$  and  $\text{RH} = 40\%$ . The standard tests for compressive and flexural strength according to the EN 1015:11 were carried out at the age of approximately one year. The specimens and the results are summarised in Table 3 and the calculated strength graphically in Figure 5.

cut at all. Flexural strength can be even more influenced by the induced cracks during the sample preparation. However, in this case the comparative flexural tests did not show such influence of cracks. The standard and non-standard three point bending tests resulted in similar values of the flexural strength.

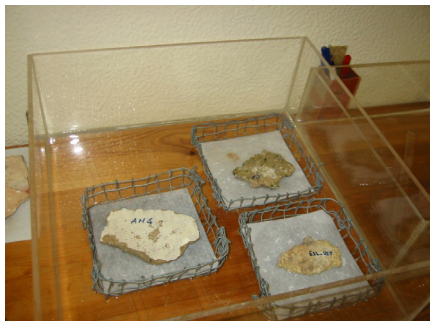
Figure 6: Capillarity test by the contact technique.

The irregular samples collected from the site were cleaned from the powder and from biologic colonisation. They were kept in their original shape and dimensions without any cutting in order to avoid any damage. The samples were first submitted to the water absorption tests (see Figure 6) using the technique of

capillary absorption by contact, which was developed and calibrated previously [11]. The capillarity coefficient obtained by this test gives an idea of the compacity and consequently of the state of conservation of samples. Moreover, it is a non-destructive test introducing no changes to historic samples.

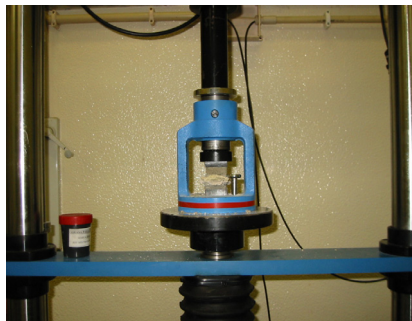
Figure 7: Compression test with confinement mortar.

The compressive strength tests were carried out after the complete drying. The regular shape necessary for adaptation to the compression machine and for the calculations was achieved, in this case, through a confinement mortar designed to be stronger than the extracted samples and which composed of cement and siliceous sand with volumetric proportions of 1:3 (cement : sand), see Figures 7, 8.

The confinement mortar had also certain influence on the results in compression. The influence depended on the strength and elastic properties of the confining mortar and the geometry of the sample. Similarly as in masonry, the strength of the whole composite can be much higher than that of the single material. In our case the significance of the influence on the compressive strength has not been established. The compressive strength of 7.3 N/mm<sup>2</sup> seemed however quite high for a lime mortar not containing many hydraulic components. The compressive strength of the confined render sample was lower than that of the joint mortar. This could be expected as its b/a ratio was lower.

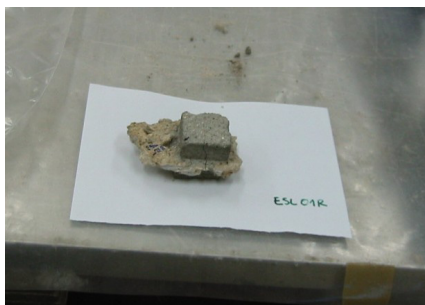
Figure 8: Samples from the Pisece Castle prepared for the compression test (render and joint mortar).

Strength obtained for the joint mortar from the Pisece Castle was much higher when the technique with the confinement mortar was used in comparison with the cutting technique. This could be explained by the visible heterogeneity of the joint mortar, even though it originated from the very same joint. Another possibility is that some micro cracking occurred due to the cutting, which contributed to the reduction of the mortar's strength. This assumption would be in agreement with the other comparative tests where the non-standard specimens had 2 to 3 times lower compressive strength than was that of the standard specimens. This influence was not fully quantified but it obviously depends on the compactness and strength of a mortar sample as some are not possible to be
