The maintenance of historic iron and steel structures: coping with corrosion

G. G. Nieuwmeijer

*History of Structural Design Group, Department of Architecture,
Delft University of Technology, The Netherlands*

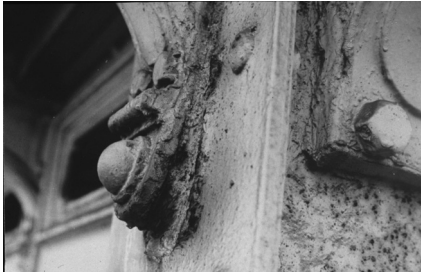
Figure 1: Platform roof HS Station Den Haag. Crevice corrosion between the cast iron bracket and the wrought iron strut. The pressure of the rust has demolished the bracket.

Crevice corrosion may occur when metal parts are locally joined. Dirt and moisture collects, so that corrosion quickly occurs. This often happens when brackets and windows are fitted against struts, gutters are being supported by a longitudinal beam or brackets and frameworks are installed on facades that are infilled with masonry. With riveted elements too, crevice corrosion may occur when the distance between the rivets is too big and a split occurs between the two parts.

seven times greater than that of the original iron and the resulting pressure caused some of the windows to break. Mounting the window frames by using strips on the struts made it possible to ensure that the structure dries out after rain and that good maintenance is possible. The cast iron brackets that support the gutters were attached to the struts by hooks and bolts. The holes for the hooks allowed dirt and moisture to accumulate behind the brackets, leading to corrosion, during restoration the hooks were removed and the joint were closed with foam strips and mastic.

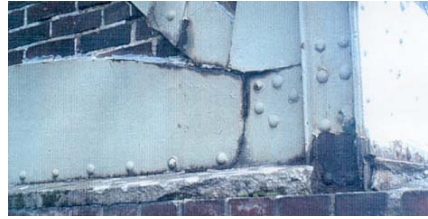
Figure 2: Engine House, Zeche Zoller II, Dortmund-Bövinghausen. Severe corrosion has occurred on the facade between the masonry and the framework.

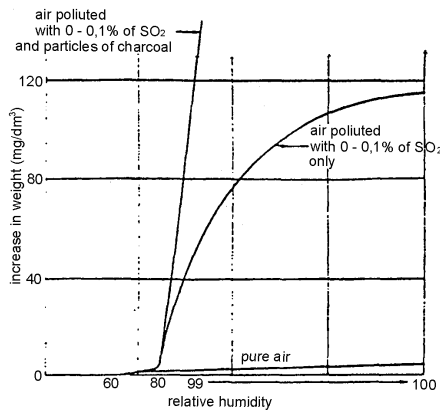
Figure 6: The influences of relative humidity and air pollution on the corrosion of iron.

Iron begins to rust at relative humidity of around 60%. As the relative humidity increases the rate of corrosion accelerates. When the air contains hygroscopic chlorides, as it does close to the sea, the corrosion starts at a relative humidity of around 40%.
