Structural design, typical damages and reinstatement of the Malakoff Towers

S. Niederhagemann

Deutsches Bergbau-Museum [DBM], Informationssysteme, Germany

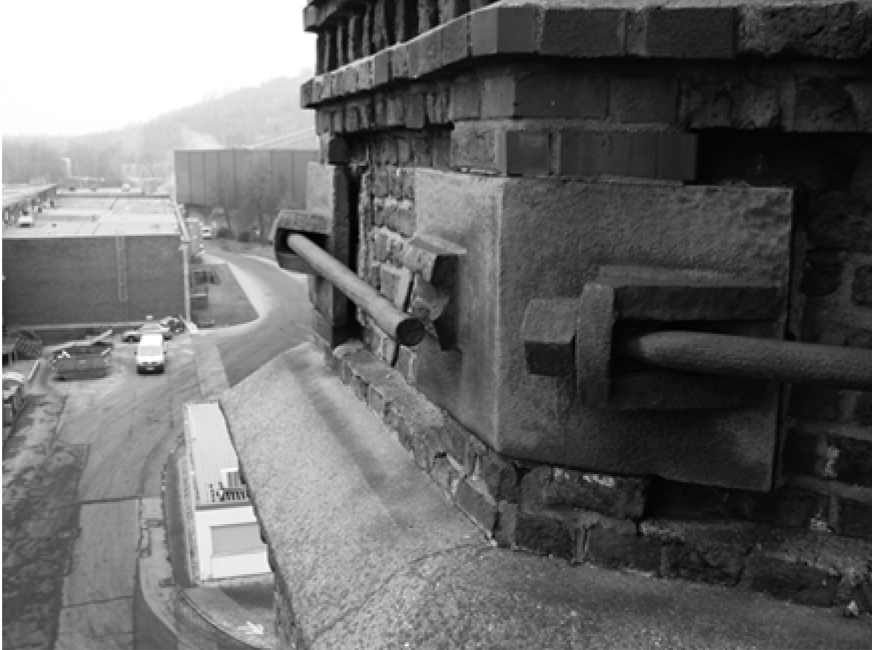
Figure 2: Broken tie.

The most frequent form of damage is occurs because of the fact that the tie bolts lost their function. Because of the failure of individual support elements the whole installation becomes inefficacious. The results are vertical cracks in the lower tower areas, which are attributed to the high pressure loads from the weight of the massive walls.

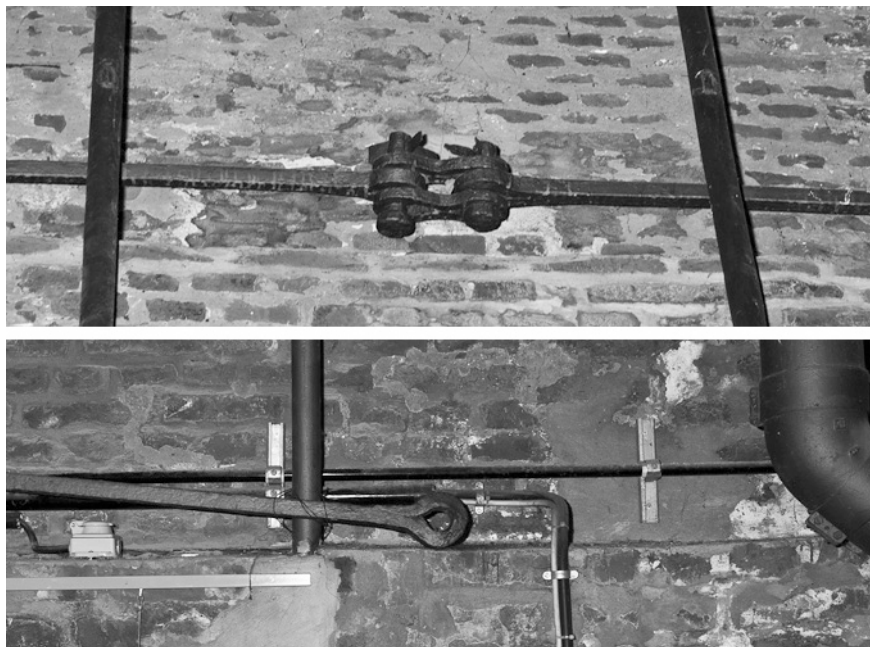
Figure 3: Tie at the original state and on the opposite side.

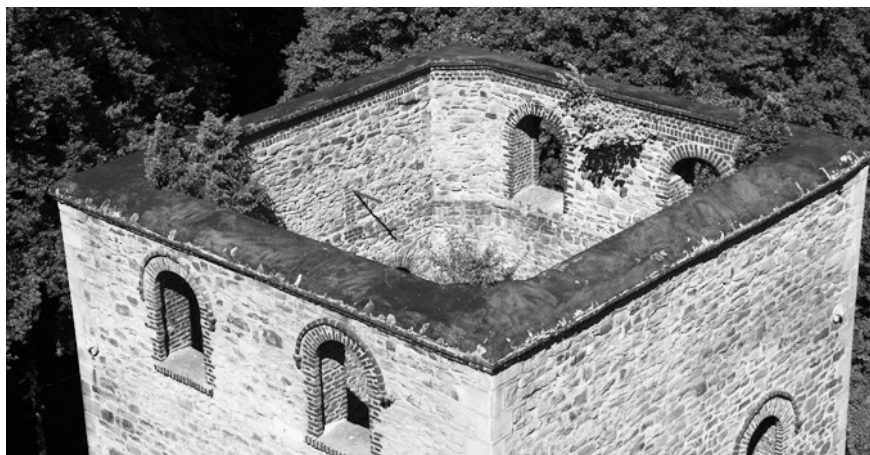
Figure 4: Missing roof and vegetation of Brockhauser Tiefbau (picture by Hensing/Knappenverein Schlängel u. Eisen).

With the closure of the plants the adjacent buildings, if they were not declared as a national monument, are often dismantled. Furthermore rotten components are removed without replacement. The results are openings in the building where weather, plants and animals can invade and damage the masonry.

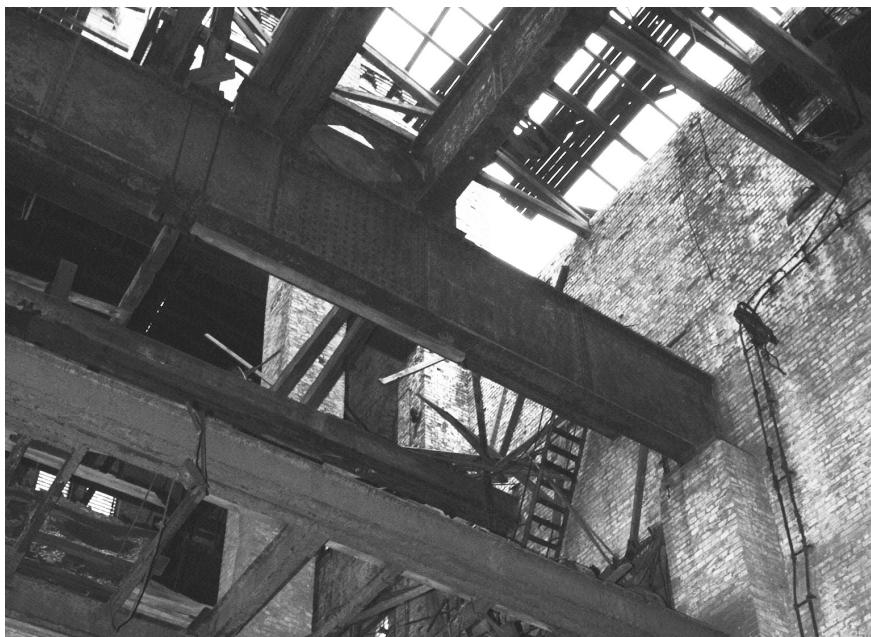
Figure 5: Partial demolition at Ernst Schacht IV.

Another problem is the commonly occurring demolition of stabilizing components. After decommission of the plants all still usable parts are recycled. For this purpose, machines and recyclable steel internals are used. Disassembly can lead to a destabilization of the overall structure.

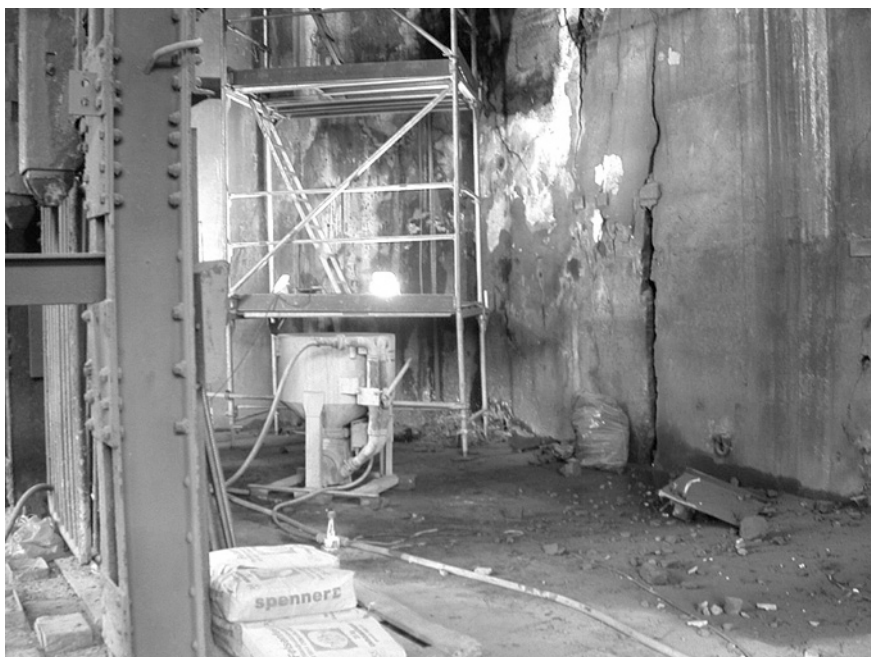
Figure 6: Needling and concrete injection at masonry cracks.

If there are damages in the support structure, the static system has to be reviewed under consideration of the weakening. If necessary, substitute support structures have to be installed or the capacity of the original system has to be restored. For example cracked masonry can be repaired by needling and concrete injections [6].
