Incentives to retain late 19th century housing and the practicalities of conservation and repair of that stock

B. J. Hickson

Bathurst Regional Council, Australia

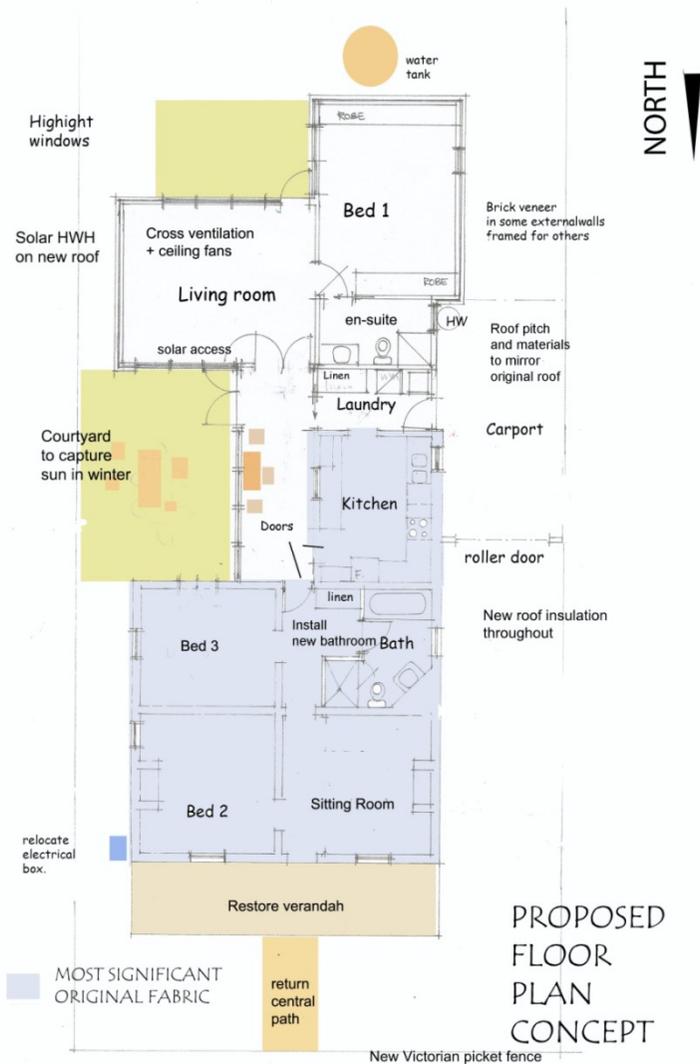
The most significant part of the fabric was assessed as being the original Victorian house of five rooms (see Figure 2). Later additions, at the rear and an altered front verandah, were assessed as being of little or no significance. The additions were not well constructed and the front verandah alterations were unsympathetic, altering the character of the facade.

Figure 2: Villa Laura sketch plan above showing areas of heritage significance and proposed energy efficient, sustainable additions.

Villa Laura is a poorly oriented residence facing north in fair physical condition. Except for the front verandah most sunlight was excluded from the house. No insulation existed in walls, floor or ceiling and the house is cold in winter but generally cool in summer. Additions needed to correct this aspect and improve overall energy efficiency.

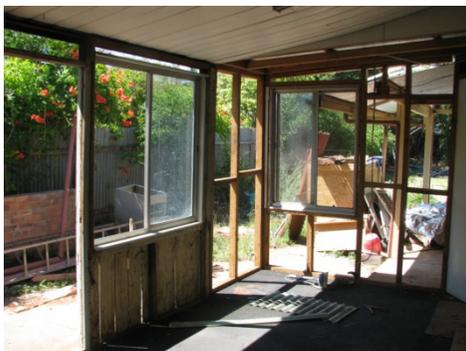
Figure 3: Asbestos linings removed from the eastern enclosed verandah.

This is a specialist field unless the quantity is small. If less than 10 sq.m an owner builder can carefully remove asbestos, wrap it and make arrangements for it to be accepted at the tip. (The local council will have instructions.) Otherwise, a specialist firm must be engaged. They will dismantle, wrap and remove the asbestos, and will take all necessary precautions including notifying all those in your immediate neighbourhood. There may still be work the owner must carry out in preparation, such as removal of wall paper so that fixings are exposed.

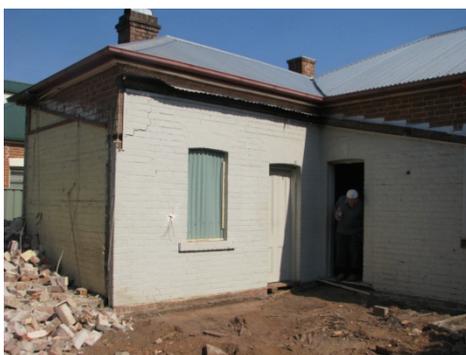
Figure 4: All unwanted additions removed. Note crack in brickwork top LH wall where a brick was toothed into the additions.

- That the building parts can be separated (removing any joining elements carefully e.g. toothed in bricks, tie rods)
- That dust shields or covers are in place.
