Conservation of a historic building through sympathetic thermal enhancement

J. Stinson, J. Bros Williamson, A. Reid & J. Currie
*Scottish Energy Centre, Institute for Sustainable Construction,
Edinburgh Napier University, UK*

This paper documents research undertaken by the Scottish Energy Centre at Edinburgh Napier University to refurbish a historic library building by means of thermal improvements. The interventions selected were specifically chosen to minimise any impact on the architectural integrity of the building.

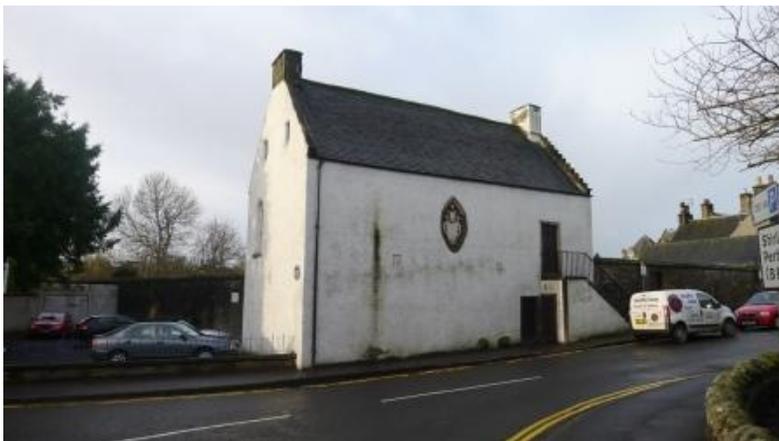
The library has a simple rectangular footprint with masonry lime bonded walls and crowstepped gables in the traditional Scottish vernacular, with chimney stacks on both gables (Figure 1). The elevations and gables have been harled with a wet dash cement finished with modern masonry paint. Such finishes are not considered ideal in building conservation terms in that they tend to lock in moisture. Bituminous roofing felt was installed under the slates during a period of refurbishment in the mid-1980s further preventing ventilation through the roof

Figure 1: Leighton Library, Dunblane (2012).

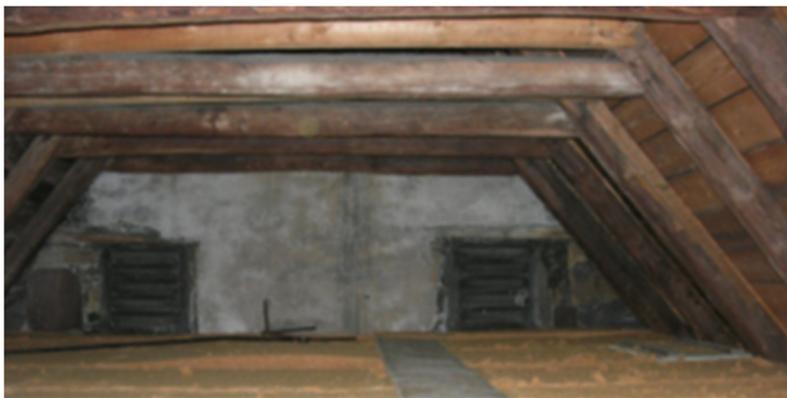
fabric. Roofs with bituminous roofing felt in place typically require other methods of ventilation, such as roof vents, or venting at the ridge and eaves. In the case of the library the previous means of ventilating this roof space was through two large louvered vents on the south-east gable. These had been partially closed off, but were re-opened, ensuring an adequate degree of ventilation into the roof space (as shown in Figure 2).

Figure 2: The louvered opening provides cross ventilation (courtesy of Historic Scotland).

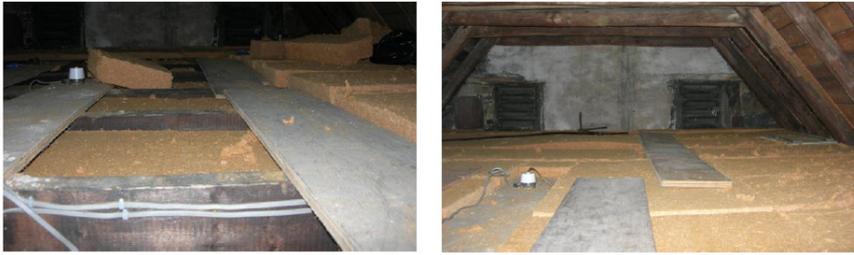
The insulation of the ceiling involved the installation of two layers of 100 mm wood fibreboard insulation directly above the internal timber panel finish. Made

from a renewable resource (wood), this material was considered appropriate for traditionally constructed buildings, where the use of materials with a low resistance to liquid vapour and hygroscopic and high capillarity active qualities are considered important. The upper level of insulation finished 50mm above the timber ceiling joists (see Figure 3). The wood fibreboard insulation used has a manufacturer stated thermal conductivity value of 0.038 W/mK and a water vapour/diffusion resistance factor 3μ (mu-value) (BS EN ISO 10456: 2007 [5]).

Figure 3: Photographs of wood fibreboard insulation. Crawl boards were used to assist installation (courtesy of Historic Scotland).

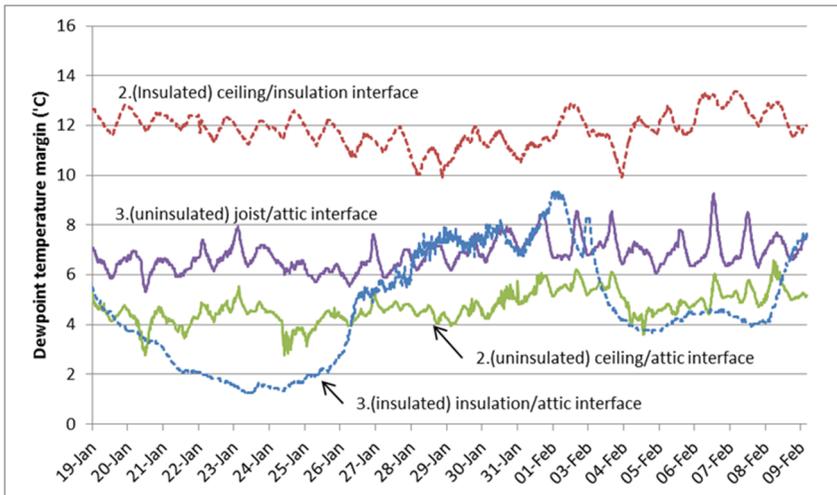
The dewpoint margin data for the pre-intervention (uninsulated) and post-intervention (insulated) monitoring periods have been overlaid and plotted in Figure 4. The two loggers located at the two critical interfaces are likely to experience condensation episodes have been plotted. The monitoring period shown in Figure 4 displays 21 days in January/February during 2012 for pre-intervention data and for post-intervention data recorded in 2013. The lines are numbered for comparison and relate to the logger placement described in Section 4.1.

Figure 4: Dewpoint margins two loggers located in attic space 19th Jan–9th Feb, for 2012 (uninsulated) and 2013 (insulated).

The data shows that during the 21-day pre-intervention monitoring period before the ceiling was insulated, conditions for a condensation episode were not detected. This is noted as none of the data recorded in the attic reached 0°C , which

is the point at which a condensation episode is most likely to occur. Data sets 2 and 3, pre-intervention are similar in pattern and magnitude because they are only separated by 150mm of open space, although one of the uninsulated data sets (data set 2) recorded slightly higher temperatures and relative humidity levels being transferred from the library below.

Data set 2 recorded during post-intervention monitoring at the ceiling and insulating interface shows a notably increased DPM, meaning it did not experience any condensation episodes. This was to be expected as this interface is the warmest and driest given the insulation type and proximity to the internal space below.

Data set 3 recorded during post-intervention monitoring at the interface between the insulation and attic space was the interface where it was expected to see the largest variation in DPM pattern. Condensation conditions are mostly likely to be witnessed at this interface. The magnitude and pattern of the data recorded at this interface is considerably different when compared to the pre-intervention data recorded over the same time the year before. The DPM pattern is distinctively different at the start and end of this comparative period, recorded conditions very likely to give rise to condensation. Analysis of the internal and external weather conditions show that internal DPM recorded before the insulated was added ($M = 7.19$, $SE = 0.01$) and that recorded after insulation was added ($M = 11.17$, $SE = 0.17$) were statistically different from each other, $t(2016) = -226$, $p < 0.00$. The same dependent T-test was conducted on the external DPM data, the pre-intervention external DPM ($M = 0.64$, $SE = 0.03$) was significantly different from the external DPM recorded during the post-intervention monitoring ($M = 0.08$, $SE = 0.01$), $t(2016) = 18$, $p < 0.00$.

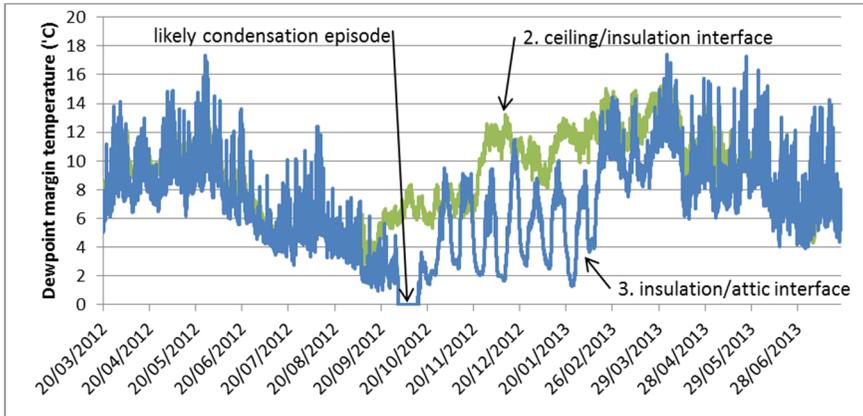
Figure 5: Post-intervention dewpoint margin for the two loggers above and below insulation in attic space.

monitoring periods. Analysis of the full 494 days of post-intervention monitoring shows that the critical data set (the interface between the insulation and attic being the data set most likely to record 0°C DPM) recorded only one episode where condensation was likely to occur. This single episode appeared continuously for 13 days between 1st and 15th October. For the remainder of the monitoring period, no further conditions which were conducive to condensation were recorded.
