## **A survey on the efficiency and safety of the temporary cover systems in architectural conservation and restoration works**

C. Ş. Binan<sup>1</sup> & E. T. Sipahioğlu<sup>2</sup>

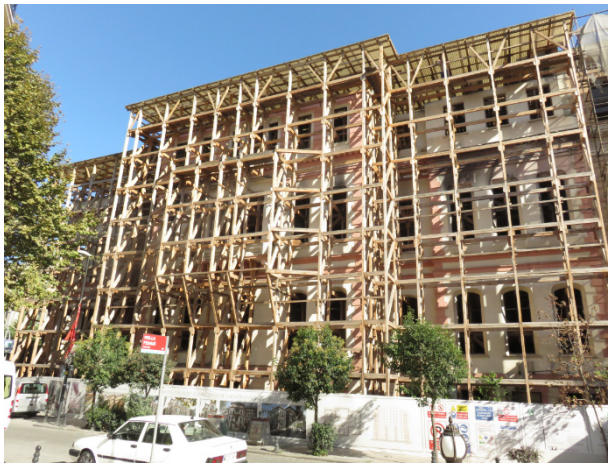
Figure 1: National Education Administration Building.

the scaffolding very easy. This material is easily constructed and deconstructed. It is much cheaper in comparison with other alternatives. A less qualified workforce with no additional equipment is needed in order to install, but the installation may take a longer time. The scaffolding and the temporary cover structure is light which makes taking support from the building itself possible. There is always the flexibility to adjust to the situations like length changes in the construction site. Since the cover structure is integrated to the scaffolding the cover is close to the building, which decreases the area needed to be closed with cover material on the top and on the sides. The distance between vertical supporting elements should not exceed 4–5 m as the cross-sections of the materials are not very big. There is no need to build a foundation under the scaffolding since the materials are both light and densely installed. The timber can be re-used in another work after being dismantled with only around 10–20% being wasted. These elements must be covered with fire retardant coating for the work safety. An example for such a construction used is the National Education Administration Building in Istanbul, which was burned in a fire. There was also the need of an urgent supporting system and therefore the timber construction was the most efficient system to be implemented as shown in Fig. 1.

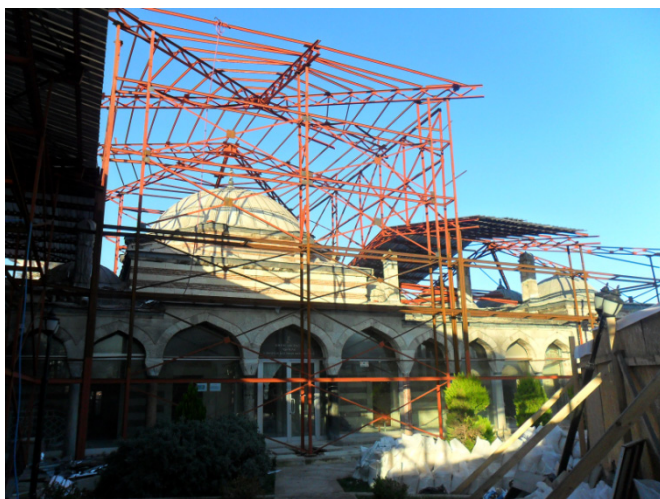
Figure 2: Semsipasha Madrasa.

the proper calculation and the construction of a pillow under the supports to lean the cover structure on the building. The system has a big advantage that it is possible to cover any distance with making the proper calculations and ordering the standard profiles needed in the design. Even though there is not a need for a heavy foundation system, still the feet of the structure should be fixed at the ground and sometimes little foot foundations need to be constructed(not necessarily reinforced concrete foundations, they can be just wide metal plates fixed on the ground). These steel materials can be dismantled to be reused with only 5% of waste. These steel materials exposed to weather conditions must be painted with anti-corrosive materials. An example of such a use is the Madrasa of Semsipasha in Istanbul, Fig. 2. The choice here was standard steel profile for the temporary cover structure, because on one side of the building there was too narrow a space for timber scaffolding or otherwise and the distance needed to be covered without supports was ranging between 9–18 m.

temporary structure and these materials can be reused with ease after dismantling. An example that this type of cover material used is Semsipasha Madrasa, Fig. 2. The reason for the choice was the location of the building. The location of directly on the coast of Bosphorus and the area is very windy. The roof structure did not have any valleys or hips in the open, so there was no constructional deficiency.

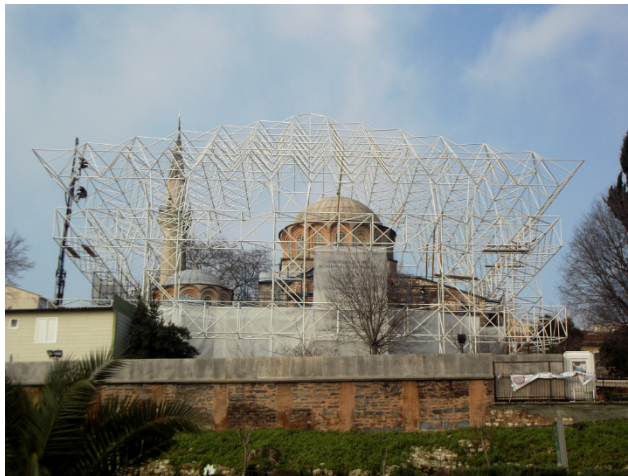
Figure 3: Chora Museum.

are large pillars put on large single foundations. The large single foundations on the feet are necessary to create weight and stability. Since this system is not flexible and is not integrated with scaffolding. The area needed to be covered in order to protect the building from external weather conditions is larger. The materials are each plugged into each other and therefore they can be dismantled without any waste, but the process may be as long as the construction time. These materials are painted with anti-corrosive materials when they are produced. It is also possible to create such a system from aluminium as well, which is much lighter material, bringing the total weight almost to a quarter of steel construction, the high cost of aluminium does not make it feasible. An example for this type of construction is made in Chora Museum as shown in Fig. 3. There is a very severe structural damage in the Museum and it is not possible to have any support on the building which does not make timber construction possible and also it is not possible to bring even mobile cranes to the construction site, which makes it almost impossible if not too risky to place standard steel profile trusses to cover a 30 m x 30 m area. The solution was to create a space frame system.

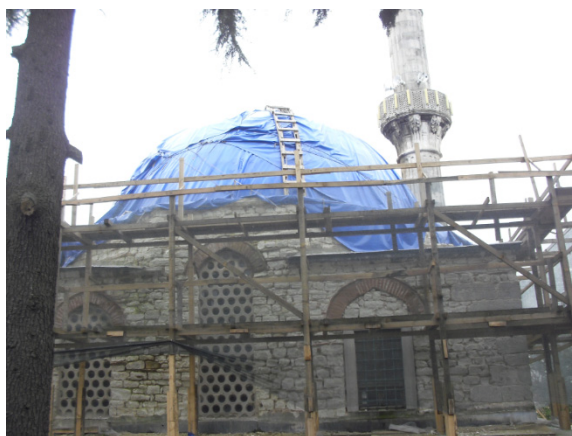
Figure 4: Cinili Mosque.

The textile cover material has a very wide range of quality, resistance and character. In restoration works the canvas used as the cover material is totally water-proof. It is a very cheap material and since different pieces are sewn into each other it is possible to get a piece as big as you need. These materials can be put on timber or steel structures or can be used without any structure directly by placing on the building. In the case of being covered on a structure, underneath there must be a very dense mesh of timber or steel and the canvas must be as tight as possible to prevent any sagging of the canvas which can carry water and eventually lead it to tear. Also the material is very vulnerable to wind. The more wind-resistant the material the costlier it is, and the other alternatives become much more feasible. They are usually not reusable since there is a great possibility of creating holes or tearing during the installation and dismantling. An example of use of canvas without any structure is the Cinili Mosque in Istanbul, Fig. 4. There was no visible structural damage and the only work to be done was the replacement of the lead cover of the mosque, so there was no need for an expensive system.

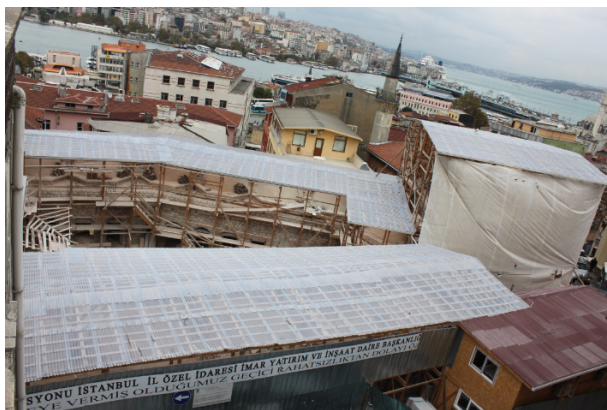
Figure 5: Siyavuspasha Madrasa.

These waterproof elements are generally not very expensive and are even used in permanent structures as cheap decorative roofing elements. They are easily accessible and applicable. They have special elements created for the hips and valleys and therefore do not pose as much weak points as metal deck sheets. They create a rigid cover structure that can even carry snow load, but they are not as resistant as metal and may be damaged physically easier. They have even transparent elements which make working under them easier and safer. Different composite materials are present made with cellulosic fibre (easily flammable, but cheaper) or glass fibre that are made rigid in cement or resin. Therefore there is a wide range of resistance and hence costs. An example is the Siyavuspasha Madrasa shown in Fig. 5.
