The Walls of Hondarribia

S. Sánchez Beitia, A. Zulueta Goienetxea & J. Barrallo Calonge

Abstract

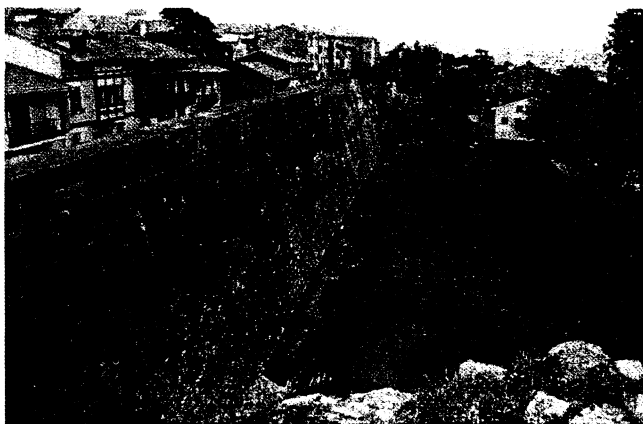
The walls present damages of different kind and nature. These can be classified into the followings:

Micro-organisms, plants, bushes and small birds nested on the Walls harm seriously their integrity. There are even old big trees which roots are embedded between the ashlar moving them and weakening the structure.

The first one should stop or minimise the damage on the material itself by protecting the ashlars from the atmospheric attacks, pollution and plants or animals. It would be required, as well, to reduce the impact of the necessary framework networks and recover the blind part of the Walls to waterproof them and strengthening of their crowns.
