Excavation, restoration and conservation of archaeological sites - *Villa dei Quintili* on the Appia Antica in Rome

M. Bellomo, S. D'Agostino

This paper presents the methodology and guidelines for intervention in the various phases of the excavation, restoration and conservation of archaeological sites. The theory and criteria it outlines are exemplified in the research project currently under way regarding the restoration of the grandiose Villa dei Quintili situated on the Appia Antica in Rome.

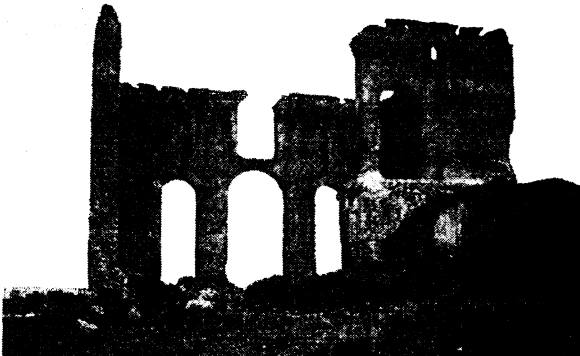
Figure 4 Façade characterised by collapse happened between 1910 and the eighties

In the above case the safety of a ruined structure was ensured given that, in the near future and as a result of natural phenomena, a new collapse mechanism would undoubtedly have developed, resulting in greater damage and further impairment of the monument's identity. In this case, on the other hand, we have evidence of a quite recent collapse in terms of the site's centuries-long history. It concerns the masonry structures of the southwest façade of the so-called *Piscina* (bathing pool), see fig. 4.

An engraving by Labruzzi, published by Ashby in 1909, shows the whole of the lefthand side of the façade still standing, and thus we can be sure that the great collapse took place between 1910 and the eighties.

At present the façade is badly damaged and the lefthand pillar of the only vault still extant on the first floor shows severe erosion of the wall facing which has drastically reduced the supporting cross-section. Here too an effective strengthening of the facing is needed to integrate the remaining support.

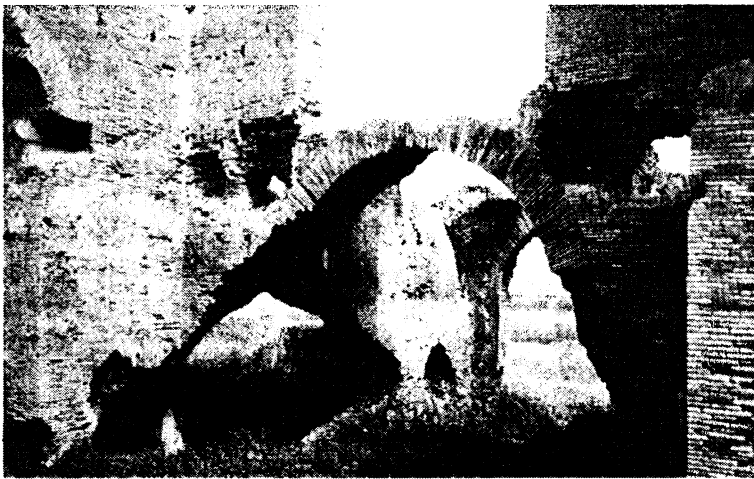
Figure 5 Baths hall B. The present form of the ancient construction

This is one of the most interesting architectonic structures in the whole complex. Its excavation is nearing completion, and it has brought to light various highly significant decorative features, such as the polychrome marble floor, and also construction elements. The large central vaulted ceiling has collapsed but it is possible to reconstruct its form and dimensions. The small vault in the apse presents a series of gaps which can be filled in, while the erosion of the wall facing on the northern side has reached a stage at which only a series of "pillars" are left supporting the remaining wall surfaces, creating a strikingly theatrical effect, see fig 5.

Extensive in-filling of the masonry would cancel all trace of the long process by which the ruins have reached their present condition and which is of particular interest from the historical and construction point of view. Thus any work we undertake must be carefully calibrated in order to halt the progress of decay, which at some time in the future is bound to provoke further collapses, and at the same time to avoid riding roughshod over the monument's historical evolution with indiscriminate rebuilding.
