The use of aramid fibres in the restoration of the Basilica of St. Francis of Assisi

G. Croci, A. Viskovic

Aramid fibres are used to strengthen the vaults of the upper nave in the Basilica of St. Francis of Assisi, after the last important and destructive earthquake of Sept.26.97.

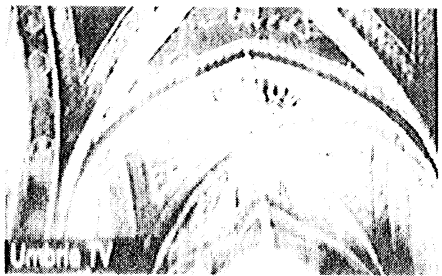
The failure mechanism of the vaults close to the facade, filmed by Umbria Television, resulted from the progressive loss of curvature of the ribs. Then a "hinge" was produced in the middle, just where there was the maximum resultant of the fill's mass action, and finally the rib collapsed drawing the vault down with it (Fig. 4). A similar mechanism occurred in the zone close to the transept, where the second vault collapsed.

Figure 4: The collapse mechanism.

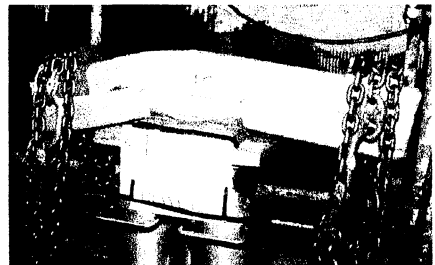
Different samples of the constitutive materials and of the composite ribs have been tested in specialised laboratories (Fig. 14), as up-to-day there was no large experience on the application of these products to consolidate historic masonry structures. The tests allowed to refine the ribs design in such a way to improve their mechanical characteristics and, contemporary, to reduce their section to a minimum, that is to reduce the impact of this new technology on the existing structure.

Figure 14: Rib-beam shear-bending test.

It was also tested the shear and bending bearing capacity of the timber nucleus alone which results 4÷5 times lower than those of the complete composite beam solution. On the other hand a 220x100mm section composite beam (18kg/m of weight) showed around the same yeld limit resistance which we can obtain by an IPE400 steel beam or by a HEM220 steel beam.

The experimental tests have also shown a considerable conservation of bearing capacity also after having passed the yielding point, with a good ductile behaviour even after several loading and unloading cycles.
