POLLUTION OF THE VAAL RIVER SYSTEM IN SOUTH AFRICA: A CASE STUDY

ELKINGTON SIBUSISO MNGUNI
Trans-Caledon Tunnel Authority, South Africa

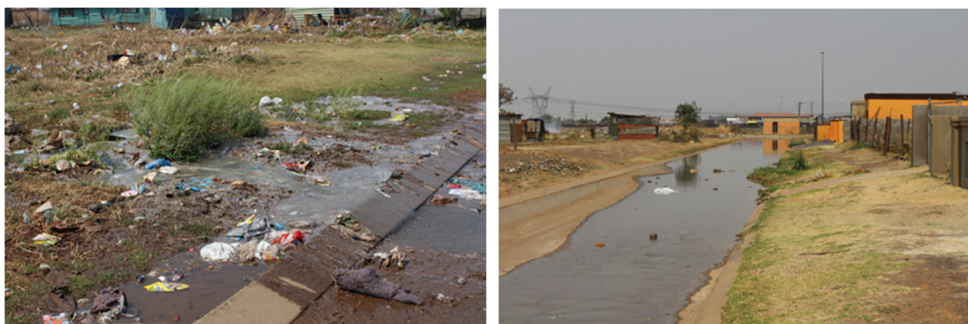
Failure to maintain the sewage collection network by conducting scheduled or periodic maintenance and predictive or condition-based maintenance is evidently what led to the spillage of sewerage into the streets in residential areas as shown in Fig. 3. These spillages are not at low points in the sewer collection network, but at manholes. These blockages typically occur at points where the sewer main changes direction or grade or where there is an intersection of another sewer line. Such blockages would generally be reported to the municipality’s water and sanitation operation and maintenance department to be cleared out. If there are no appropriate measures in place and the situation is not rectified timeously, one ends up with the situation that unfolded in the Municipality.

Figure 3: Sewage spillages in Sharpeville [9].

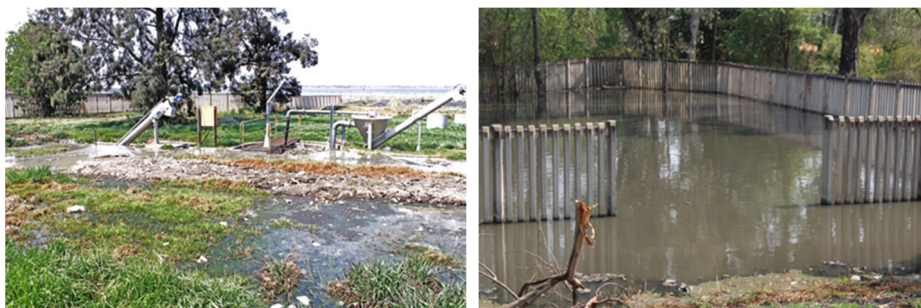
Failure to operate and maintain the pump stations according to sound asset management principles and best practice will invariably lead to sewage spillages at the pump stations. With the pump stations located at low points in the sewer networks, the sewage accumulates and ponds up without being pumped up and away from the pump stations. Fig. 4 shows typical cases where pump stations have failed as a result of which sewage created a pond inside and in the vicinity of the pump station. There are 44 pump stations in the Emfuleni sewer drainage basins or catchments, most of which have become dysfunctional.

Figure 4: A vandalised and abandoned pump station in Sharpeville and a flooded one in Vereeniging [9].

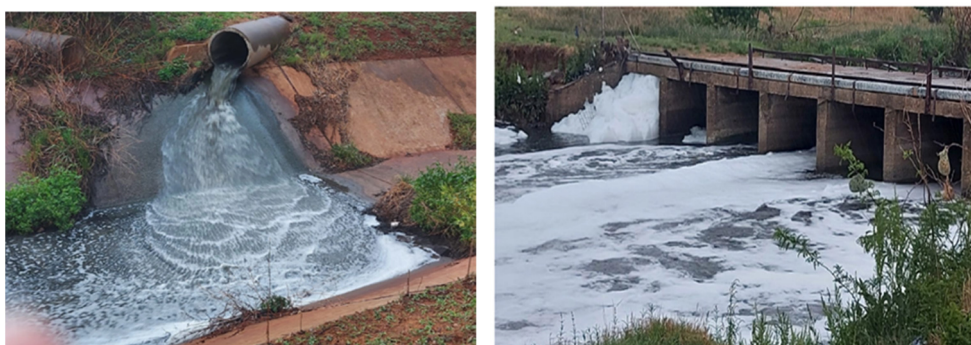
The performance of the three wastewater treatment plants seems to have deteriorated to the extent that by 2018 there was a pollution crisis in terms of the water discharges coming out of the treatment plants. The pollution problem seems to be continuing even as the short-term intervention is being implemented because reports from as recently as October 2021 show that there is little improvement in the situation as shown in Fig. 5 [10]. The treatment works would be overloaded as the wastewater collection network blockages get cleared.

Figure 5: Images taken on 25 October 2021 showing effluent discharged into a canal from the Rietspruit WWTW and the pollution of the Rietspruit River 2 km downstream from the WWTW [10].

The primary focus of the VRSI which was initiated in 2021 is to revitalise the existing wastewater collection, conveyance and treatment infrastructure. This is aimed at restoring the infrastructure to operational efficiency in the region. This intervention is part of the original SRSS envisaged in 2010 in terms of the scope of work for the medium to long term, but the current focus is on the short-term intervention which entails clearing up the wastewater collection network, clearing out the pump stations and treatment plants by carrying out remedial civil works and refurbishing and/or replacing the mechanical and electrical components [12].

The appointed civil engineers indicated that besides the refurbishment of the three WWTWs of Sebokeng, Rietspruit and Leeuwkuil, 44 individual pump stations are being upgraded, and the associated conveyance and sewer network pipelines are being unblocked. The DWS procured the services of Plant Hire and Bio-solids to unblock the sewer network and conveyance system and to handle bio-solids, respectively. The DWS also procured Civil Framework Contractors and aim to further procure the services of the Mechanical and Electrical (M&E) Contractors [12].
