Preliminary observations on the building materials at the prehistoric settlement of Toumba Thessaloniki

P. Spathis*, B. Christaras**, A. Stergiou***
** Dept. of Chemistry, Aristotle University of Thessaloniki (A.U.T.).*
***Dept. of Geology, (A.U.T.). ***Dept. of Physics, (A.U.T.).*

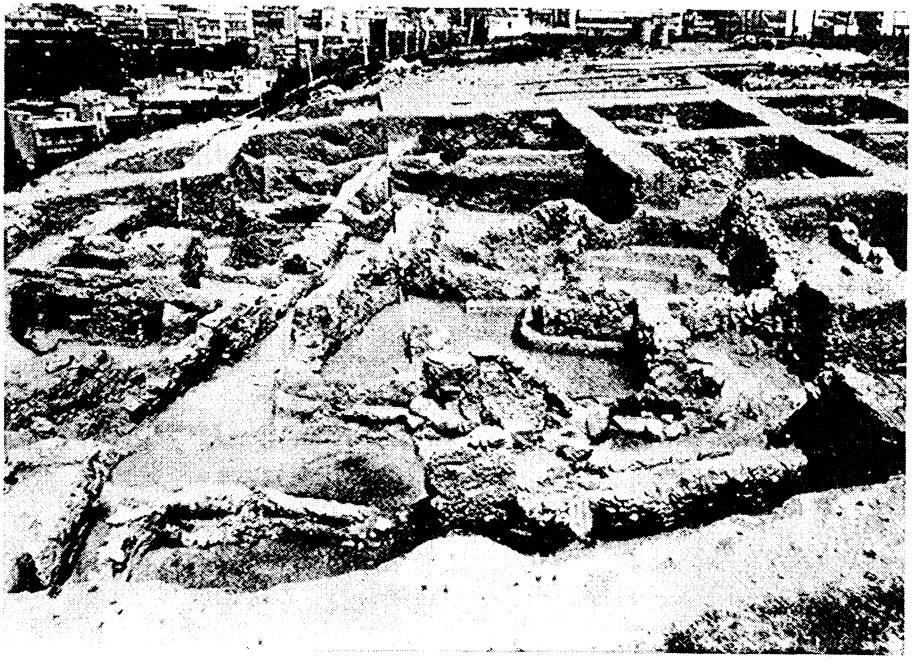
Figure 1: Part of the settlement-Main building and neighbouring constructions

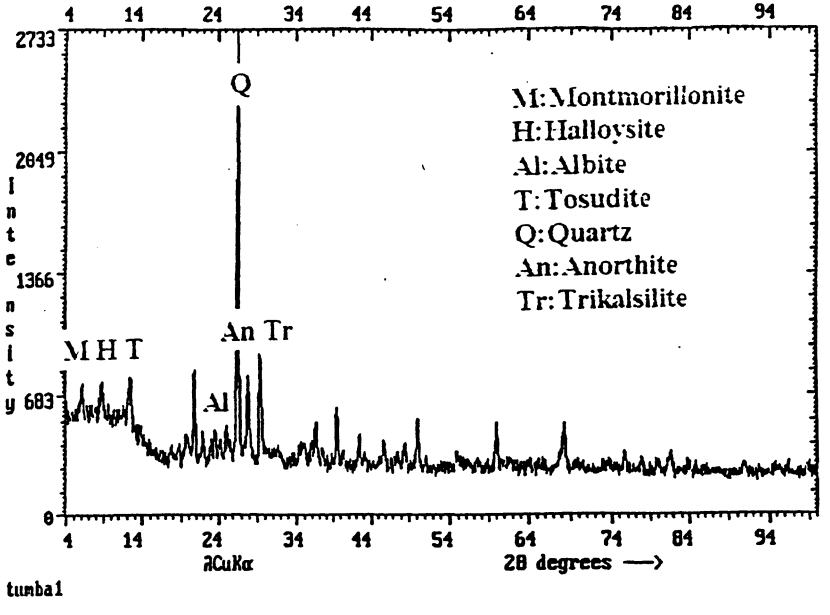
Figure 2. X-R diffractogram of the samples

The X-R diffractogram was the same for all the examined samples, indicating no mineralogical difference between them. The results of chemical analysis show slight only differences between the different samples, indicating also no significant difference in the composition of the mineral that contains (in oxide, hydroxide or hydrate form) Al and Si, also Fe, K, Mg, Ca and minimal carbonate salts, Mn, Na, S.

. From the results of Table 1 and Fifure 2 follows that the material is mainly composed of quartz (SiO_2) and natural aluminosilicates such as halloysite (aluminum silicate hydroxide hydrate-$Al_2Si_2O_5(OH)_4.2H_2O$), feldspars (albite-sodium aluminum silicate-$NaAlSi_3O_8$, anorthite-sodium calcium aluminum silicate-$(Ca,Na)(Al,Si)_2Si_2O_8$), montmorillonite (calcium magnesium aluminum silicate hydroxide hydrate-

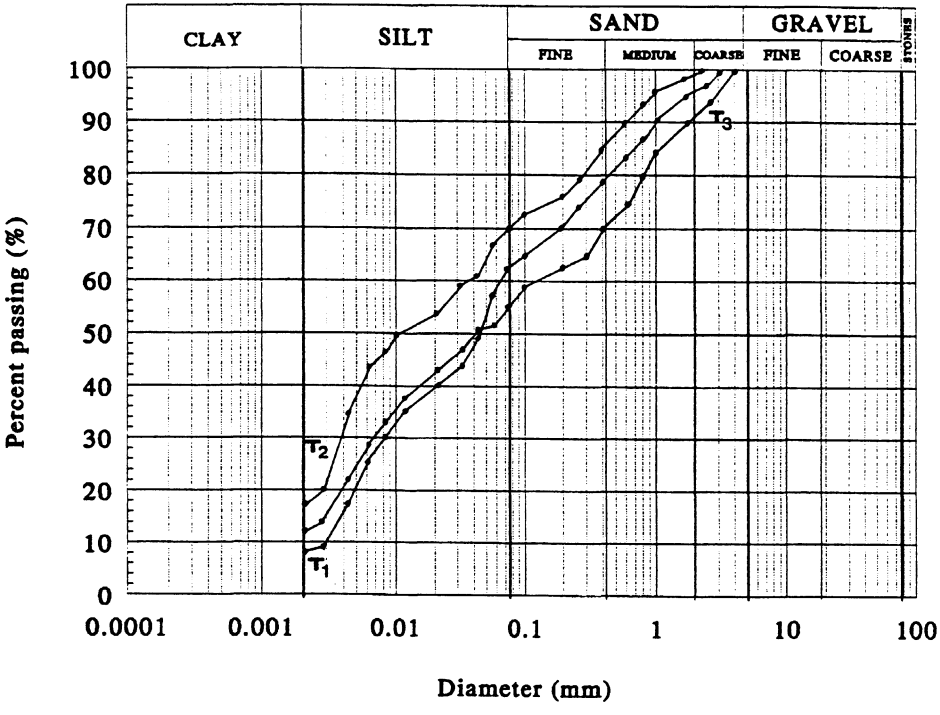
The particle size distribution shown in Figure 3 indicates that the mineral is composed from 10% clay, 50% silt and 40% sand.

Figure 3. Particle size distribution of samples
