SYNERGISM IN CONDITIONS EVALUATION TECHNOLOGIES: THE EXAMPLE OF THE SAN JUAN FORTIFICATION WALLS

J. FEINBERG¹, D. WOODHAM² & C. CITTO²

The original construction of the San Juan fortification walls in Puerto Rico dates from the mid-16th century. The fortifications were constructed with the single purpose of defending the City of San Juan and its harbour from attack, principally by sea. Over a four-century period of construction and reconstruction, the fortification walls evolved from one construction typology into at least ten identifiable types. The walls investigated in this study are 750 m long and 15 m high, and include two bastions and the San Juan Gate. The challenging task of evaluating such complex structures required the synergism between historic research and modern diagnostic techniques to develop a deep understanding of the history, materials and structural behaviour of the fortification walls. In addition to historic research, 21st-century technologies selected to evaluate the walls included laser scans, digital photo-documentation, wall coring, remote visual inspection of the core interior, microwave radar scans, thermography, characterization of stone and mortar typ

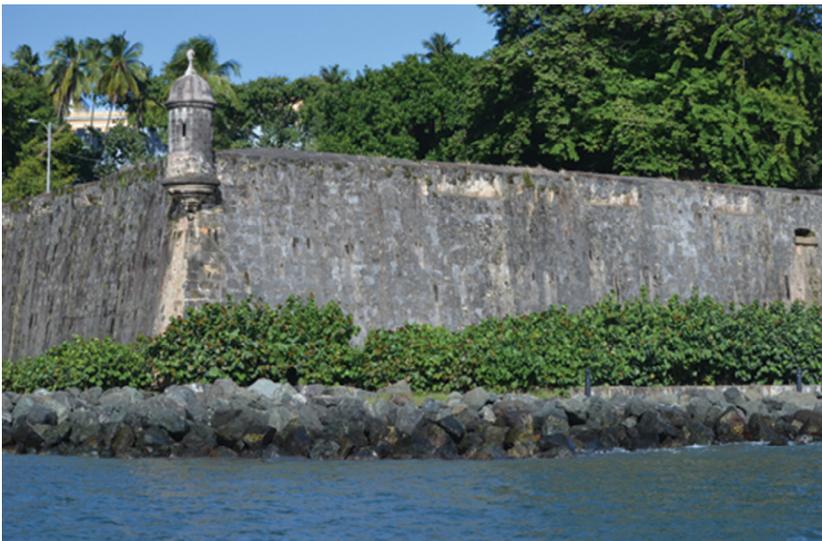
Figure 1: View of San Agustín Bastion from the sea.

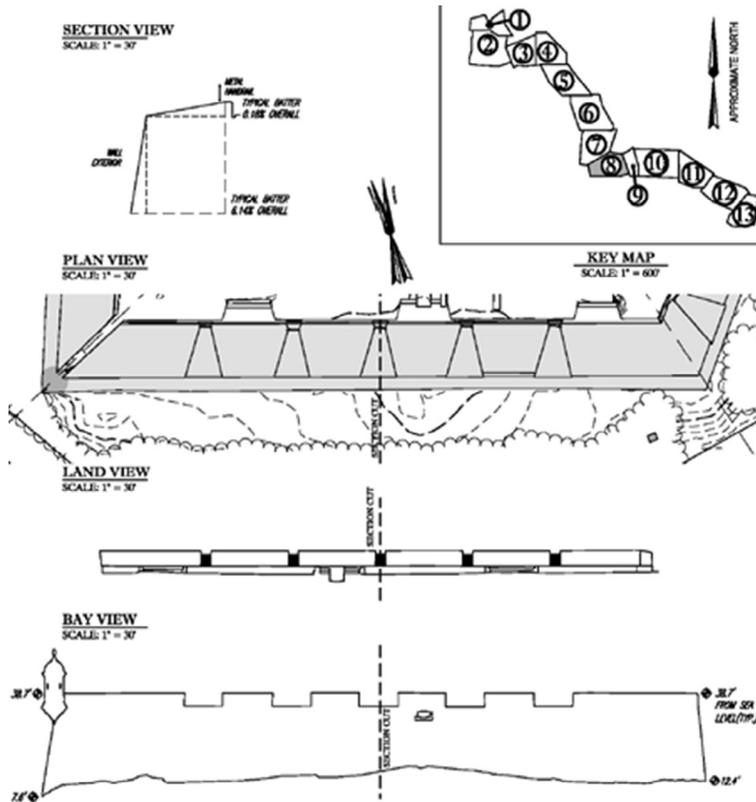
Figure 4: Wall survey for San Agustin Bastion.

anomalies and movement adjacent to cracks. This test was in addition to the laser scan used for computer-aided design drawings (Fig. 4). The thermographic images were taken at the same time as the high-resolution digital photography, both from a boat. The photography covered large sections of wall and detailed subsections of the larger scale images. Cooler areas seen in the thermographic images could be compared with the photographs of the same area to assist in determining if the temperature difference was attributable to through-wall water seepage or apparent vegetative growth (Fig. 5). These images were taken after an extended period of above-average rainfall. Correlation of the locations of areas of seepage with areas later revealed by ground-penetrating radar (GPR) as having above-average voids in the masonry at depth confirmed the water source to be largely groundwater.
