ISLAMIC HERITAGE ARCHITECTURE ANALYSIS AND RESTORATION OF RAS CHERRATINE IN FEZ, MOROCCO

K. EL HARROUNI¹ & A. EL HAMMOUMI²

3.2 Visual inspection: Main damage and problems requiring intervention

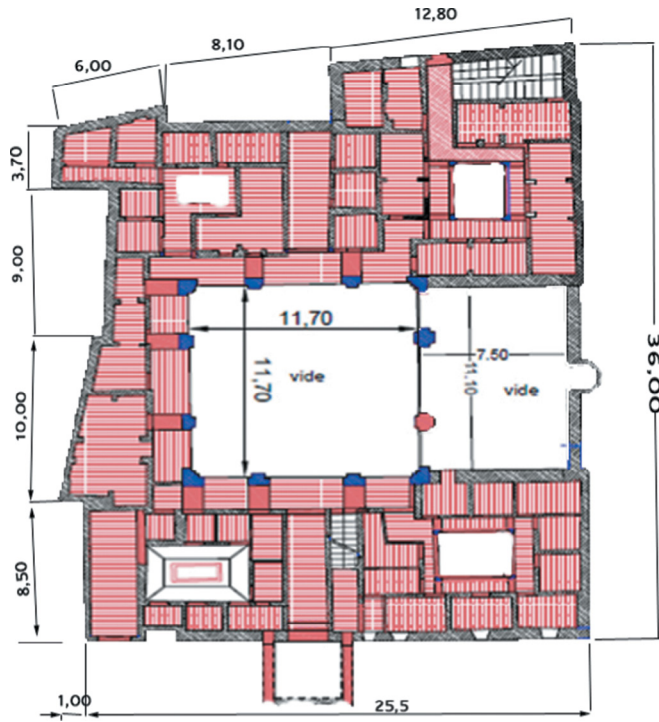
Figure 4: Structural plan of the ground floor.

The Ras Cherratine Madrasa structure has three levels and the common materials of masonry construction are fired bricks. The thickness of the front walls ranges from 60 to 80 cm, while that of the inner wall is 40 cm. The ground floor is 4.8 m high, while the first and second floors are 3 m high. The overall building height is about 12 m. The floor diaphragms are made of wooden beams and the type of wood commonly used is cedar. The geometry is described in the structural plans (Figs. 4 and 5).

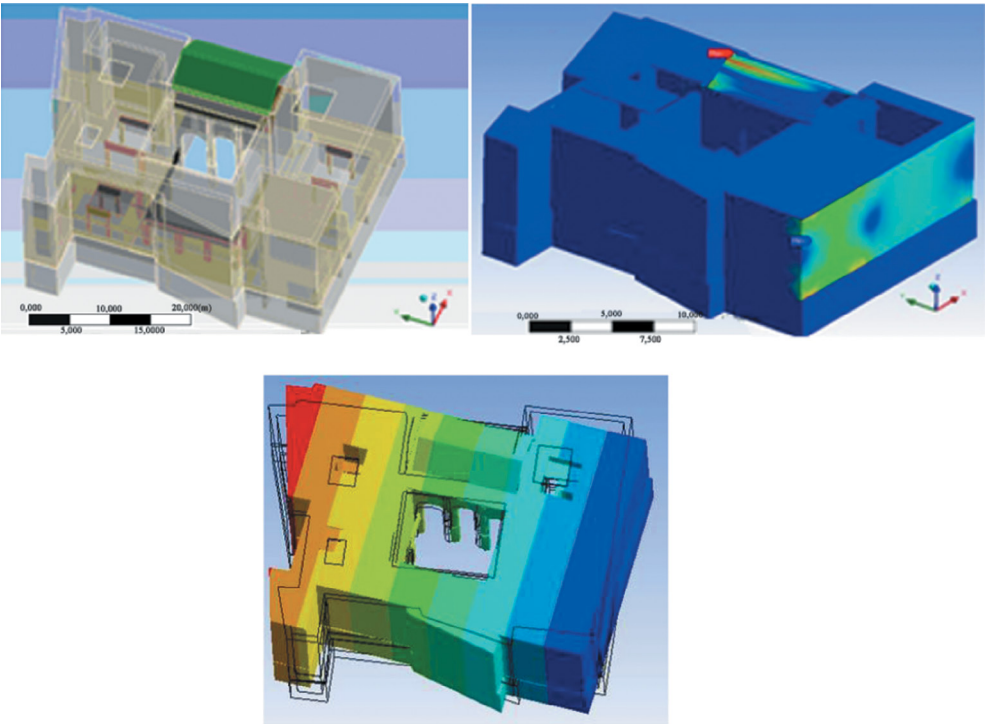
Figure 8: The virtual model of the Madrasa and the nonlinear static and modal analyses.

The performed three-dimensional modelling technique is based on the numerical calculations using ANSYS software (Fig. 8): the nonlinear static analysis and the nonlinear modal analysis. The main results obtained by the nonlinear static analysis approach for each seismic acceleration (% g) include the deformation (%), the shear stress (MPa) and the maximum displacements (cm) along *x*- and *y*-axes. The nonlinear modal analysis allowed to obtain the displacements (cm) along the *x*- and *y*-axes as the main results for each frequency value.

Damage analysis related to the ground acceleration of 10% g for the region of Fez Medina has shown that the terrace floor of Ras Cherratine Madrasa building may collapse.

The Madrasa structure reached the performance point and may suffer major damage for seismic accelerations higher than 18% g. Analysis of the Madrasa structure with seismic excitation applied to the two horizontal directions of the structure (x and y) has indicated that the Madrasa is vulnerable in both directions. This vulnerability can be justified as follows: The structural system consists of load bearing walls to resist both gravity and lateral loads; there is no connection between the diaphragm and the walls; the flexible diaphragm is unable
