THE DIALOGUE BETWEEN ANCIENT AND MODERN MATERIALS IN THE RESTORATION OF A COLLAPSED ANCIENT CHAPEL

ANTONIO GALIANO-GARRIGÓS¹, VÍCTOR ECHARRI-IRIBARREN¹, ANGEL-BENIGNO GONZÁLEZ-AVILÉS¹ & MARÍA DOLORES ANDÚJAR-MONTOYA²

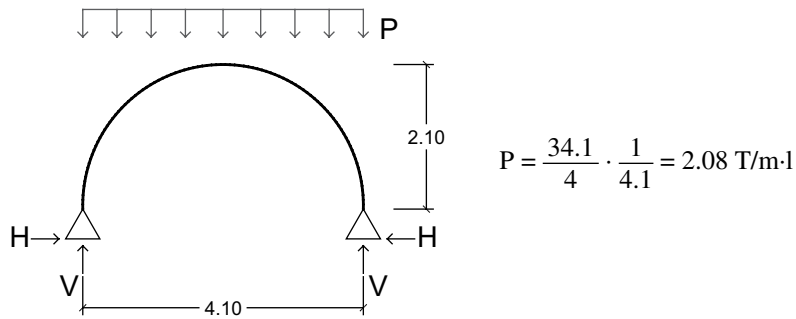
Dome supporting cylinder:	Estimated Thickness, <i>e</i>	30 cm
	Height, <i>H</i>	100 cm
	External Radius, <i>Re</i>	270 cm
	Internal Radius, <i>Ri</i>	240 cm
	Volume = $\pi \cdot (Re^2 - Ri^2) \cdot H$	= 4.81 m ³
Dome:	Estimated Thickness, <i>e</i>	25 cm
	External Radius, <i>Re</i>	265 cm
	Internal Radius, <i>Ri</i>	240 cm
	Volume = $\frac{2}{3} \pi \cdot (Re^3 - Ri^3)$	= 10.0 m ³
Total Volume = 4.81 + 10.0 = 14.81 m ³		
Weight = $V_T \cdot \gamma = 14.81 \cdot 2.30 = 34.10$ tons

Once the loads were estimated, it was necessary to size the stays considering their position in the lower part of the supporting arches.
