Large wood and flash floods: evidence from the 2007 event in the Davča basin (Slovenia)

F. Comiti¹, L. Mao^{1,3}, E. Preciso², L. Picco¹,
L. Marchi² & M. Borga¹

Abstract

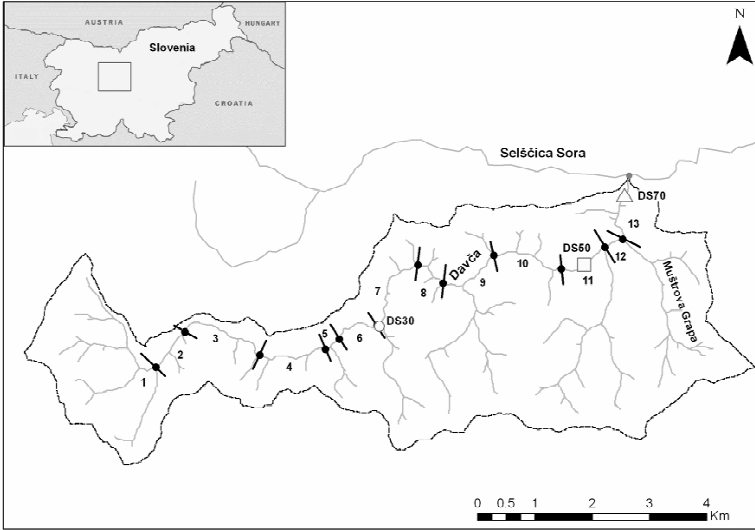
Figure 2: The Davča catchment with channel subdivision into 13 reaches and the cross-sections where peak discharge was estimated. The location map in the upper left corner shows the area affected by the flood of September 2007 in the Sora River basin.

The steeper, narrower reach downstream (11, Fig. 7) was characterized by diffuse bank erosion and local bed incision. Peak discharge here (drainage area 21.4 km^2) was estimated around $150 \text{ m}^3 \text{ s}^{-1}$ (i.e., $7 \text{ m}^3 \text{ s}^{-1} \text{ km}^{-2}$, DS50 in Figs. 2–3).

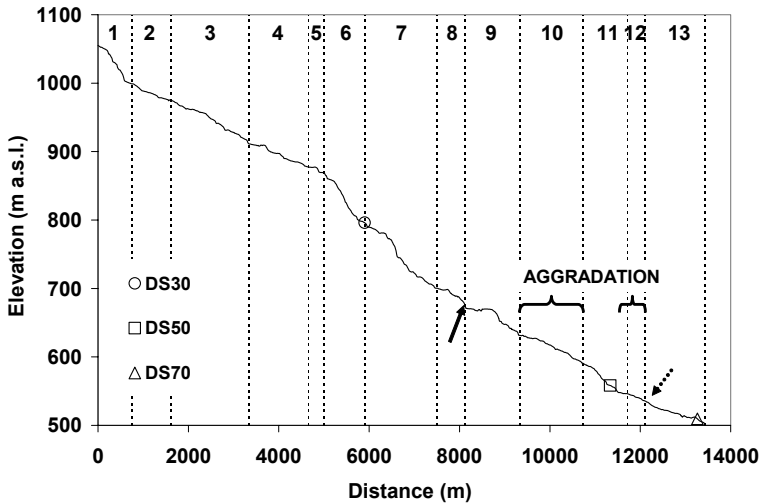
Figure 3: Longitudinal profile of the Davča Torrent. The solid row indicates the location of a major debris flow tributary, and the dotted line arrow the confluence with the Muštrova Grapa. The void symbols (circle, square, triangle) locate cross-sections where discharge was estimated (see also Fig. 2).
