# Contribution of radar measurements to the inspection and condition assessment of railway bridges – case study at a historic masonry arch bridge in Oleśnica/Poland

Ch. Trela, J. Wöstmann & S. Kruschwitz

*Federal Institute for Materials Research and Testing (BAM), Germany*

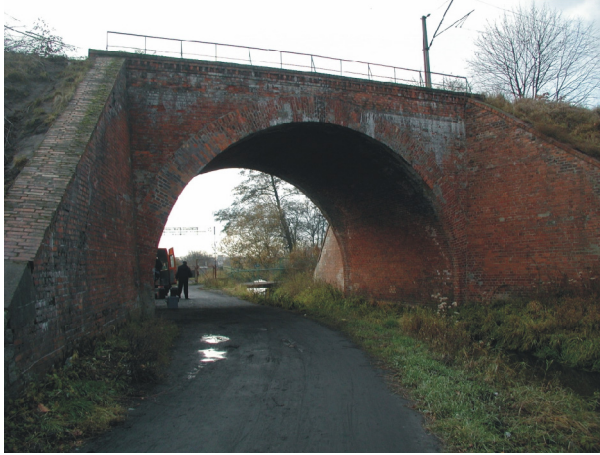
The selected masonry bridge is located in Oleśnica, 40 km northeast of Wrocław. It belongs to the railway transportation system, which has only one track in use. This masonry bridge was constructed as from brickwork with one span and two tracks, see Figure 1, in 1875. The circular arch barrel covers a radius of nearly 5 m.

Figure 1: View of the railway bridge from Oleśnica.
