CAUSES OF DETERIORATION OF OTTOMAN MOSQUES

MARIA LOUKMA & MARIA STEFANIDOU

Laboratory of Building Materials, School of Civil Engineering, Aristotle University of Thessaloniki, Greece

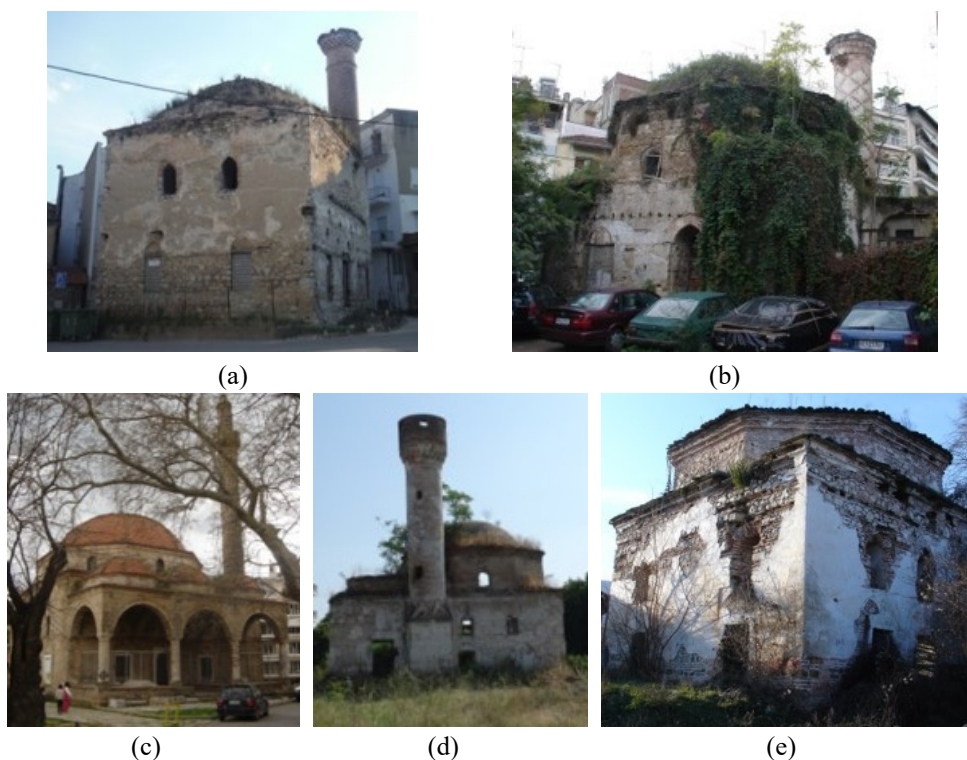
Figure 1: The five mosques. (a) Koursoum Mosque; (b) Orta Mosque; (c) Geni Mosque; (d) Ahmet Bey Mosque; and (e) Mosque in Exochi.
