## **An assessment of the rate of siltation in Jibia reservoir, Jibia, Katsina state**

Y. O. Yusuf & F. Yusuf

*Department of Geography, Ahmadu Bello University, Nigeria*

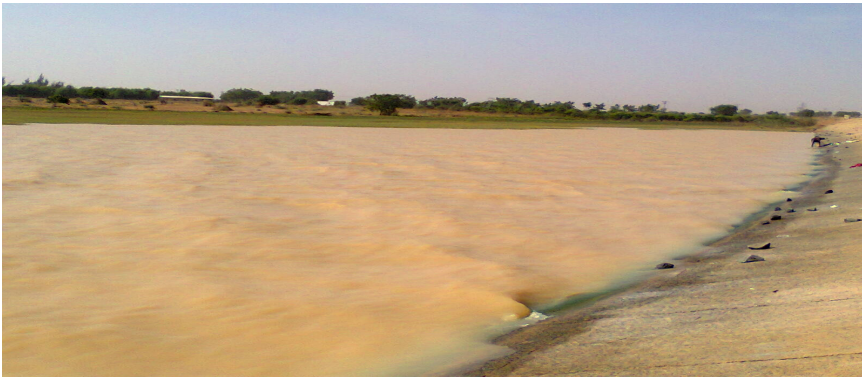
Figure 1: Jibia Dam and its reservoir.

Since the construction of the dam about 20 years ago, there has not been any research carried out to determine its current depth. The dam instruments used for monitoring and maintenance of the dam like daily reservoir level, relief wells level, checking for dislodgements and possible settlement no longer function efficiently. Hence the dam has not been properly monitored and managed (SRRBDA [9]).
