Spatio-temporal distribution of slope failures in the Western Ghats of Kerala, India

S. Sreekumar & A. Aslam

*Department of Geology and Environmental Science,
Christ College, India*

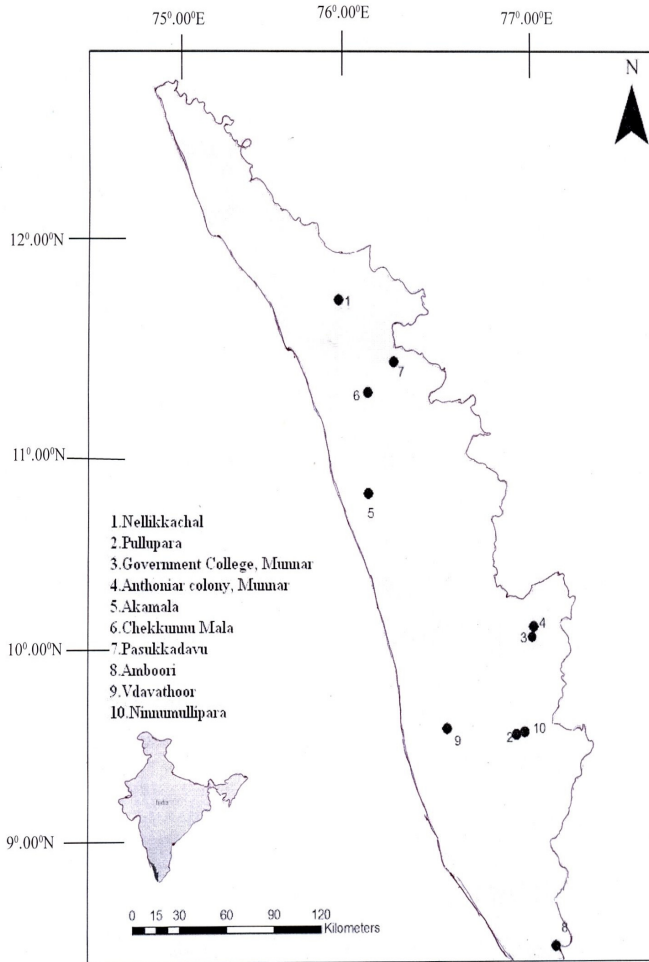
Figure 1: Spatial distribution of failed hill slopes.

Major and typical slope failures, which are spatially distributed from South to North in the Kerala Western Ghats from 1993 to 2009, are studied in detail (fig. 1). The locations from south to north are Amboori in the Trivandrum district, Vadavathoor in the Kottayam district, Pullupara, Ninnumullipara, Govt. College, Munnar and Anthoniar Colony, Munnar in the Idukki district, Akamala

in the Thrissur district, Chekkunnu Mala in the Malappuram district, Pasukkadavu in the Kozhikkode district and Nellikkachal in the Kannur district.
