# **The lessons learned from conducting a condition survey on unsealed roads surfaced with marginal materials in the Iringa region, Tanzania**

R. R. Mwaipungu & D. Allopi

*Department of Civil Engineering and Surveying,  
Durban University of Technology, South Africa*

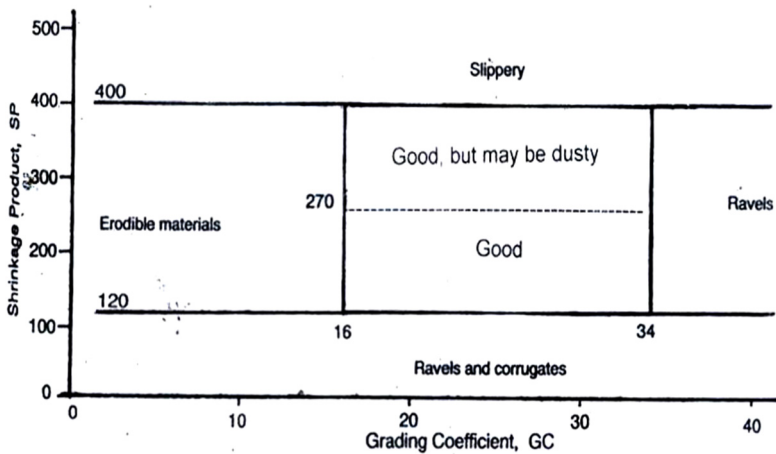
Figure 4: Performance specification for gravel wearing course.

In general, test results of GC for all the marginal gravel materials borrow pits employed to surface test sections did not meet the requirement as per TZ-MoW [7]. Despite not meeting the stated specifications, these materials performed relatively well during the condition survey. It should be noted that Figure 4 is based on South African research conducted in the nineteen eighties and reported by Paige-Green [9] with slight changes.

From the above it is sufficient to mention here that there is a need to adjust the window frame of GC for the marginal materials as none of the distress associated with gravel materials by not meeting the given range as shown in Figure 4 were observed during the condition survey. The range for the Msembe road was 36–72, the Pawaga road was 23–62, and the Idete road 31–49. This study recommends a GC range from 23–72 for marginal materials, as it is more accommodating for all the marginal gravel materials used to surface gravel roads covered by the study.
