# GEOMECHANICAL EVALUATION OF THE OLÓN CLIFF FOR STABILIZATION PRE-DESIGN OF THE BLANCA ESTRELLA DEL MAR SANCTUARY, SANTA ELENA, ECUADOR

Olón commune has one of the quietest and safest beaches on the Ecuadorian coast, among its tourist attractions stands out the “Blanca Estrella de Mar” sanctuary, which is located on a cliff approximately 40 m high. This sanctuary is part of the route of the seven churches in the Santa Elena Peninsula, which is continuously visited by tourists. Nowadays, the erosion caused by the wind, added to the rain and strong waves that hit the base of the Olón cliff directly and the anthropic activities affect the slope stability, in which block detachments have already been reported, generating risk to people and the foundations of the buildings of the place. The aim of this research is to evaluate the stability of the slope by means of the geological and geomechanically characterization for the proposal of the pre-design of the stabilization measures. The methodology of this work includes four phases: (i) drone topography and systematization of information; (ii) geological and geomechanically characterization of the area; (iii) evaluation of the stability

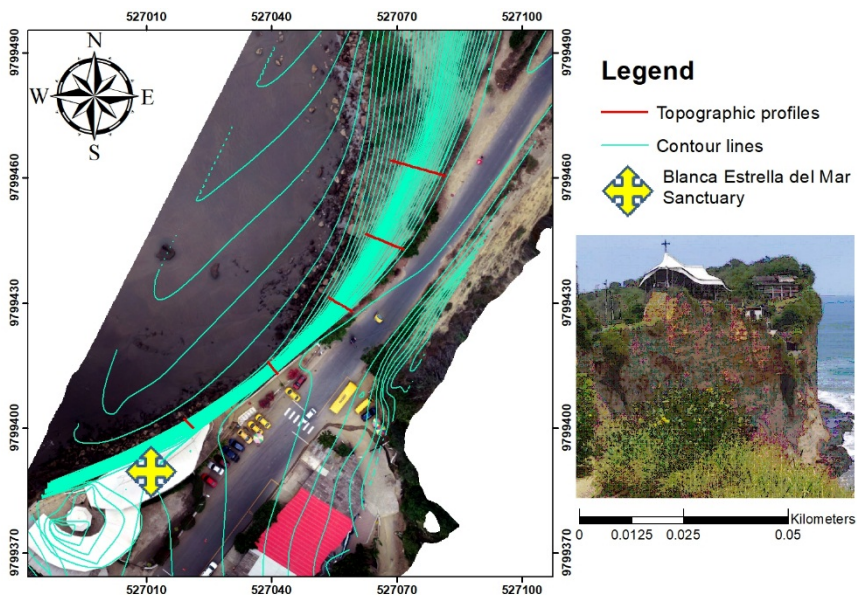
Figure 6: Location of topographic profiles along the slope.

For the calculation of the safety factor, five topographic profiles (Fig. 6) and the geomechanical properties of the materials were used, using the method proposed by [21], considering the lowest factor for the analysis and considerations for the stabilization pre-design.
