# STRUCTURAL (PHYSICAL–TECHNICAL) VULNERABILITY OF LOW-INCOME HOUSING IN THE FACE OF SUBSIDENCE IN URBAN AREAS: CASE STUDY OF THE ERMITA ZARAGOZA NEIGHBORHOOD, IZTAPALAPA DISTRICT, MEXICO CITY, MEXICO

GUSTAVO ALONSO BACA-SÁNCHEZ, BERTHA NELLY CABRERA-SÁNCHEZ  
& MILTON MONTEJANO-CASTILLO

Escuela Superior de Ingeniería y Arquitectura Unidad Tecamachalco del Instituto Politécnico Nacional, Mexico

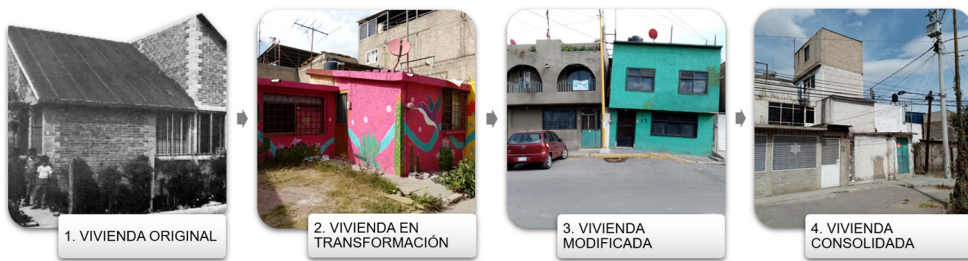
Figure 2: Transformation of low-income housing. (Source: Picture 1 – López Parcero [12]; Pictures 2 to 4 – Alonso Baca, 2020.)
