## Slope instability along some sectors of the road to La Bufadora

### Abstract

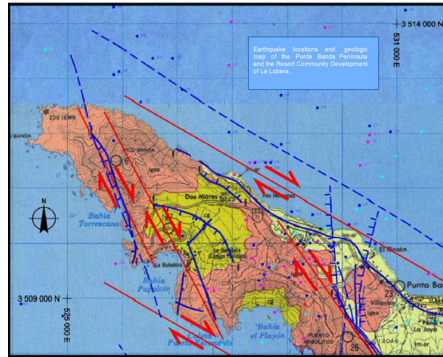
Figure 2 shows two of those ruptures located in the study area.

Figure 2: Proposed faults (dashed lines) and interpreted faults (solid lines) for the study area (modified from González-Fernández *et al.* [2]).

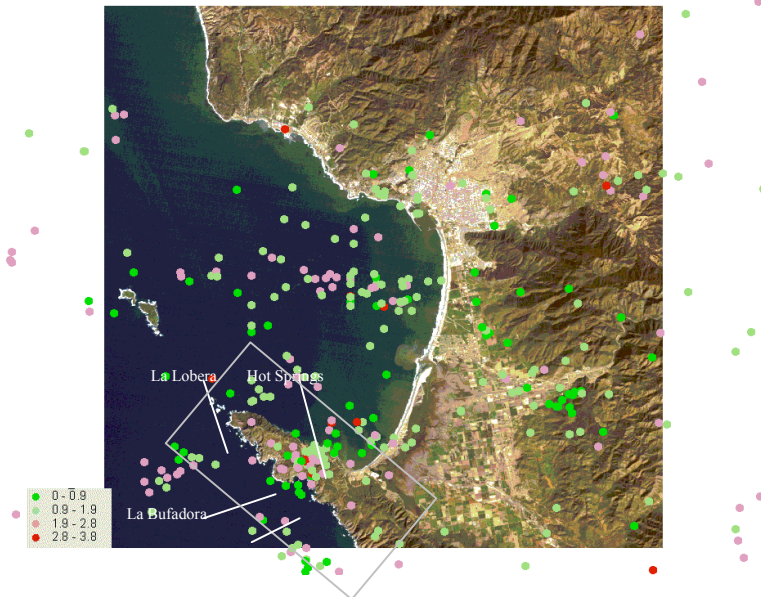
Figure 3: Microseismicity registered from 1982 to 2007 (CICESE [3]). The area in the rectangle comprises the Peninsula of Punta Banda.

months in one section of the main road to La Bufadora, near a hot spring area (Figure 3) and at El Playón Bay which shows evidence of normal faulting.

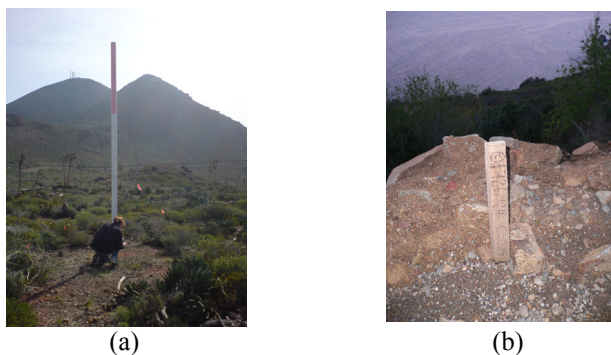
maps, gather information of possible rupture zones and to deploy 35 stack poles on La Lobera Resort Development and on its access road to measure possible displacements. Preliminary information from the stacks was collected in January and February of 2008 (figure 4) and is still being collected.

Figure 4: Stack pole deployment along the La Lobera Development (a) and on the access road to La Lobera Development (b).

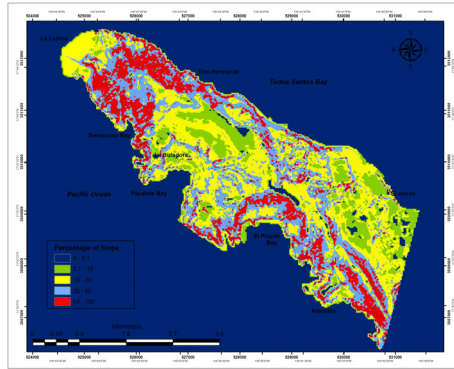
Based on field recognition and maps, we have classified the slopes as shown in Figure 9 and their analysis is given in Table I.

Figure 9: Slope classification in the Punta Banda Peninsula.

In addition, it is strongly recommended as a preventive measure to avoid any building or development at least at a minimum distance of 50 m. to the superficial trace of any fault.
