Diagnostic strategies for the repair intervention on churches damaged by earthquakes: the Toscolano Maderno Monumental Complex

L. Binda¹, S. Lagomarsino², S. Podestà², A. Saisi¹ & C. Tedeschi¹

Abstract

This paper describes the methodology applied to two churches of the Garda area damaged by the 2004 earthquake in order to define the repair intervention. After interpretation of the damage causes, based on an accurate onsite survey and documentary research, the intervention strategies were supported by an onsite testing campaign.

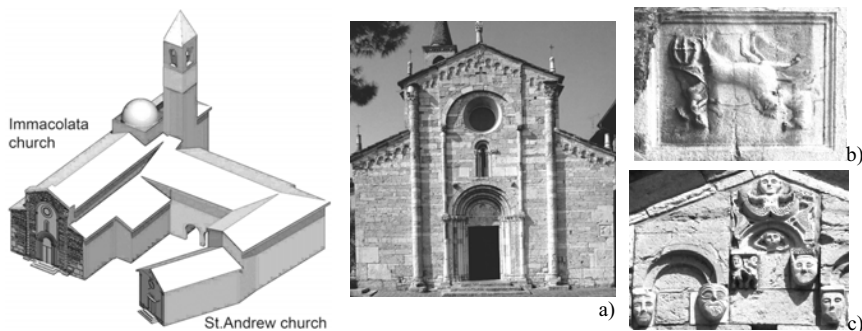
Figure 1: View of the Monumental Complex

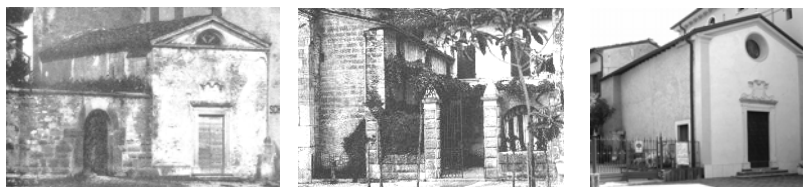
Immacolata Church was built in the 1605 as a baptistery, and successively modified in 1675. A 1929 intervention modified the church as it appears today: in the façade the cornice was removed, the window transformed in an oculus and the perimeter wall was substitute by a steel railing (Fig. 3). Interventions were carried out in the '90s with the insertion of buttress corresponding to the apse.

Figure 3: Immacolata church: evolution from the 1929 to the current situation.

The lack of the original lateral constraint (masonry buttress and the bailey) favoured the activation of the previously described damage mechanisms (Fig. 3). The thrust, provided by the adjacent building, was not balanced adequately: the existing steel tie-rods are not able, in fact, to create a real contrast, because their position reduces the effectiveness of these aseismic devices. The steel tie rod, in correspondence of the façade, is not positioned in the masonry wall axis (situation structurally more accurate) and it seems too high to limit an in-plane mechanisms. On the other hand, the tie rods in correspondence of the barrel vault are too low to absorb the vault thrust correctly. It is worth noticing, moreover,
