Evaluation of the structural behaviour of historic masonry buildings by using a sonic pulse velocity method

F. Casarin, M. R. Valluzzi, F. da Porto & C. Modena
*Department of Structural and Transportation Engineering,
University of Padova, Italy*

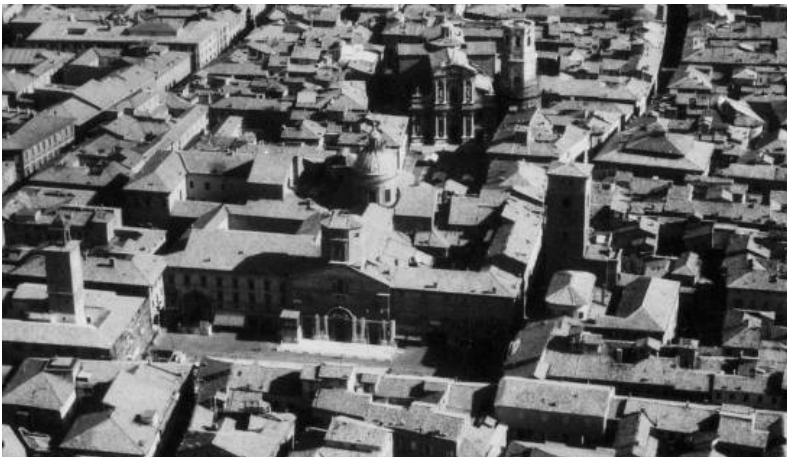
The cathedral presents an original Latin cross plan, with central nave, two aisles and transept. The length of the church is 77.40 m, the width is 33.80 m, the span of nave and aisles is 10.15 m and 6.50 m, respectively. The maximum height is reached at the top of the dome, with 44.60 m; the height of the façade dome lantern is 33.80 m and the height of the roof above the central nave corresponds to 22.25 m. The cathedral is mainly composed by clay brickwork masonry. The diverse constructive phases comported the use of different materials, and some structural elements or parts (e.g. Romanesque pillars, lower façade veneers) are made of stone (Figure 1).

Figure 1: Santa Maria Assunta cathedral in the city centre of Reggio Emilia.

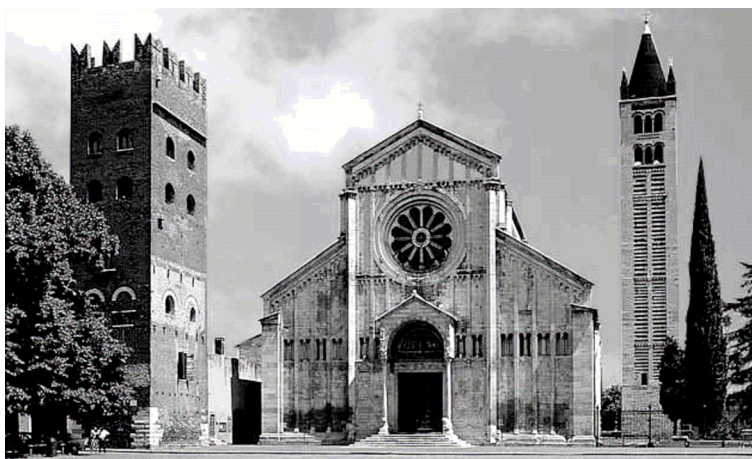
On the right side of the basilica and separated from it, the bell-tower rises to a height of 66 m. Erected in 1045 AD and repaired in 1120 (after the 1117 earthquake), was finished in 1178. Above the base it presents the characteristic alternation of colours due to the sequential use of calc-tufa stones and brickwork bands. The rhythm of the bell-tower is marked by cornices decorated with tuff stone arches and it is crowned by a double order of thee mullioned windows and by a spire with 4 side pinnacles.

Figure 5: S. Zeno basilica, façade. On the background, on the right, the bell-tower.
