# Non-destructive testing techniques applied to the masonry and timber structures of the Crocifisso Church in Noto

L. Binda, L. Cantini, P. Condoleo & A. Saisi

*DIS – Department of Structural Engineering, Politecnico of Milan, Italy*

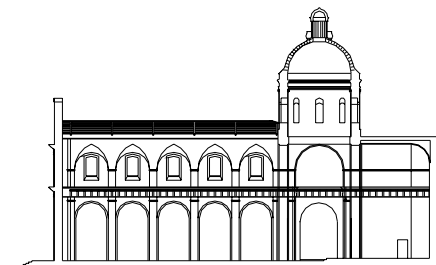
Figure 4: Longitudinal section of the Crocifisso Church.

The church was built using the local limestone, the same as the one of the Cathedral and was finished in a relatively short time after the earthquake; also here, due to the mass of building in the new town, the construction was made by a poor workmanship. In Fig. 4 the Church vertical section is shown.

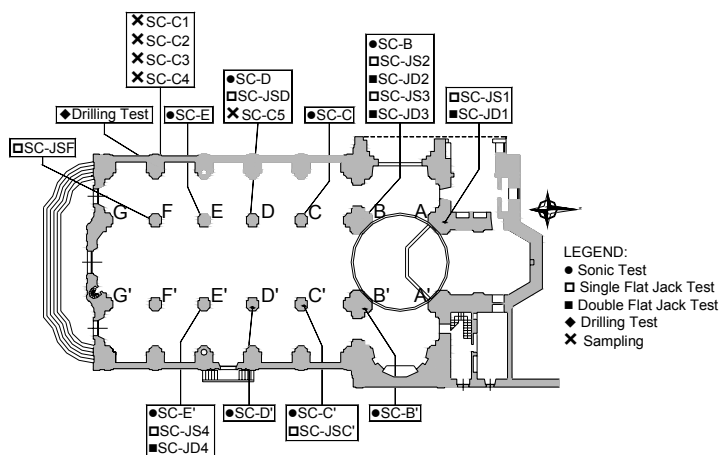
Fig. 5 shows the church plan with the localisation of the tests on the masonry.

Figure 5: Crocifisso Church plan and localisation of the double flat-jack tests.

The sonic velocity also is lowered by the presence of cracks, when they are perpendicularly crossed. In fact the lowest average velocities (SC-D1) concern the pillar called D (Fig. 5), characterised by the worst crack pattern situation. It was also possible to notice that in the case of highly cracked external leaf the velocity became lower.

Higher stress values, 1.39 MPa, were measured (SC-JS4) on a pillar called E1 (Fig. 5), while the other pillars have a lower stress (0.83-0.99 MPa). The stress-strain diagrams show consistent deformability of the masonry with rather low values of the elastic modulus and hence also of the strength. Furthermore, the high diffusion of cracks caused to interrupt most of the tests. The double flat jack-tests carried out within two stones (LVDT 5,6,7) and across a mortar joint (LVDT 1,2,3,4) (Fig. 13), show a totally different deformation under the same stress when it is measured on the stones or across the joint.

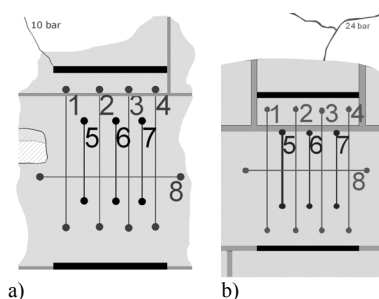
Figure 13: Geometry of the double flat jack-tests SCD1 (a) and SCD2 (b). The acquisitions are carried out within two stones (LVDT 5, 6, 7) and across a mortar joint (LVDT 1, 2, 3, 4).

In Fig. 14 and 15 (SC-D1, SC-D2) these two different behaviour are shown in the stress-strain plot as average of LVDTs 1, 2, 3, 4 and of 5, 6, 7 (Fig. 13).

It is then confirmed that there is a greater deformation in the joint when a certain state of stress is reached. Furthermore, the plot of Fig.14 shows a weaker behaviour of the masonry compared to SC-D2 (Fig. 15).

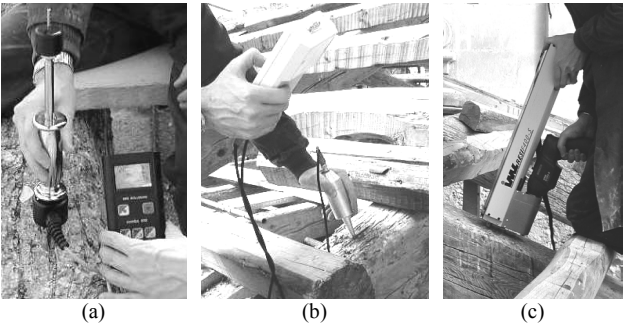
Figure 16: Testing the timber roof: thermo-hygrometric survey (a), ultrasonic test (b), penetrometric test on a truss element (c).

thermo-hygrometric conditions in the testing points were recorded (Fig. 16(a)). Successively, the ultrasonic characterization was carried out in cross-section mode (Fig. 16(b)).

Finally, penetrometric tests were performed using an apparatus, commercially denominated Resistograph (RESIF400®) (Fig. 16(c)), that measures the resistance opposed by the timber to the penetration of a pin which is rotating and penetrating at constant speed. This parameter is related to the material density, which of course is influenced by the presence of knots, irregularities, decay, etc.
