Deans Eye Window – Lincoln Cathedral, Lincolnshire, UK

G. A. Clifton

Director Historic Buildings, Gifford – Consulting Engineers, UK

Abstract

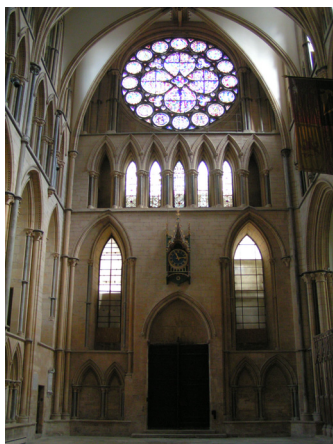
Figure 1: Internal view.

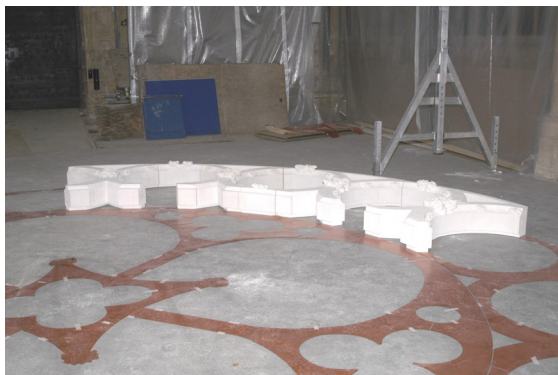
Figure 6: Setting out – floor.

The agreed sequence for the reconstruction was to install all the outer roundels, then to install the lower two quadrants with the hoop ring, followed by the lower two spokes. At this point the steel assembly for the quatrefoil was installed and held in place and the upper two spokes fixed. The upper two quadrants were then placed with the assistance of centring and the last section of the hoop ring tightened. The final task was to clad the quatrefoil steel assembly in stone.

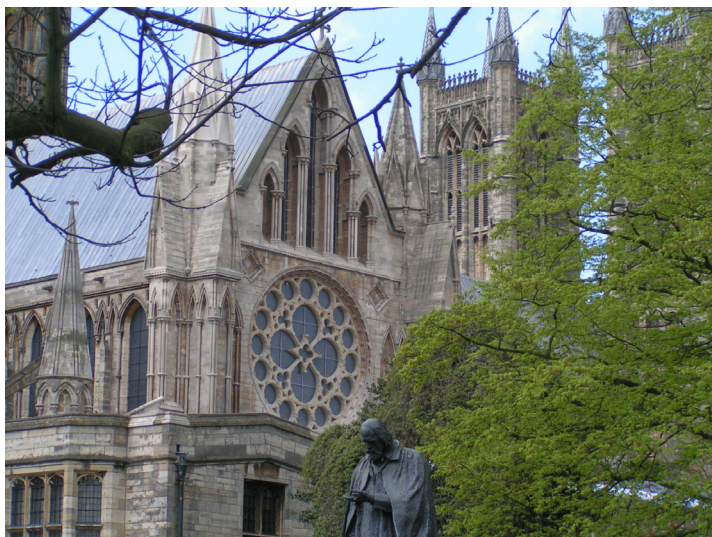
Figure 7: External view of completed window.

The reconstruction of the tracery was an eight-month task. The masons performed well and the tracery was erected to close tolerances of within 3mm across the opening, a far tighter tolerance than one would normally expect on masonry.

The glazing was installed as expected within 4 months and the project completed to acclaim within programme and budget.
