Methodologies for the evaluation of seismic vulnerability of complex masonry buildings: case histories in the historic centre of Sulmona

L. Binda, A. Anzani & G. Cardani
D.I.S – Politecnico di Milano, Italy

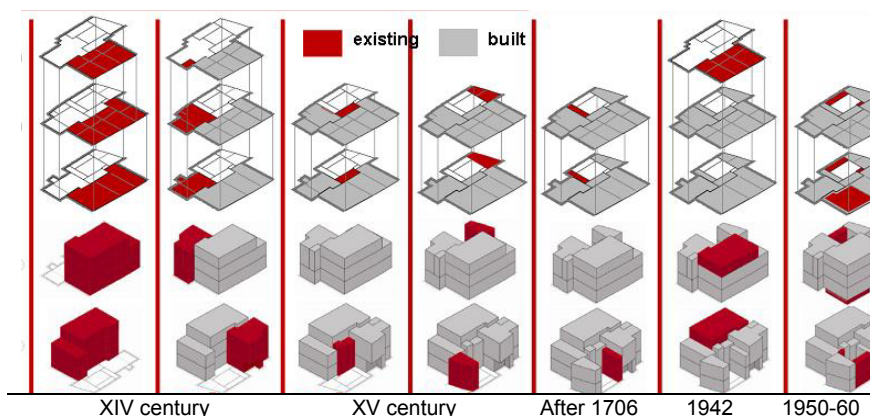
Aggregates of historical buildings have generally been subjected to the addition of several volumes in different times, and the possible discontinuities between the different volumes could affect the overall seismic behaviour. In fig. 6 block 69 in Acuti Street is shown as an example. Its volume was apparently rather simple when looked from the outside, whereas required to be subdivided into three macro-elements once surveyed in more detail (figs. 7-9). For a reliable interpretation of the signs of damage, the preliminary in-situ survey, useful to obtain details on the geometry of the structures, identifying irregularities like vertical deviations, rotations, etc. needed complementary indication coming from the investigation of the historical evolution of the structure in its complexity (fig. 10).

Figure 10: Historical evolution of block 69.
