Structural consolidation of the Apostle Santiago's church in Jerez de la Frontera (Cádiz, Spain)

E. Rodríguez-Mayorga, E. Yanes & A. Sáez

*Department of Continuum Mechanics and Structural Analysis,
University of Sevilla, Spain*

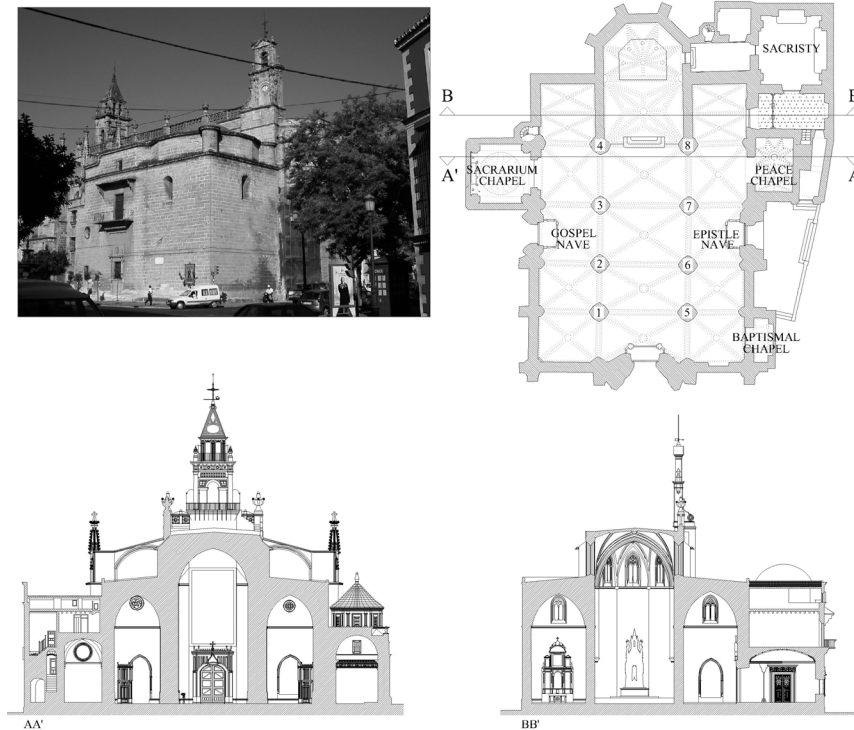
Figure 1: Geometry of the Church of Santiago Apostle.

The temple has suffered severe structural problems along its history. The first documented problem dates from 1695, when columns 2 and 3 collapsed (fig 1), and were immediately reconstructed. In 1905 column number 1 was substituted using better-quality sandstone, in order to avoid a new catastrophe. In 1928 the lower part of column number 7 was substituted as well. In 1956, during some repairing works column number 6 and the adjacent vaults collapsed. Some years later, column number 6 was rebuilt using the original stone filled with reinforced concrete, and column number 8 was filled with concrete.

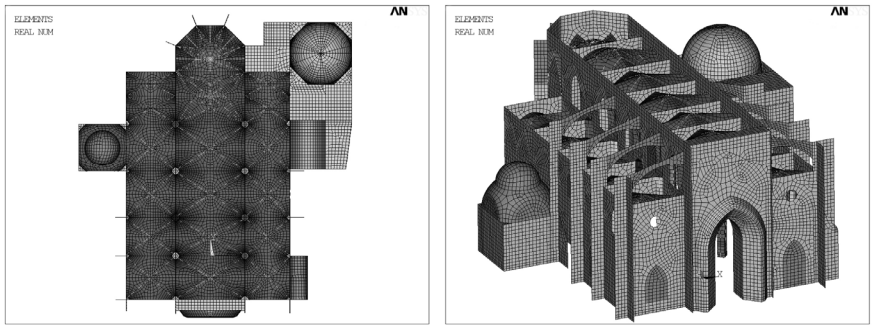
All the known geometrical and material irregularities were introduced into the model. The values of the material parameters for a linear elastic analysis were obtained through tests mentioned previously. In particular, different Young modulus values were considered for the lower and upper (above 2.00 m.) part of the piers to account for the material degradation due to rising damp (table 1).

Figure 3: Two views of the EF model
