## Assessment and restoration of a masonry dome in the cathedral of Tortosa enclosure

J. Lluís i Ginovart, A. Costa & G. Fortuny

### Abstract

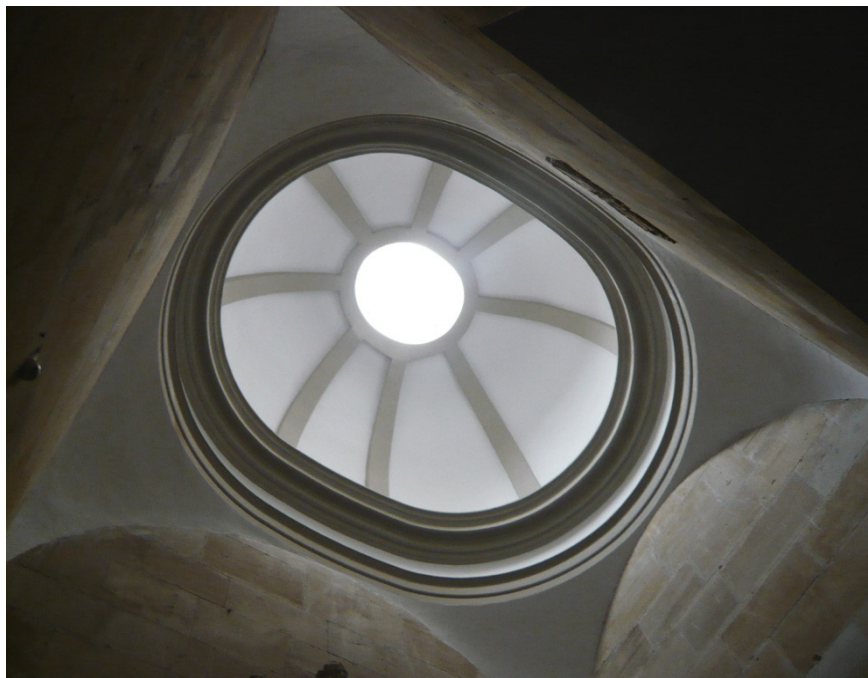
Figure 11: Bottom view of the restored dome.

The studies performed revealed that the dome itself was not enough to hold the lantern on top, collaboration of other resistant elements being necessary. Thus, it has been possible to preserve the original dome by introducing new structural elements which ensure the stability. Moreover, it has been possible to restore it with traditional techniques, keeping the historical value of this XVIIIth century masonry dome.
