## **Inspection of Palladio's Bridge in Bassano del Grappa, Italy, using positioning techniques by ropes**

D. Foppoli

*Foppoli Moretta e Associati, Italy*

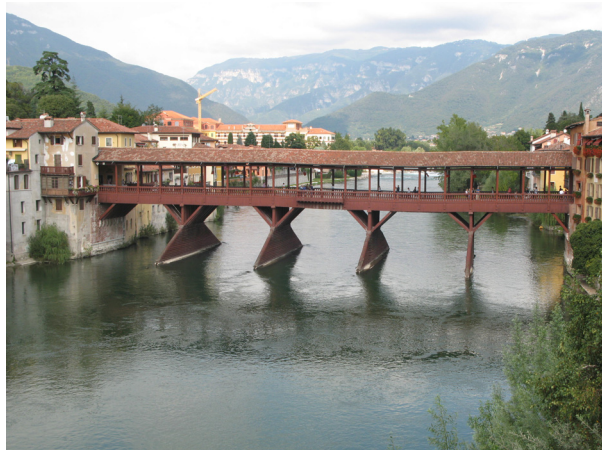
The old bridge of Bassano del Grappa (in Italy) is placed along the Brenta River that flows through the city from north to south. The structure has an overall length of 65 m and a width of 8.5 m; it is composed of 5 spans resting on two masonry abutments and on 4 piers sunk in the riverbed (Fig. 1). Each pier is made of 8 poles of equal length, arranged with equal spacing to support the deck, and six additional poles in decreasing lengths arranged both upstream and downstream to form the spurs. The poles are joined at their top by a cross beam. The deck is then supported by 8 beams arranged longitudinally to the bridge; their span length has been reduced with the interposition of cantilevers between the poles and the beams, and with the placement of other beams that act as struts, sloping close to the poles and horizontal at the centerline. The same poles are connected with wooden elements inserted between them, and opposed externally with a couple of tie rods anchored with plates in correspondence with the first and last pole. The spurs are superiorly protected by a watershed: in the upstream spur a sloping beam connects the head of the poles and is coupled with a pair of tie rods, anchored at the piles placed in the riverbed just upstream from the spur itself.

Figure 1: View of the old bridge of Bassano del Grappa from downstream.
