# KNOX METROPOLITAN CHURCH BELL TOWER RESTORATION PROJECT

JUNE BOTKIN

Botkin Historic Building Conservators Ltd., Canada

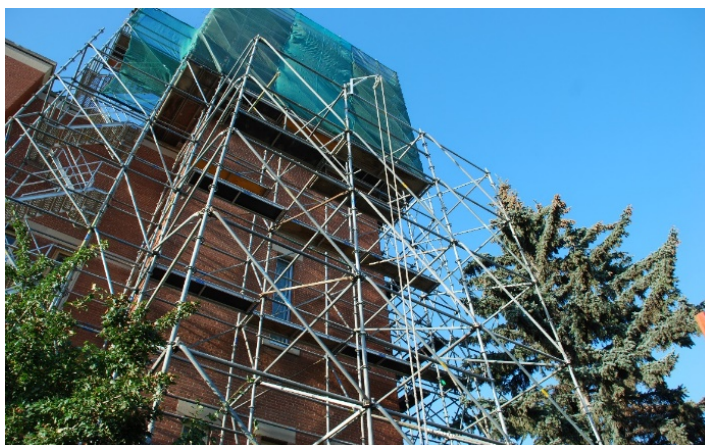
The engineered scaffold was constructed using systems scaffolding (see Fig. 2). The scaffolding components were kept 100 mm–150 mm (4"–6") away from the face of the building to prevent any damage from occurring to the masonry units. The required vertical tie-ins every 4000 mm (13') required putting the scaffold standards under tension in two directions without piercing the brick faces. Deck heights were placed at 2000 mm (6'6") and were designed to accommodate workers weighing 113.4 kg (250 lbs) each with six people maximum/tower with, 11 kg (25 lbs) of tools and a material allowance of 122 kg/m<sup>2</sup> (25 psf)/tower distributed evenly.

Figure 2: Scaffolding tower.

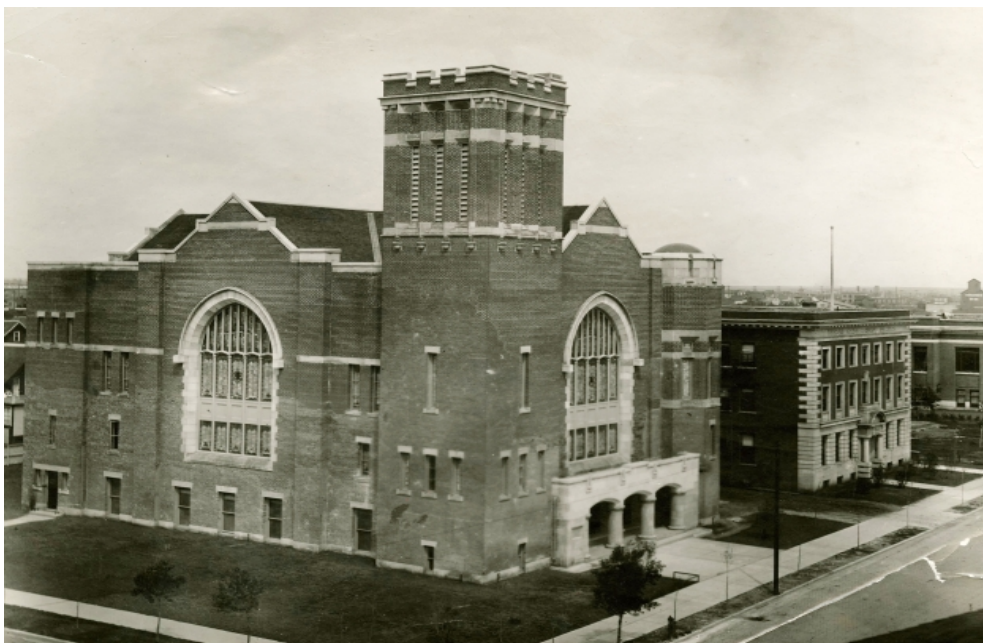
The church's windows, as they appear today, appear to be designed using the Gothic style with slender tracery which separated the five main central glazing units where the upper window section which is divided in half creating ten glazing units. The original three pairs of rectangular windows were incorporated into the significantly larger windows and eliminated in the new design (see Fig. 7). String courses that were an original part of the 1906 design were removed. Pilasters with gable caps were removed and the domed north east tower was modified to obscure the prominence of dome cap at this location. The main front entrances' wood frame, cedar shake roof was removed and a balcony with a concrete slab roof was created with a decorative parapet.

Figure 7: Metropolitan Methodist Church looking North-west, circa 1914.
