# VISUAL DOCUMENTATION OF THE STATE OF CONSERVATION BY MEANS OF UAV: THE CASE OF MARBLE CLADDING SYSTEM ON THE FAÇADES OF THE BRAZILIAN PALACE OF CONGRESS

BRUNA BARBOSA LIMA & VANDA ALICE GARCIA ZANONI  
Faculdade de Arquitetura e Urbanismo, Universidade de Brasília, Brazil

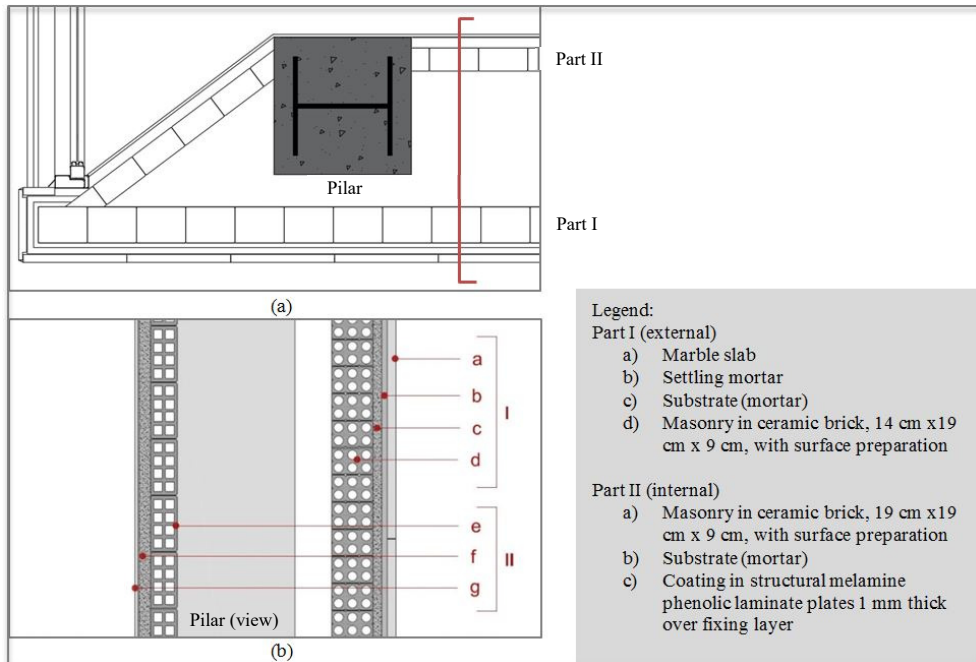
Figure 4: Detail of the marble cladding system of the Brazilian Palace of Congress, South tower. (a) Plant; (b) Vertical section. (Source: Author, 2019.)

A prospecting on the outer wall of the Southeast gable showed the presence of 20 mm marble slabs and 1/8 galvanized steel fixation wires at the back of the slabs. Petrographic tests carried out on samples of stone from this area suggested that they are interventions subsequent to the building construction, and interviews conducted with the teams responsible for building maintenance corroborate this hypothesis.

The internal prospecting of the Northwest façade confirmed the existence of double walls, according to the original designs. The outer wall, the support of the façade cladding system, is made of 6-hole ceramic bricks and dimensions of 14 cm x 19 cm x 9 cm of light brown colour, which probably indicates a brick of high burning and greater resistance. The masonry type of seating observed is very common in external vertical wall systems due to resistance and water tightness improving. The internal masonry, in its turn, has 8-hole clay red ceramic bricks of 19 cm x 19 cm x 9 cm (Figs 3 and 4). It is also possible to observe at Fig. 3 the pillar of concrete and steel located between the double walls.

The information collected allowed the characterization of the components, in other words, the four layers of the system (five, if included the preparation of the masonry surface), as shown in Fig. 4.
