Seismic behaviour and strengthening of a vulnerable structure

F. V. Karantoni

University of Patras, Department of Civil Engineering, Greece

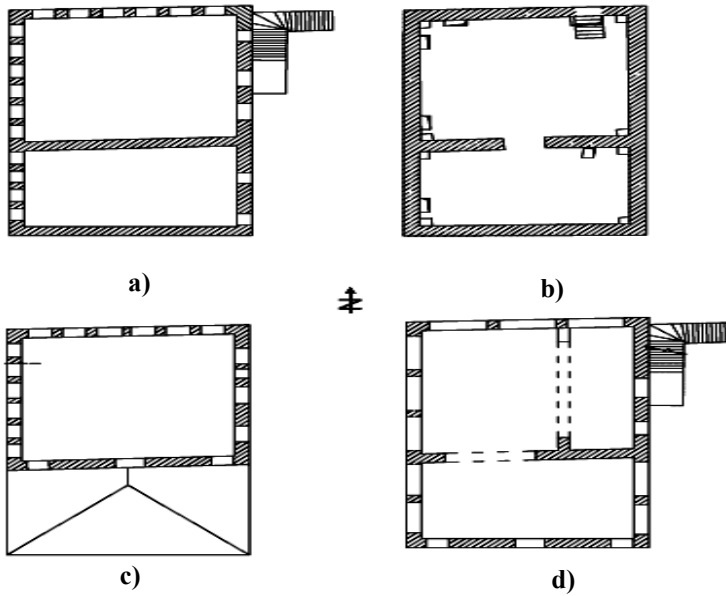
Figure 1: Plane view of the building: (a) basement, (b) ground, (c) first, and d) second storey.

The building was erected around 1900 AD. The data collected shows that it was built in two phases. One part of the building has three storeys with a total height of 11.2 m, and the other part has two storeys with a total height of 7.0 m. The adjacent wall (running from east to west) carries the load from the two parts. Each one of the two sections has a basement. In Fig. 1 the plane view of the storeys is presented. The main material of the structural walls is uncoarsed stone masonry but some parts are of solid bricks and some other of parallel alternate rows of solid bricks and stone. The building has floors of wooden beams and a roof of wooden truss and clay tiles and its main characteristic is the high percentage of openings in the north and the west side (71% of the length of the walls, see Figs. 1 and 2), and the two cross vaults which constitute the basement roof (see Fig. 3). One of the four columns, which support each one of the cross vaults, is also shown in Fig. 3. These columns are not in conjunction to the structural walls but they are 50 mm apart. The openings in the south face have been filled up with stone and cement blocks. The openings in the west side of the second storey of the two storey part of the building have also been filled up. These walls are embedded to the adjacent walls and are not jointed to them. This yields the separation of the majority of the vertical interfaces due to developed cracking. On the ground floor the only internal wall running from north to south is supported from the vaulted roof of the basement and was added after the erection of the building. This wall has developed diagonal cracking near the lower part due to settlement. Another unusual characteristic is that the openings of the ground story intersect the floor of the first storey (see Fig. 4).

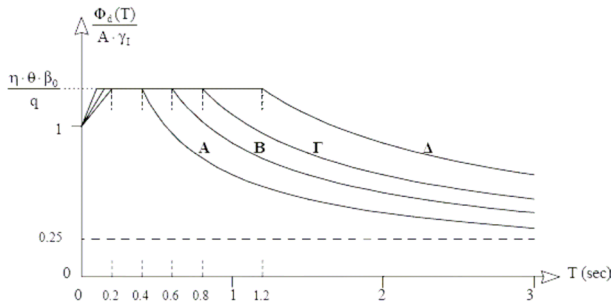
Figure 6: The design spectrum of Greek Seismic Code for $\frac{\eta\theta\beta_0}{q} = \frac{2.5}{2.0}$.

First, a spectral analysis of the original building was performed. The equations (2) and (3) were used for the calculation of the spectral coordinate of the design spectrum shown in Fig. 6.
