## Case study: the strengthening and seismic safety of the Oni synagogue in Georgia

### Abstract

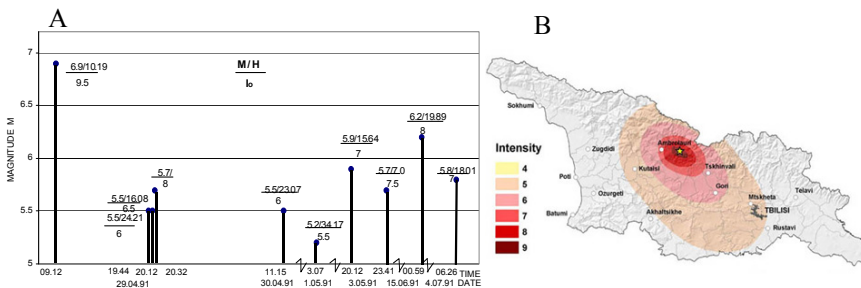
The building of the synagogue in Oni is located in an active seismic zone in North Georgia, Caucasus. On April 29, 1991 there was an earthquake in northern Georgia. Magnitude of the earthquake in Racha, Georgia, on April 29, 1991 by Richter scale according to the accepted estimations was  $M_s = 6.9$ . This magnitude corresponds to the intensity of  $I_0=9.5$  on the MSK-64 twelve-step scale. Several thousands of aftershocks were registered later on, during four months. Their magnitudes varied between  $M = 6.2$  and  $M = 5.3$ , being sometimes almost as powerful as the primary shock. The following chart (Fig. 2) illustrates this situation [7].

Figure 2: Seismic situation caused by the earthquake in Racha, Georgia, between April 29 and July 04, 1991, in the epicenter: A – diagram: M – Richter magnitude; H – focus depth, km;  $I_0$  – intensity on MSK-64 scale; B – calculated earthquake intensity map.

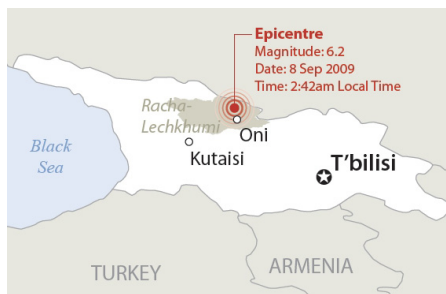
On September 8, 2009, there was an earthquake in northern Georgia. The magnitude in the epicentre of the earthquake was 6.2. 1,400 houses were damaged or destroyed. The epicentre was 12 km from Oni which was the most damaged location (Fig. 13).

Figure 13: Seismic situation caused by the earthquake in Georgia, 2009.

The building of the synagogue in Oni survived this earthquake without any substantial damage caused. It proves the effectiveness of the strengthening and rehabilitation works in these buildings performed by us.
