Assessing damage for Herkenbosch, The Netherlands, due to the Roermond earthquake of April 13, 1992

P.M. Maurenbrecher, G. de Vries

*Faculty of Mining and Petroleum Engineering, University of
Technology, 2628 RX Delft, The Netherlands*

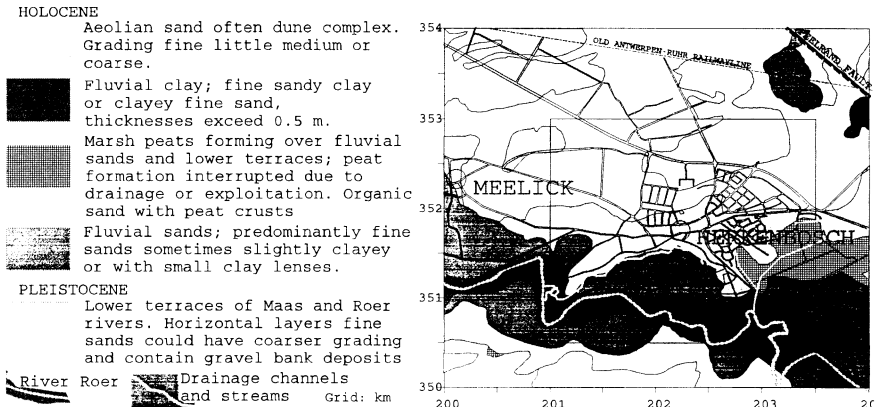
Figure 3: Herkenbosch present urban road structure in relation to geology from 1933 map²

The maps were combined to conform to the topographical map³ Amersfoort coordinate system. Examples of geographical and statistical distribution of types of damage based on database selection criteria are given in Fig. 2. The geology map in Fig. 3 depicts the same geographical features as the thematic maps so as to enable comparisons with the type of information presented in Fig. 2.
