# **Structural defects and solutions: A case study of Fort Cornwallis, Penang, Malaysia**

## **Abstract**

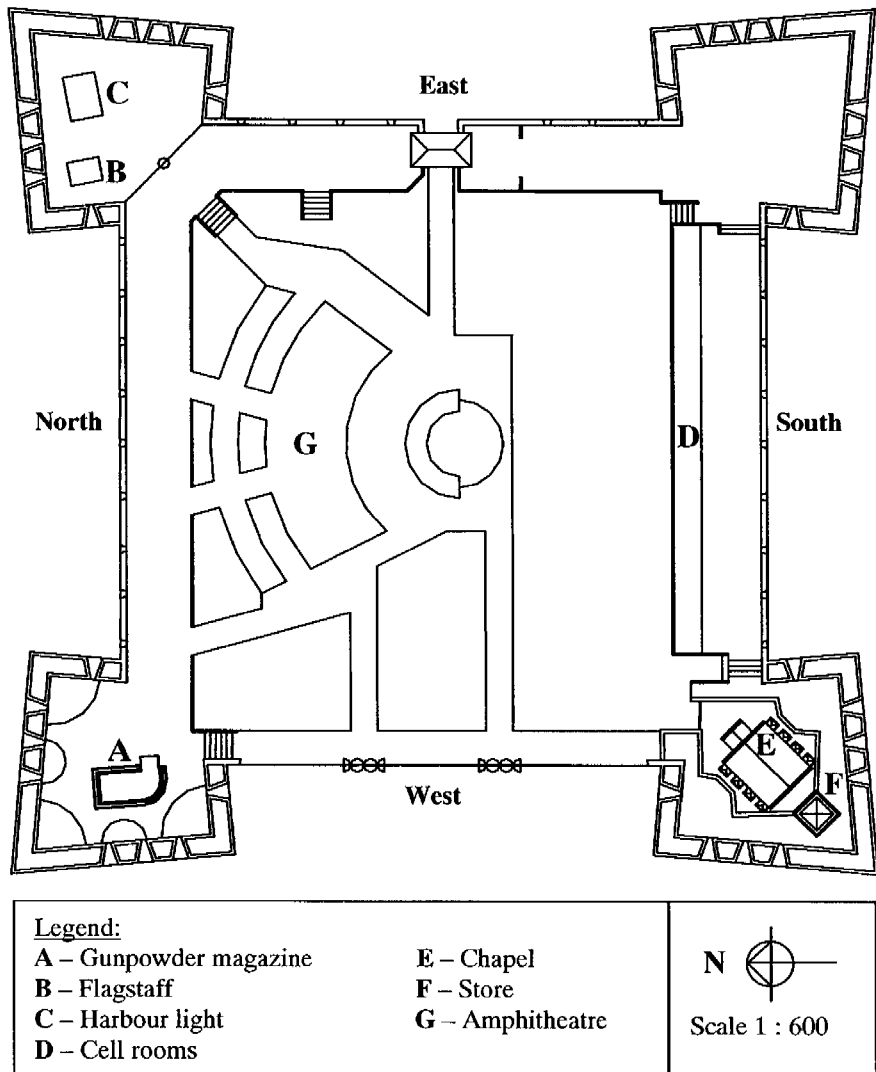
Figure 1: The floor plan of the Fort Cornwallis (before restoration) showing the four zones of its walls and the locations of some of the original structures (A, B, C, D, E and F). The amphitheatre (G) was built in early 70's.

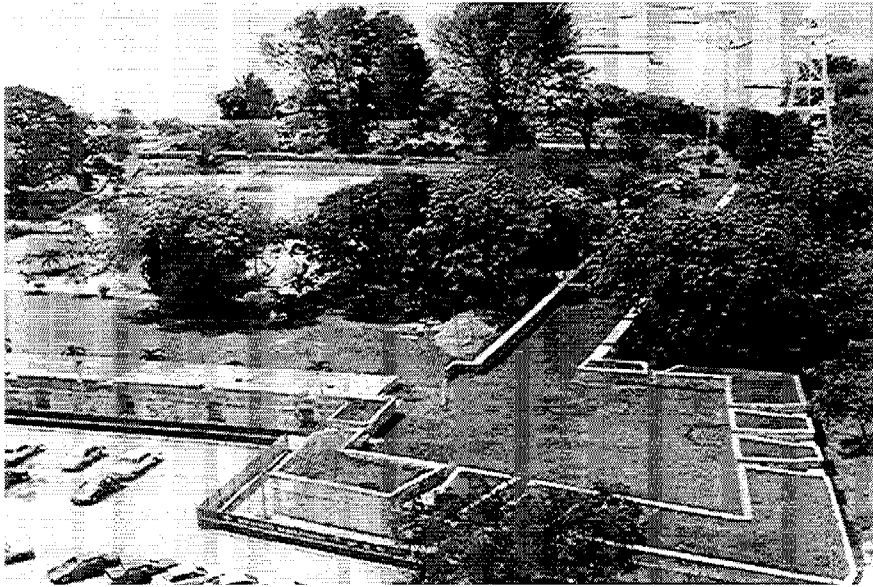
Figure 2: An aerial view of the Fort Cornwallis (during its restoration work) showing one of its double-walled corners as well as the flagstaff and harbour light at the upper right.

north zones mainly at double-walled corners. As the result, major cracks had occurred at these affected walls. Due to the conditions of the leaning walls, the earth filled in between the double walls were found to be sagged and uneven. On the other hand, collapsed walls were found mostly on the top of the walls located at both east and north zones of the Fort. Apart from the existing walls that had been leaned or collapsed, the demolished walls at the west zone were also taken into account as one of the structural defects of the Fort Cornwallis. Reconstruction of the walls at the west zone was carried out to bring back the Fort to its original shape.
